# Recall Campaign Bulletin

Campaign No. 2010100002, October 2010

SUBJECT: **Models 204, 207, 212 Model Year 2010, Model 207.4 Model Year 2011  
Check Power Steering Line Connection Fitting**

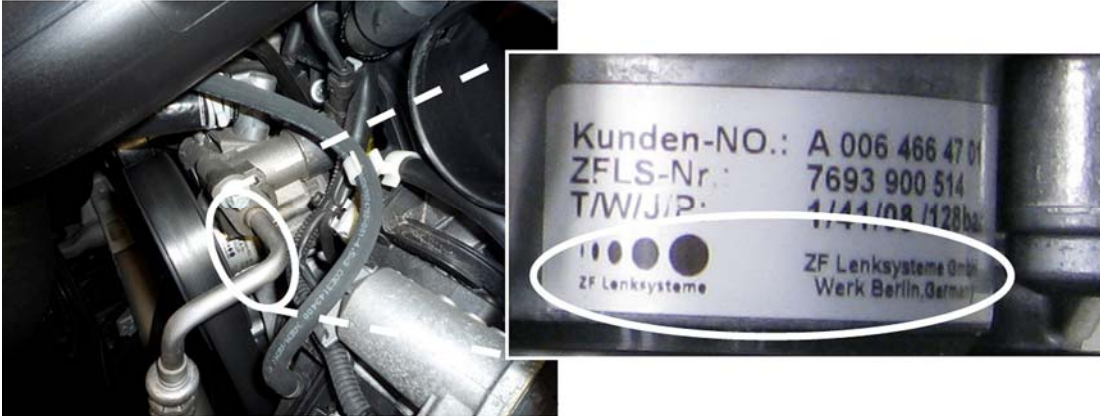
Figure 1

2. Check identification plate of power steering pump (Figure 1).

- If Manufacturer is "ZF Lenksysteme": Proceed to Subject B, **Check Power Steering Pump**
- If other manufacturers: **Procedure is complete.**

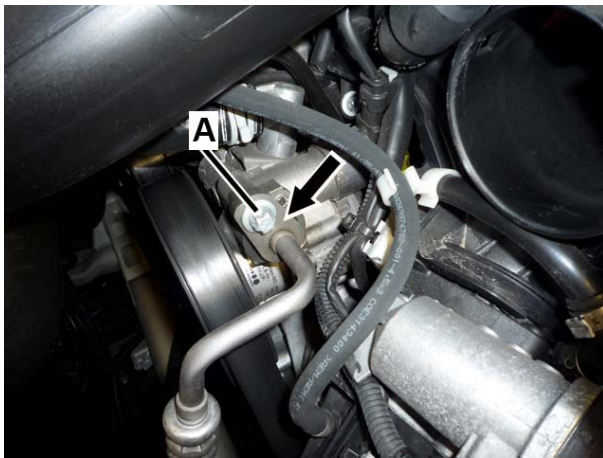
Figure 3

This Recall Campaign has been initiated because Daimler AG (DAG) has determined that the power steering system in the subject vehicles may fail due to the loss of power steering fluid. The connection fitting on the high-pressure power steering line at the connection to the pump did not have sufficient torque applied during the production process. Loss of torque of the connection fitting may, over time, result in a loss of power steering fluid. As a result of the loss of power steering fluid, owners may not have sufficient control of the vehicle in areas, such as parking, where maximum power steering is required, and could lead to a vehicle crash.

2. Disconnect power steering high pressure line fitting (arrow, Figure 3) from the pump:
  - Place a shop rag below the power steering pump line fitting (arrow, Figure 3).
  - Remove bolt (A)
  - Disconnect power steering high pressure line fitting (arrow, Figure 3) from power steering pump.
3. Put socket wrench bit (special tool) onto connection fitting (arrow, Figure 4) and check whether it can be turned **by hand** (without any tools).

4. Check for leaks at the power steering line connection fitting (arrow, Figure 3) to the power steering pump.

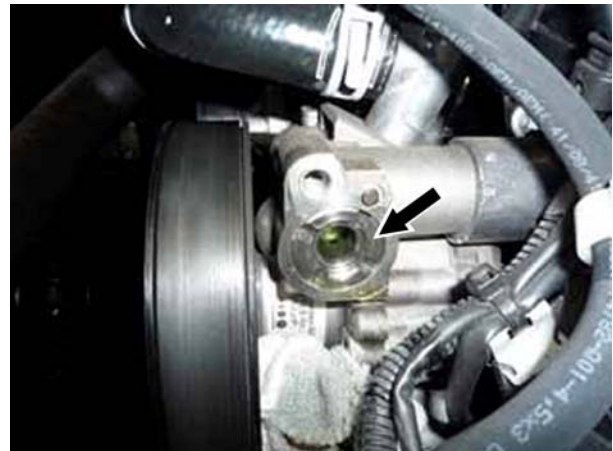
Figure 4

- If the connection fitting (arrow, Figure 4) **cannot** be turned by hand: Proceed to **Subject C**.
- If the connection fitting (arrow, Figure 4) **can** be turned by hand: Proceed to **Subject D**.

- If the connection fitting (arrow, Figure 4) **cannot** be turned by hand, the O-ring of the fitting does **not** have to be replaced.
- If the connection fitting (arrow, Figure 4) can be turned, as a precaution, the O-ring ring must be replaced.

1. **Torque connection fitting** (arrow, Figure 4) using socket wrench to 55 Nm.
2. Reconnect power steering high pressure line fitting (arrow, Figure 3) to the connection fitting on power steering pump then torque bolt (A, Figure 3) to 18 Nm.

1. Completely unscrew connection fitting (arrow, Figure 4) and replace O-ring on connection fitting (arrow, Figure 4).
2. **Torque connection fitting** (arrow, Figure 4) using socket wrench to 55 Nm.
3. Reconnect power steering high pressure line fitting (arrow, Figure 3) to connection fitting on power steering pump then torque bolt (A, Figure 3) to 18 Nm.
