SERVICE BULLETIN

Number: 15-001

GM 6.6L Cable Connection Mandatory Product Improvement

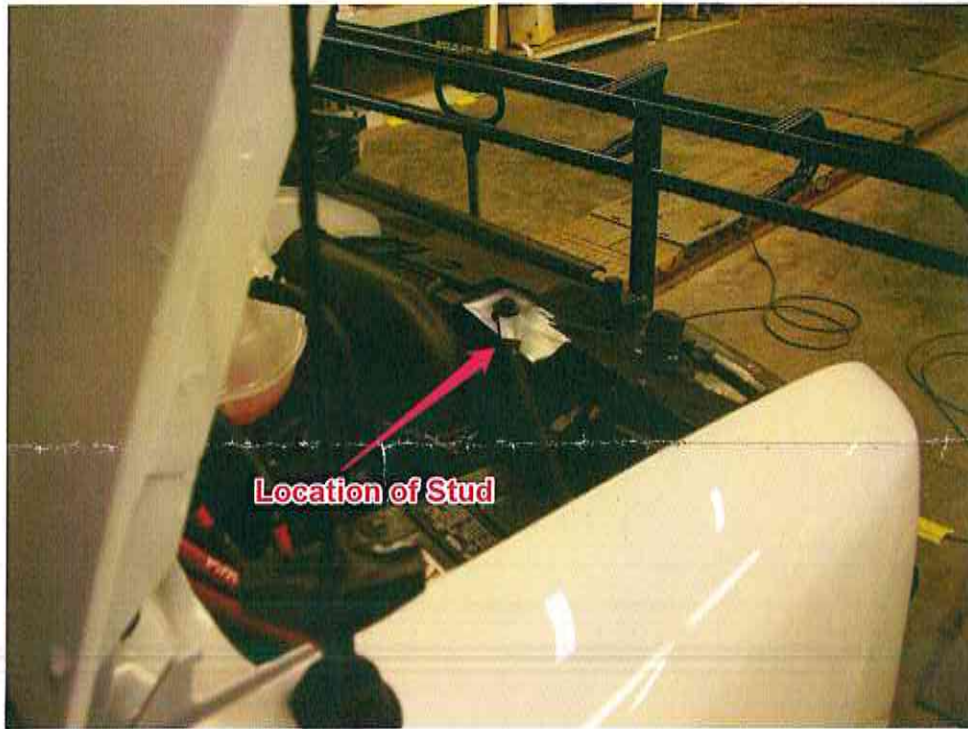
Fig 1

1. Open hood.
2. Locate the terminal strip (three studs) See Fig. 1 & Fig 2
3. Verify that the cable (blue) on the stud nearest the driver's side is secured correctly. See Fig. 3 & Fig 4

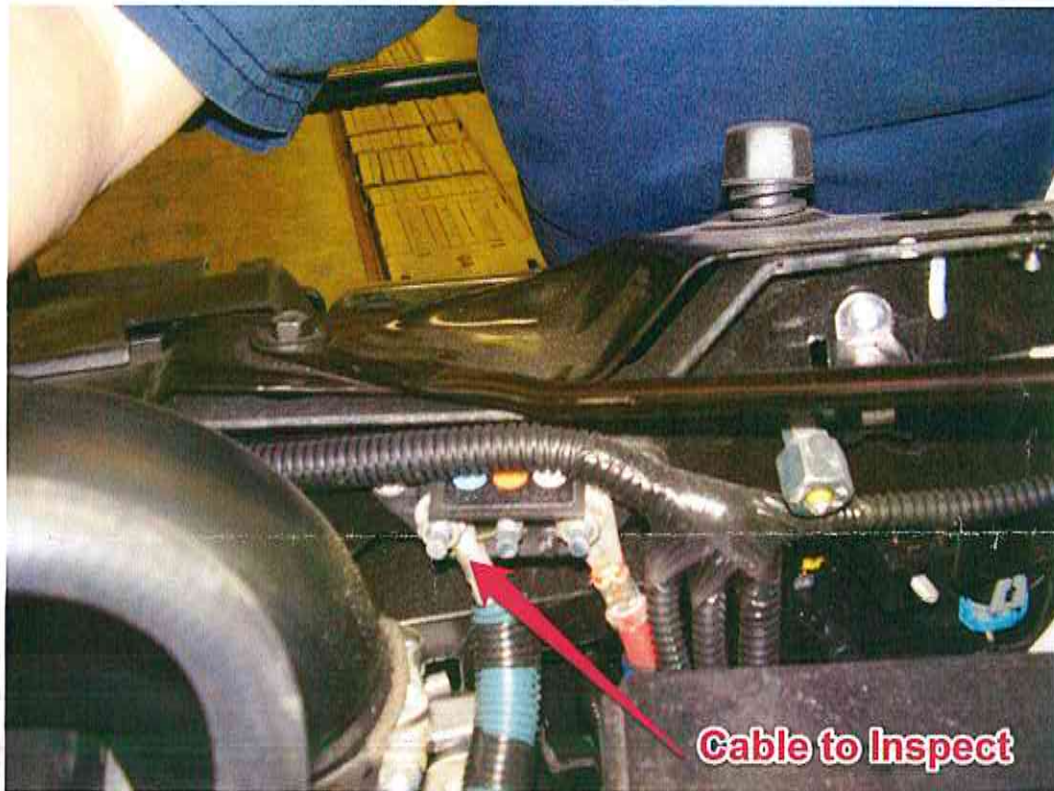
Fig 3

Trans/Air has become aware of isolated instances where, the cable routed across the top of the fan shroud is not properly positioned on the terminal strip, located at the front of the engine compartment. This could cause a poor connection, or a loose connection, causing heat or arching, and leading to a possible ignition source.

Inspect cable-to-stud connection. If the cable is angled (off vertical) over the edge of the terminal strip, loosen the self-locking nut and slightly rotate the cable to its proper vertical position, and tighten the nut securely.
