# INDIANA UNIVERSITY

### **ON-SITE REDESIGNED AIR BAG INVESTIGATION**

CASE NUMBER - IN00-001  
LOCATION - WISCONSIN  
VEHICLE - 2000 CHEVROLET SILVERADO K-1500  
CRASH DATE - October, 1999

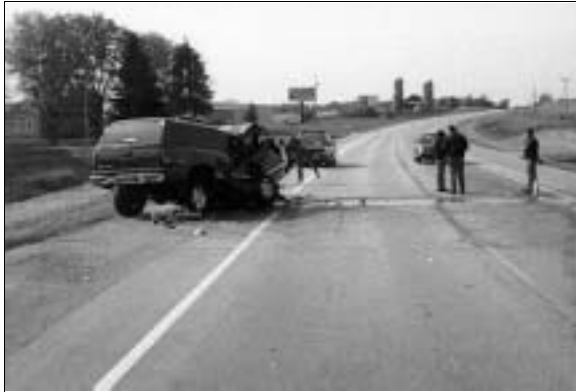
**Figure 2:** On-scene southwestward view of case vehicle's final rest position on southeast shoulder; Note: vehicle #2 was traveling northeastward in left-hand curve (case photo #02)

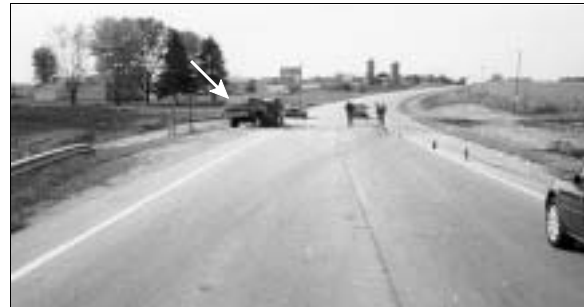
The U.S. highway was curved slightly to the right for southwestbound traffic [i.e., case vehicle (**Figure 1**); left for northeastbound traffic (i.e., vehicle #2; **Figure 2**)] and level at the area of impact. The pavement was bituminous, and according to police measurements, the width of the travel lanes for both vehicles was 3.7 meters (12 feet). The shoulders were improved (i.e., bituminous), with a 0.9 meter (3.0 foot) wide paved shoulder and a 2.7 meter (8.9 feet) wide gravel shoulder immediately adjacent. There was a guardrail along the southeast side of the road which was adjacent to a small cement bridge, approximately 3 meters (10 feet) west of the impact area. Pavement markings consisted of a single broken yellow centerline for both northeast and southwestbound traffic. In addition, solid white edge lines were present. The estimated coefficient of friction was approximately 0.85 when dry. There were no visible traffic controls in the immediate area. The posted speed limit was 89 km.p.h. (55 m.p.h.). At the time of the crash the light condition was daylight, the atmospheric condition was cloudy, and the road pavement was

**Figure 1:** On scene view of case vehicle's southwestward travel path in right hand curve as it crossed into northeastbound lane where crash occurred; Note: case vehicle's final rest position on southeast shoulder (case photo #01)

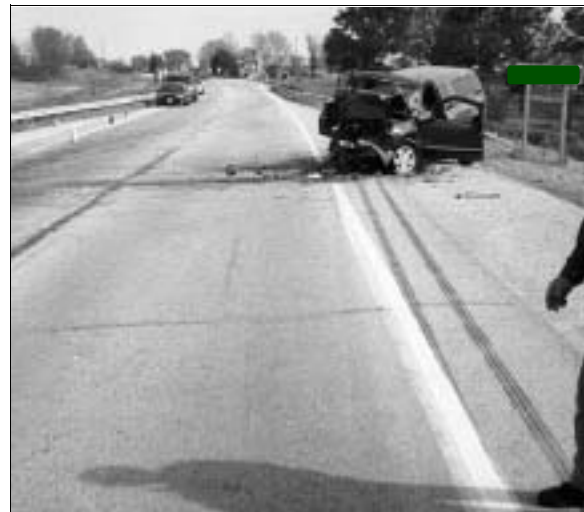
the crash (**Figure 3**). Based on the county sheriff's scene reconstruction, the crash occurred 2.9 meters (9.4 feet) into the northeastbound lane of the roadway towards the edge line; see **CRASH DIAGRAM** below.

**Figure 3:** On scene northeastward view of case vehicle's final rest position on southeast shoulder and vehicle #2's straight line skid marks into impact near right (southeast) edge line; Note: case vehicle had been traversing a right-hand curve (case photo #04)

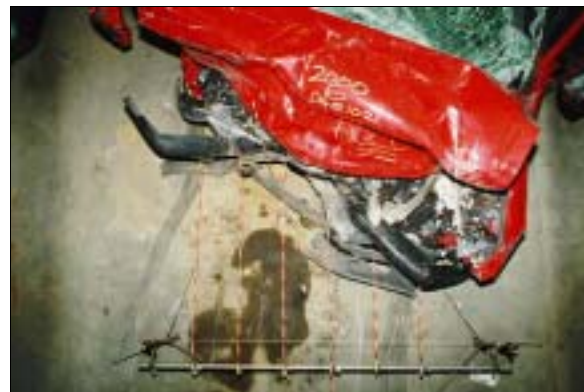
**Figure 4:** Overhead view of crush to case vehicle's front with contour gauge present showing offset (toward right) nature of crash (case photo #11)

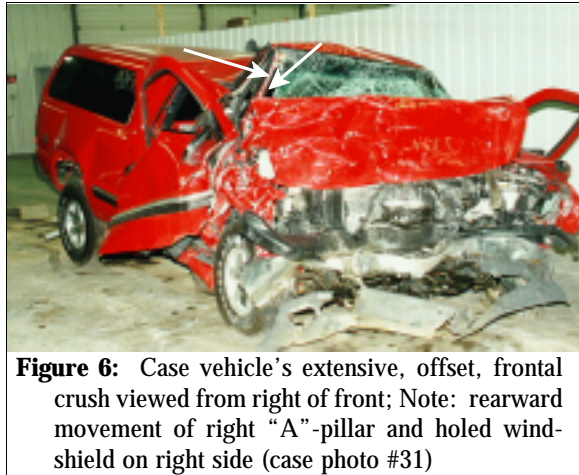
**Figure 6:** Case vehicle's extensive, offset, frontal crush viewed from right of front; Note: rearward movement of right "A"-pillar and holed windshield on right side (case photo #31)

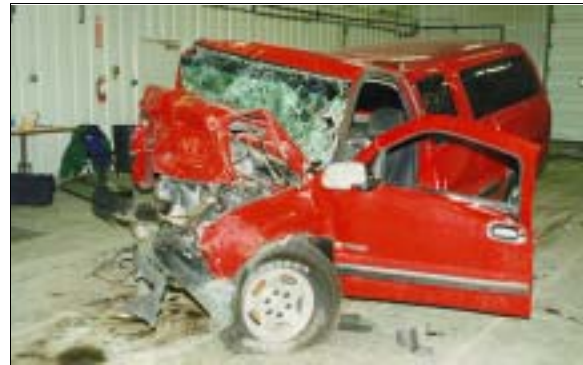
**Figure 5:** Extensive crush to case vehicle's front right portion viewed from left of front; Note: both "A"-pillars are deformed (case photo #14)

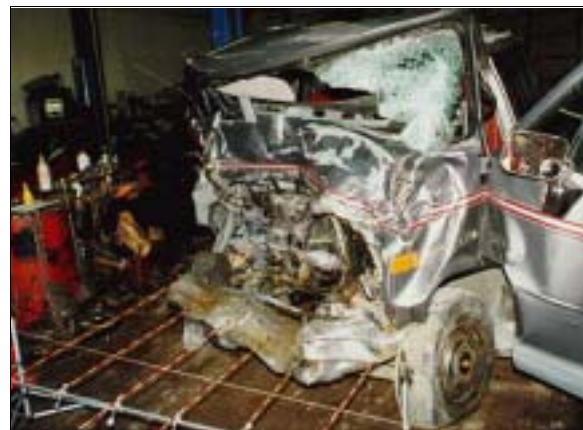
**Figure 7:** Vehicle #2's extensive, offset, frontal crush viewed from left of front with contour gauge present (case photo #65)

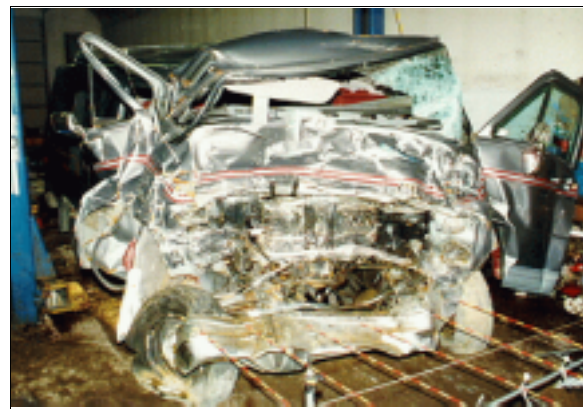
**Figure 8:** Vehicle #2's extensive, offset, frontal crush, with contour gauge present, viewed from right of front (case photo #70)

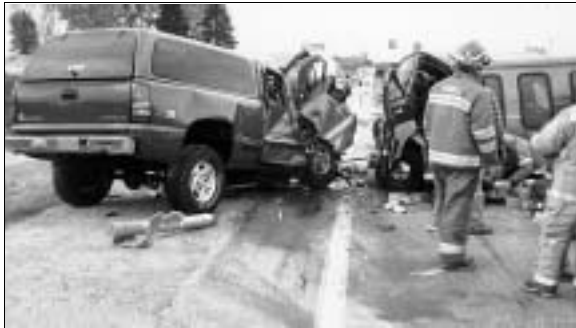
**Figure 9:** On scene southwestward view along the edge line bordering the northeastbound lane showing case vehicle (to left) and vehicle #2 (to right) at final rest; Note: technicians are attempting to stabilize vehicle #2's driver (case photo #05)

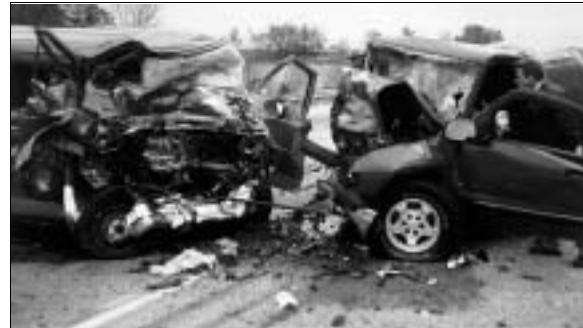
**Figure 10:** On scene northward view from southeast roadside showing vehicle #2 (to left) and case vehicle (to right) at final rest (case photo #07)

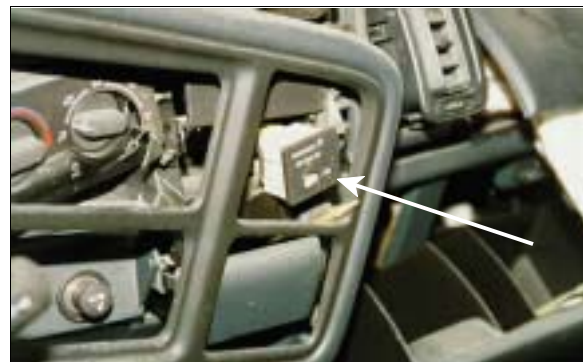
**Figure 11:** Close-up of case vehicle's key operated On/Off switch for front right passenger air bag; Note: switch was in On position (case photo #60)

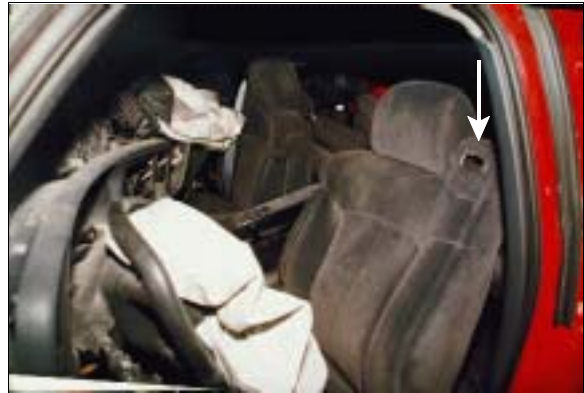
**Figure 12:** Case vehicle's driver seating area viewed from outside driver's door showing opening on seat back for driver's shoulder belt retractor; Note: intrusion to passenger area (case photo #42)

The case vehicle's driver [195 centimeters and 115 kilograms (77 inches, 254 pounds)] was restrained by his available, active, three-point, lap-and-shoulder, safety belt system. The inspection of the driver's seat belt system showed that the belt had been cut to the shoulder portion with the latch still engaged (**Figure 19**). The webbing and latch plate showed evidence of loading (i.e., waffling and heat abrasion) as well as a skin transfer on the shoulder portion. It should be noted that the retractors for the front seat shoulder belts were mounted in the driver's seat back and were designed without a "D"-ring (**Figure 12** above).

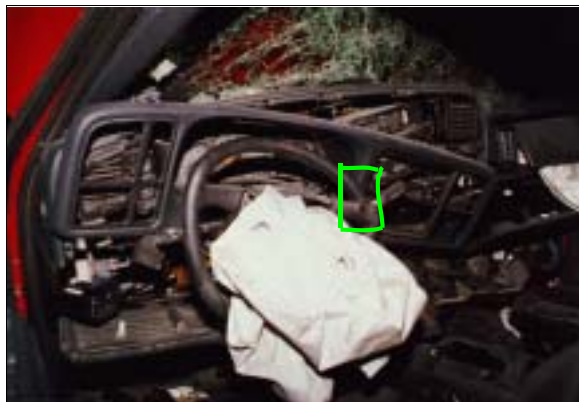
**Figure 13:** Case vehicle's driver seating area showing deployed driver air bag; Note: deformed and fractured steering wheel rim (case photo #46)

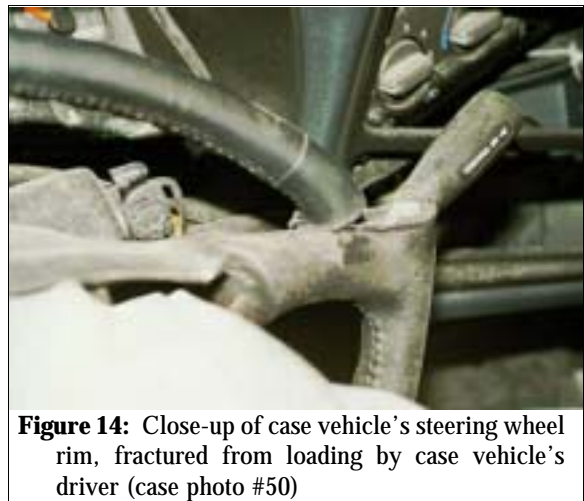
**Figure 14:** Close-up of case vehicle's steering wheel rim, fractured from loading by case vehicle's driver (case photo #50)

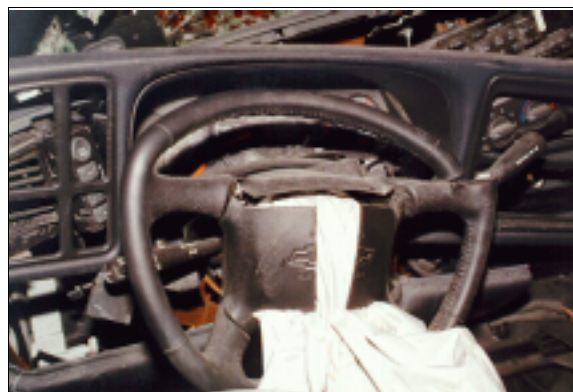
The case vehicle’s driver air bag was located in the steering wheel hub. The module cover consisted of symmetrical “I”-configuration cover flaps made of thick vinyl with overall dimensions of 8.5 centimeters (3.3 inches) at the left and right horizontal seams and 11 centimeters (4.3 inches) vertically (**Figure 15**). An inspection of the air bag module’s cover flaps and air bag fabric revealed that the cover flaps opened at the designated tear points, and there was no evidence of damage during the deployment to the air bag or the cover flaps. The driver’s air bag was designed with four tethers, each 10 centimeters (3.9 inches) wide, sewn interiorly. The driver’s air bag had two vent ports, approximately 3 centimeters (1.2 inches) in diameter, located at the eleven and one o’clock positions. The deployed driver’s air bag was round with a diameter of 66 centimeters (26.0 inches). An inspection of the case vehicle’s driver air bag revealed three areas of skin transfer and blood splotch evidence readily apparent on the driver’s air bag. The largest area of skin was 12 x 6 centimeters (4.7 x 2.4 inch) located near the top. There was what appeared to be a small chunk of skin or possibly mucous in the center near the right side of the tether stitching, and there was skin and blood along the right side of the air bag’s fabric (**Figure 16**). In addition, there was a small spot of blood on the backside of the air bag’s shell near the top.

**Figure 15:** Case vehicle’s loaded and deformed steering wheel showing deployed driver air bag, “I”-configuration cover flaps, and cracked rim (case photo #49)

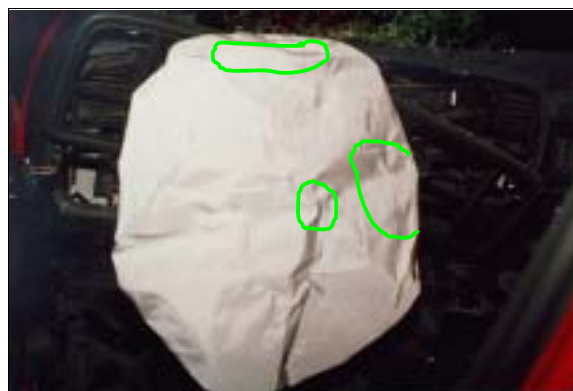
**Figure 16:** Case vehicle’s deployed driver air bag; Note: highlighted areas denote skin transfers (case photo #51)

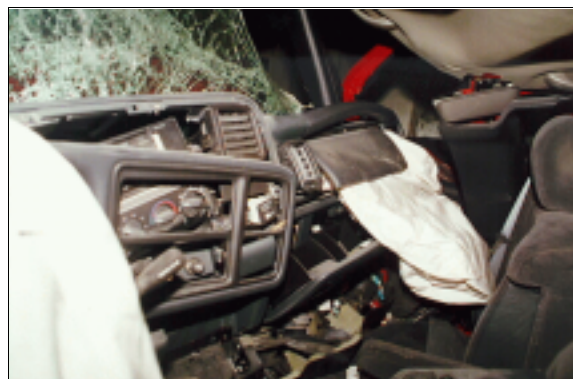
The front right passenger's air bag was located in the middle of the instrument panel. As previously mentioned, the case vehicle was equipped with a key-operated On/Off switch for the front right passenger air bag which was turned to the "On" position (Figure 11 above). There was a single, essentially rectangular, hinged modular cover flap (Figure 17). The cover flap was made of a thick vinyl over a thick cardboard type frame. The flap's dimensions were: 38 centimeters (15.0) along both horizontal seams and 14 centimeters (5.5 inches) along both vertical seams. The profile of the case vehicle's instrument panel was flush with the leading edge of the cover flap. An inspection of the front right air bag module's cover flap and air bag revealed that the cover flap opened at the designated tear points, and there was no evidence of damage during the deployment to the air bag or the cover flaps. The front right passenger's air bag was designed without any tethers. The front right air bag had two vent ports, approximately 5 centimeters (2.0 inches) in diameter, located at the ten and two o'clock positions. The deployed front right air bag was rectangular with a height of approximately 32 centimeters (12.6 inches) and a width of approximately 56 centimeters (22.0 inches). There was no contact evidence readily apparent on the front right air bag; although, there was a drop of blood on the far left side of the front portion.

**Figure 17:** Case vehicle's deformed center instrument panel and front right seating area showing front right passenger air bag module's On/Off switch and module's cover flap and deployed air bag (case photo #59)

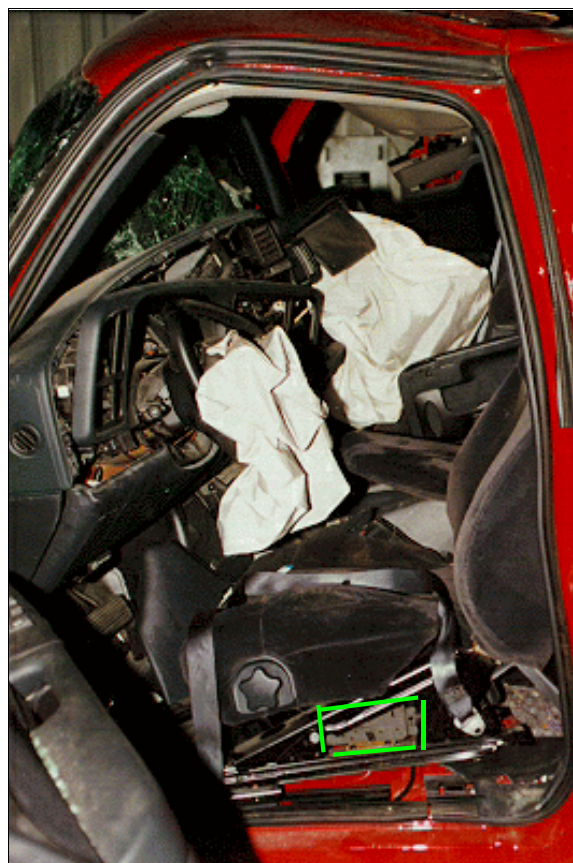
**Figure 18:** Case vehicle's front seating area viewed from outside driver's door showing intrusion to front right passenger seating area; Note: area highlighted under driver's seat is location of the Sensing and Diagnostic Module (case photo #37)

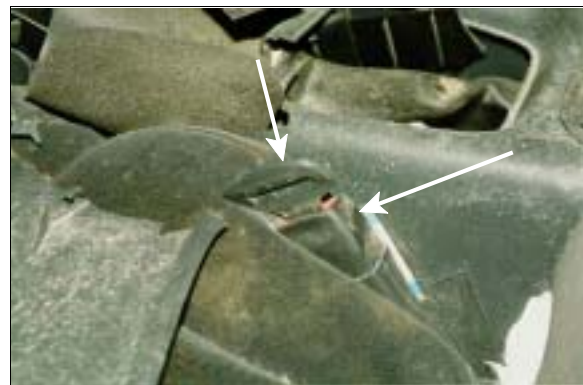
**Figure 19:** Close-up of case vehicle's engaged driver seat belt buckle and latch plate (case photo #39)

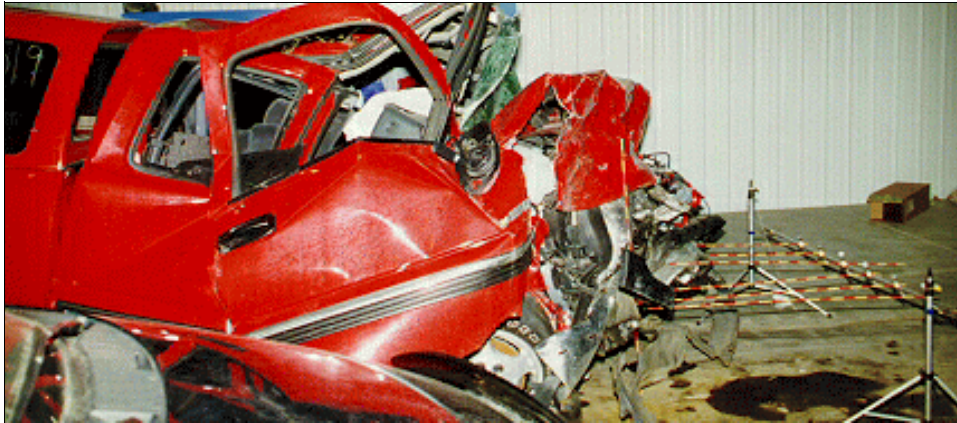
**Figure 20:** Right side view of extensive deformation to case vehicle's front (case photo #27)

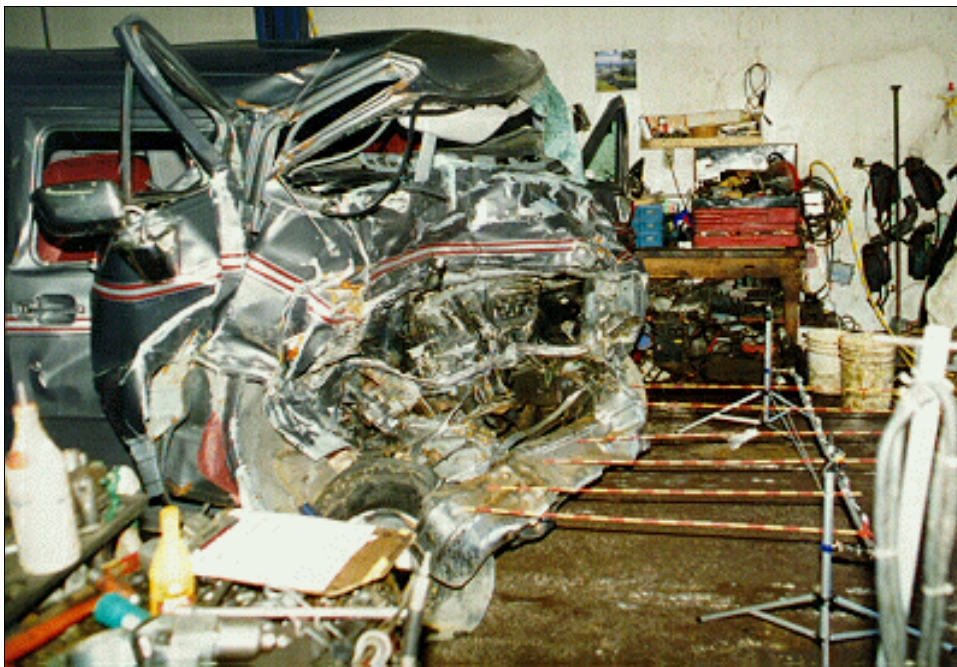
**Figure 21:** Vehicle #2's offset (toward right) frontal crush viewed along front reference line from right with contour gauge present (case photo #69)

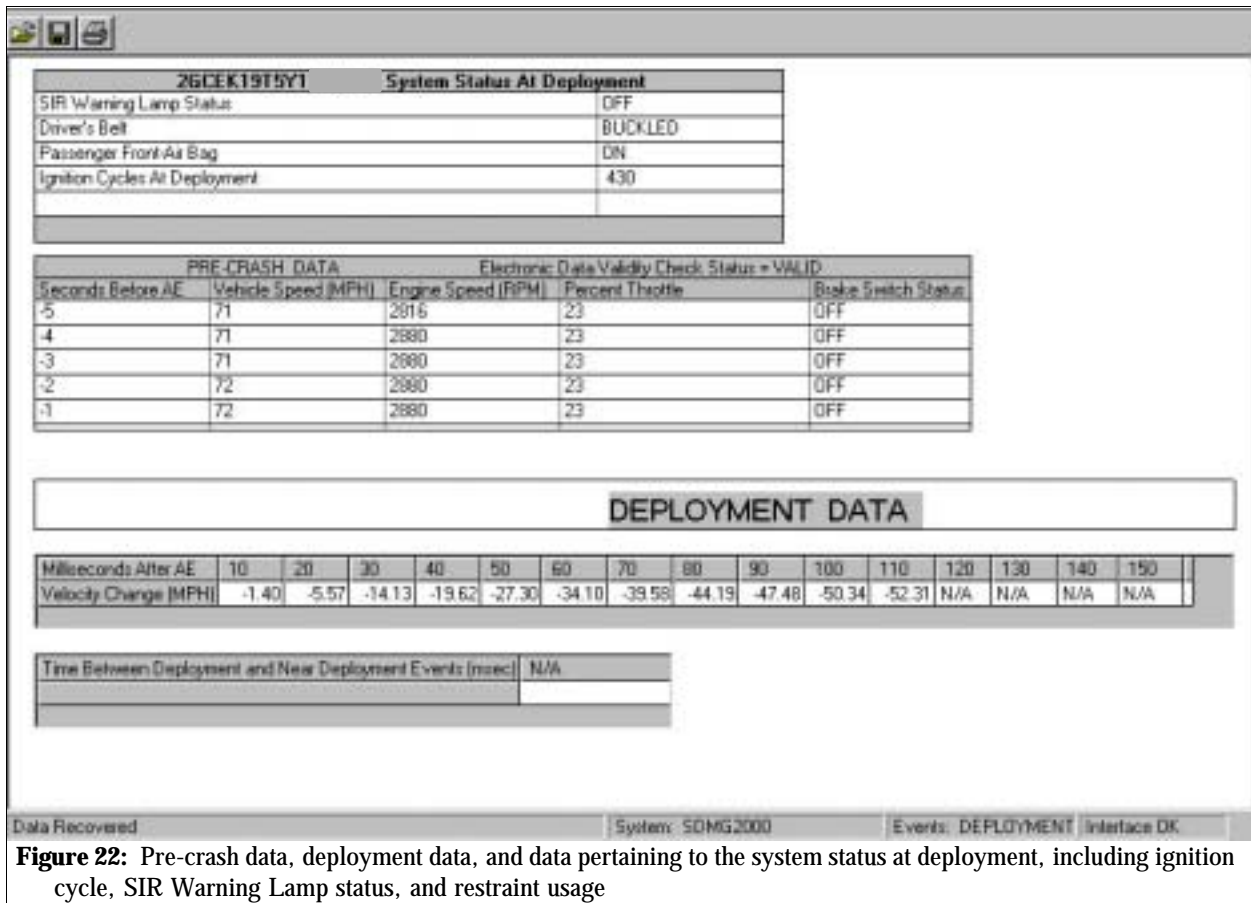
The SDM recorded and stored a **crash event** that occurred on ignition cycle number 430. The SDM system reported no faults or warning codes because the SIR Warning Light was **OFF** at the time of the deployment. The case vehicle's air bags were commanded to deploy 30 milliseconds into the event (i.e., after the collision was first detected by the SDM). The SDM recorded a maximum change in velocity (Delta V) of 84 km.p.h. (52 m.p.h.). The Delta V reached this maximum value at 110 milliseconds after the crash was first detected. The SDM did not record any **near-deployment** events prior to ignition cycle 430 (i.e., the crash in question). The SDM indicated that the driver's safety belt was latched at the time the deployment occurred.

**Figure 22:** Pre-crash data, deployment data, and data pertaining to the system status at deployment, including ignition cycle, SIR Warning Lamp status, and restraint usage

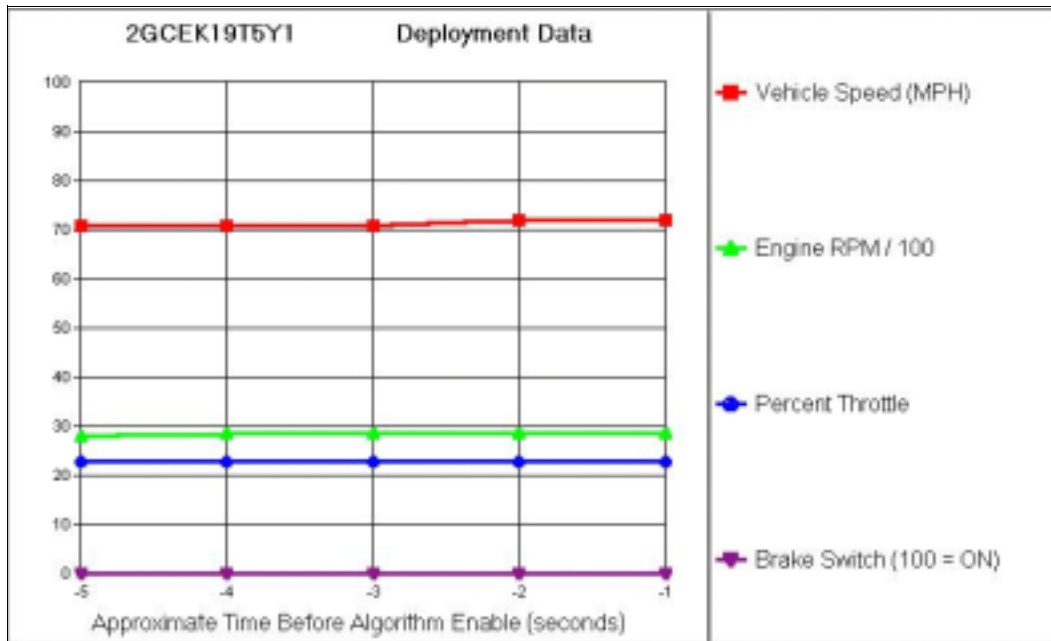
**Figure 23:** This graph charts the case vehicle’s pre-crash and shows that prior to impact the case vehicle’s speed was recorded at 115 km.p.h. (71-72 m.p.h.) and that the brake switch was OFF at the five recorded sample periods

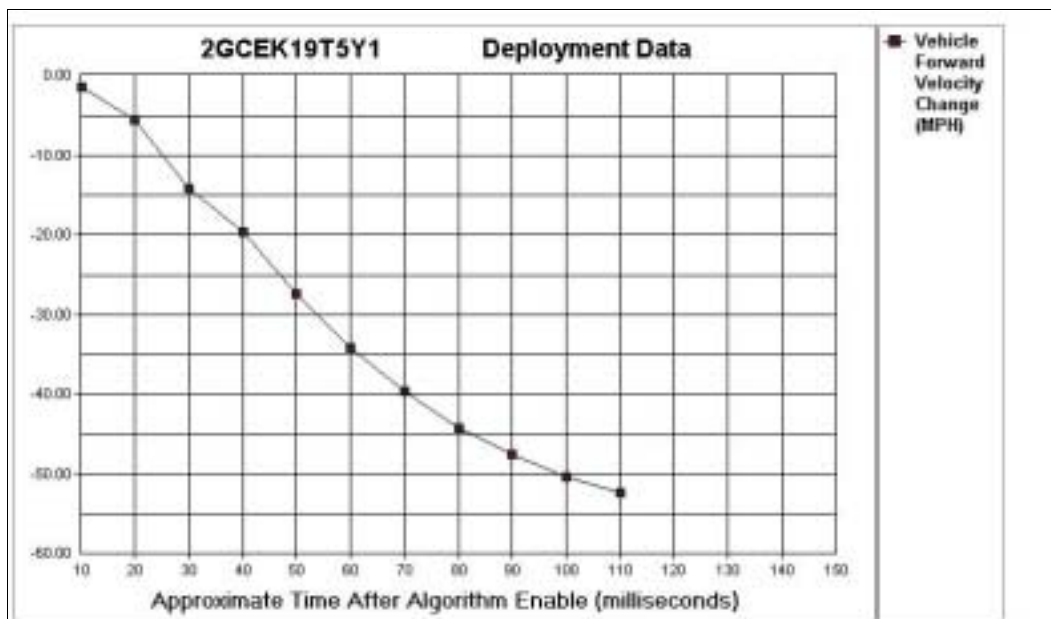
**Figure 24:** This graph charts the case vehicle’s maximum velocity change of 84 km.p.h. (52 m.p.h.) which occurred 110 milliseconds after the crash was detected
