On-scene Investigation / Vehicle to Vehicle Dynamic Science, Inc. / Case Number:DS00-006 2000 Ford Taurus California May, 2000 This document is disseminated under the sponsorship of the Department of Transportation in the interest of information exchange. The United States Government assumes no responsibility for the contents or use thereof.

Dynamic Science, Inc. Accident Investigation Case Number: DS00-006

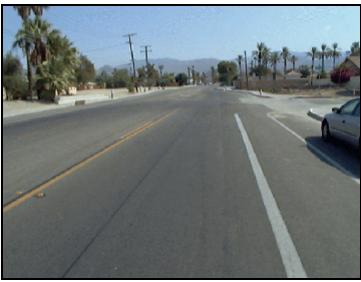
Figure 1. Case vehicle approach to area of impact

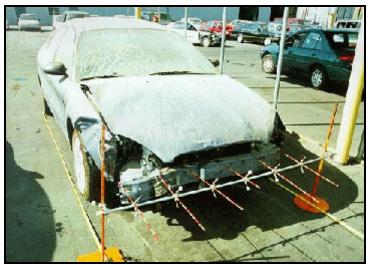
Figure 2. Exterior, case vehicle

2000 Ford Taurus				
Description:	2000 Ford Taurus			
VIN:	1FAFO5222YGxxxxx	XX		
Odometer:	5,037 km (3,130 miles	5)		
Engine:	V6			
Reported Defects:	None			
Cargo:	None			
Damage Description:	Minor to moderate fro grille.	ntal crush to bumper and		
CDC:	12FDEW1			
Delta V:	Total	18.7 km/h (11.6 mph)		
	Longitudinal	-18.4 km/h (-11.4 mph)		
	Latitudinal	3.2 km/h (2.0 mph)		
	Energy	14,229 joules (10,495 ft-lbs)

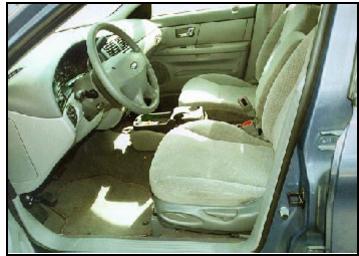
Figure 3. Driver's seated position

The 40-rear-old female driver (168 cm/66 in., 50 kg/110 lbs.) of the case vehicle was seated in a forward facing fashion. She was wearing the available lap and shoulder belt. The shoulder belt upper anchorage was adjusted to the mid position. The seat was in the full rearward position at the time of inspection, but the driver indicated that she normally had the seat in a more middle position. The seat back was set at 13 degrees from vertical. The tilt steering wheel was adjusted to between the full up and the center position. The driver of the case vehicle indicated that she saw the Marquis moving slowly in the turn lane. She took her foot off the accelerator and then noticed that the Marquis was going to turn. She braked and swerved to the right to avoid the crash. At impact, the driver pitched forward and to the left in response to the 350 degree direction of force. The impact was of insufficient magnitude to deploy the driver's air bag and the front right passenger's air bag. The driver's side seat belt pretensioner did however fire at this time. The pretensioner tube measurement on the driver's side was 5.6 cm. There was no movement of the steering column shear capsules. There was a small scuff found on the lower left instrument panel, but there were no reported injuries.

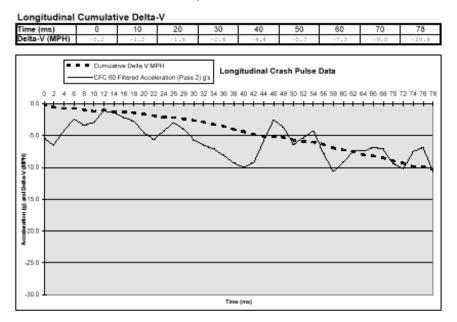
2000 Taurus/Sable EDR Report - Charts

downloaded Electronic Data Recorder (EDR) data indicates a cumulative longitudinal delta v of -16.7 km/h (-10.4 mph) at the 78 ms mark. The data indicates that the driver's seat belt was latched and that the pretensioner on the driver's side fired. The EDR report is included as an attachment to this report.
