**VERIDIAN ON-SITE REDESIGNED AIR BAG DEPLOYMENT/
INFANT PASSENGER FATALITY INVESTIGATION**

VERIDIAN CASE NO. CA00-007

VEHICLE - 2000 CHEVROLET IMPALA

LOCATION - STATE OF NORTH CAROLINA

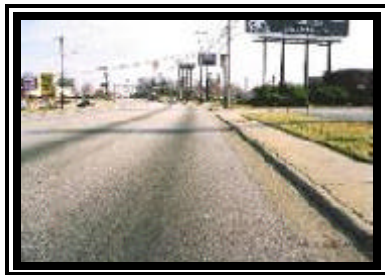
Figure 1. Northbound approach for the 2000 Chevrolet Impala.

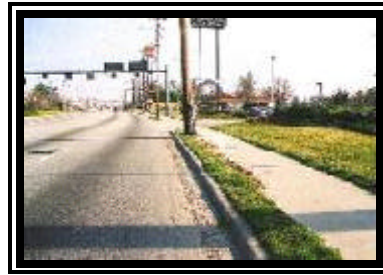
Figure 2. Northbound approach for the 2000 Chevrolet Impala.

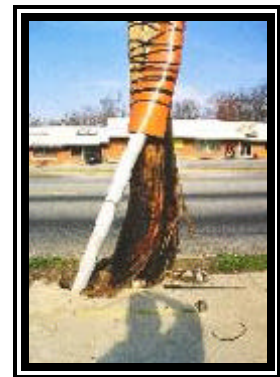
Figure 3. West view of the struck pole.

displaced forward 30.5 cm (12.0 in). The vehicle rotated counterclockwise 58 degrees and came to rest in close proximity to the pole facing northwest.

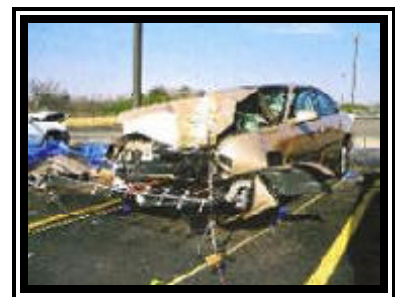
The Chevrolet Impala sustained severe frontal damage as a result of the impact with the wooden utility pole (**Figure 4**). The direct contact damage began 37.0 cm (14.6 in) to the right of the front left bumper corner and extended 32.0 cm (12.6 in) inboard. The impact deformed the full frontal width resulting in a combined direct and induced damage length (Field L) of 88.0 cm (34.6 in). Six crush measurements were documented at the level of the bumper: C1= 21.0 cm (8.3 in), C2= 76.0 cm (29.9 in), C3= 90.0 cm (35.4 in), C4= 94.0 cm (37.0 in), C5= 37.0 cm (14.6 in), C6= 0 cm. A maximum crush value of 101.0 cm (39.8 in) was documented 12.5 cm (4.9 in) inboard of the C3 position. The Collision Deformation Classification (CDC) for this impact to the Chevrolet was 12-FYEN-4 with a principal direction of force of 0 degrees. The left portion of the bumper fascia fractured and separated from the reinforcement bar during the collision sequence. Both headlamp assemblies detached from their respective mounts undamaged. The hood was deformed up and rearward from engagement against the pole. The left fender was deformed rearward which restricted the left front door opening and wheel/tire (not deflated). No wheel damage was found

Figure 4. Frontal damage to the 2000 Chevrolet Impala.

attributed to the initial curb contact. Reduction in the left side wheelbase measured 19.0 cm (7.5 in). Induced buckling was noted to the roof area at the left B-pillar. The windshield fractured from exterior impact forces and the interior front right air bag module cover flap.

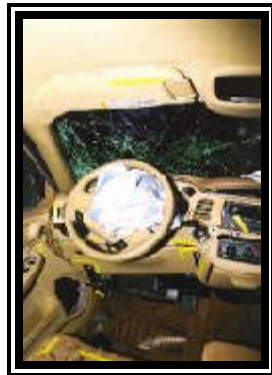
Interior damage to the Chevrolet identified through the vehicle inspection was severe and was attributed to component intrusion and occupant contact (**Figures 5 & 6**). Multiple scuff marks and indentations were documented on the left knee bolster (rigid plastic type) and instrument panel area. Additional scuff marks and indentations were found on the left front door panel. The driver's seat cushion was heavily scrubbed and torn. Induced buckling of the floor displaced the driver's seat cushion upward 4.0 cm (1.6 in) and 15.0 cm (5.9 in) forward to an upright position. The rear-view mirror fractured and separated from the windshield. No column compression or loading to the steering wheel rim was identified (tilt column set to the full up position). Longitudinal intrusions into the front driver/passenger space included 29.0 cm (11.4 in) of left toepan intrusion, 16.0 cm (6.3 in) of right toepan intrusion, 11.0 cm (4.3 in) of left instrument panel intrusion, 16.0 cm (6.3 in) of center instrument panel intrusion and 6.0 cm (2.4 in) of right instrument panel intrusion.

Figure 5. Interior view of the driver space.

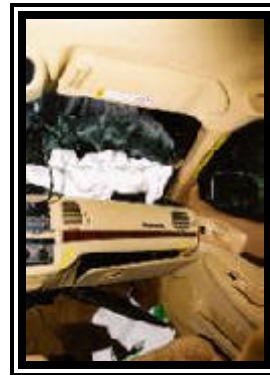
Figure 6. Interior view of the passenger space.

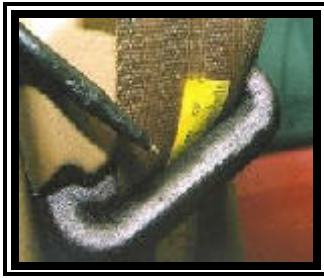
Figure 7. Abrading to the front left D-ring.

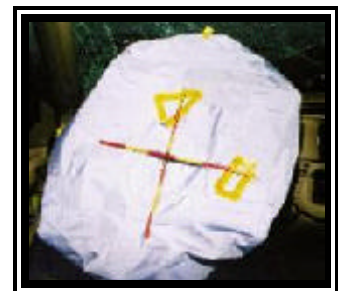
The Chevrolet Impala was equipped with redesigned frontal air bags for the driver and right passenger positions. The air bags deployed as a result of the crash. The driver air bag module was identified by the General Motors part number: *16824055-00* with a bar coded lot number of: *TRCA90087757*. The air bag was housed in the center of the steering wheel with a vertically oriented flap tear seam (I-configuration). The flaps were symmetrical in shape and measured 8.0 cm (3.1 in) in width and 11.0 cm (4.3 in) in height. Although no contact evidence was identified on the exterior surface of the module cover flaps, skin oil was documented to the lower right quadrant of the air bag along with eyelash strands to the upper (centered) section. The diameter of the driver air bag measured 64.0 cm (25.2 in) in its deflated state (**Figure 12**). The bag was tethered by four internal straps and vented by two ports located at the

Figure 12. 2000 Chevrolet Impala redesigned driver air bag.

11 o'clock and 1 o'clock sectors on the rear aspect of the air bag.

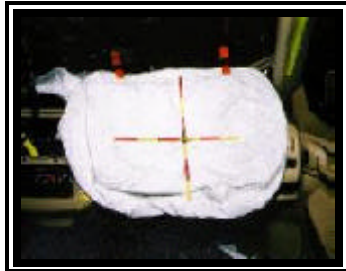
Figure 13. 2000 Chevrolet Impala redesigned passenger air bag.

The front right air bag module was identified by the General Motors part number: *10288227* with a bar coded lot number of: *AL822718168V0913*. The front right passenger air bag deployed from the right mid-instrument panel area with a module design recessed into the instrument panel. This configuration did not utilize a conventional flap as the instrument panel separated to allow the bag to expand. Although no contact evidence was identified on the exterior surface of the module cover flap, black vinyl transfers were noted to the right upper quadrant of the air bag from expansion within the module. The passenger air bag measured 37.0 cm (14.6 in) in width and 53.0 cm (20.9 in) in height in its deflated state (**Figure 13**). No contact

evidence was found on the air bag. The bag was tethered by two internal straps sewn to the top seam and vented by two ports located at the 10 o'clock and 2 o'clock sectors on the side aspect of the air bag.

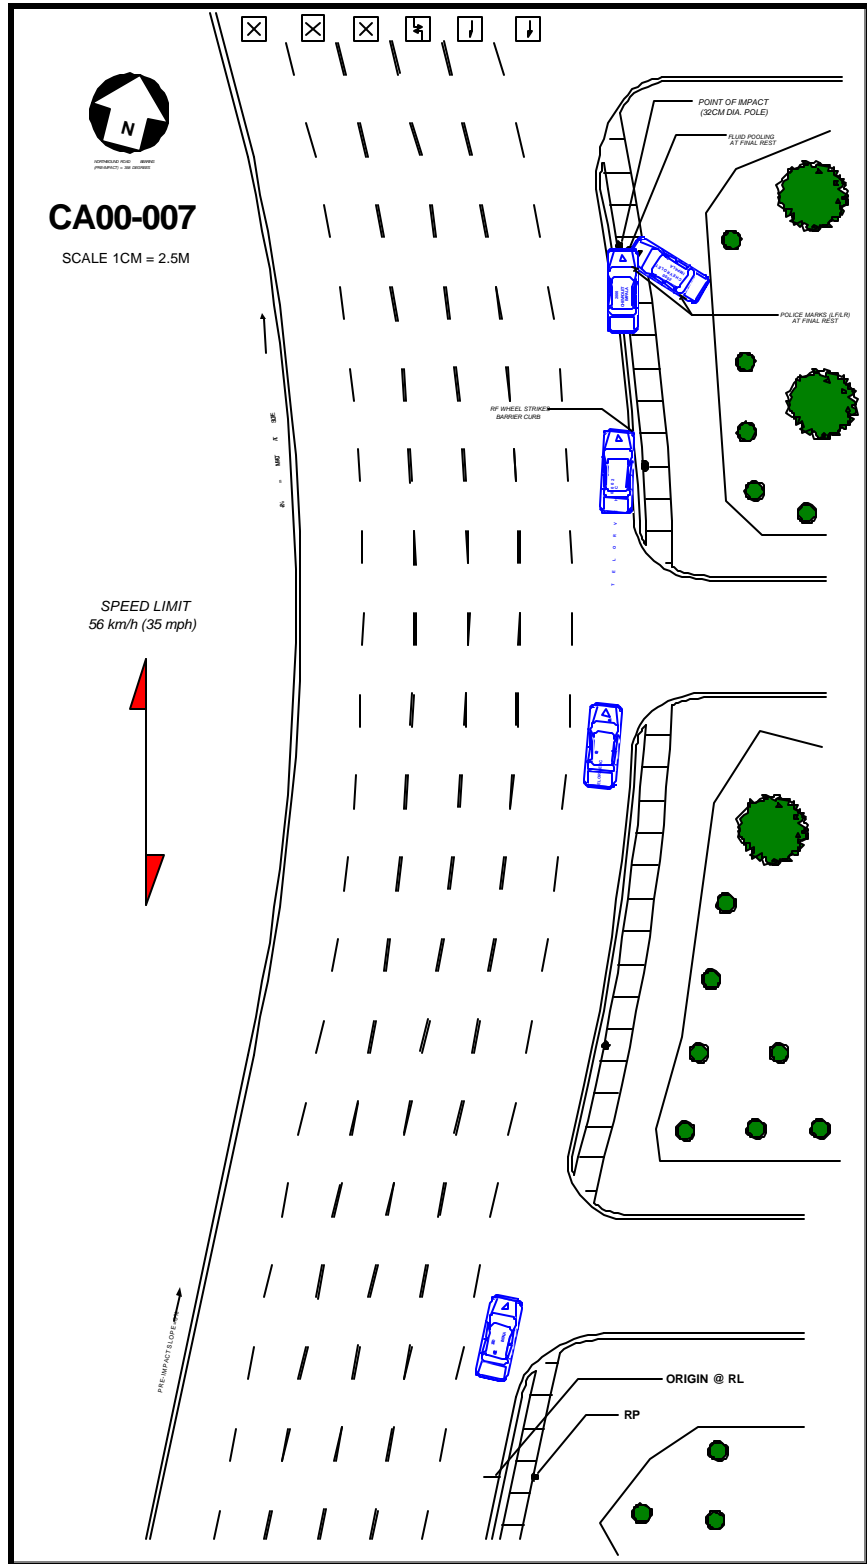
Figure 14. Scene Diagram

This single vehicle crash occurred during the afternoon hours of January, 2000. At the time of the crash, it was daylight with no adverse conditions as the roads were dry. The crash occurred off the east pavement edge of a six lane north/south (asphalt) roadway which curved left for northbound traffic (see

Figure 14 - page 9). The urban roadway was bordered by 4.5 cm (1.8 in) high barrier curbs, sidewalks and wooden utility poles located approximately 0.7 meters (2.3 feet) off the east pavement edge. The posted speed limit at the crash scene was 56 km/h (35 mph).
