On-scene Investigation / Vehicle to Vehicle
Dynamic Science, Inc. / Case Number: DS00-009
2000 Ford Taurus SE 4-door
Wisconsin
June, 2000

1. Report No. DS00-009		2. Government Accession No.		3. Recipient Catalog No.	
4. Title and Subtitle In-Depth Accident Investigation				5. Report Date .

Dynamic Science, Inc.
Accident Investigation
Case Number: DS00-009

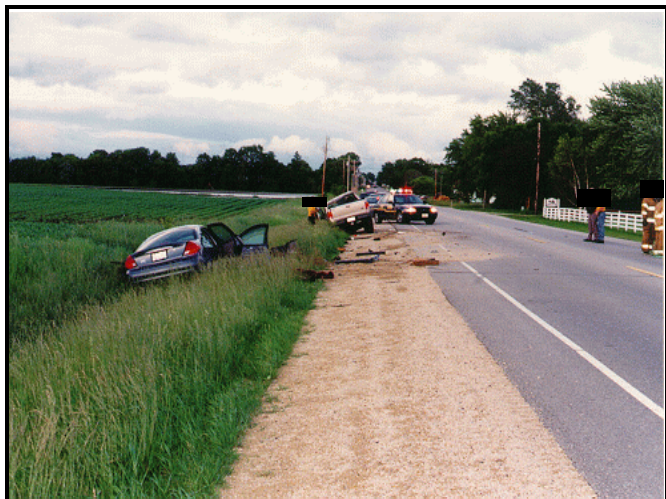
Figure 1. Final rest positions at scene—looking east.

other vehicle to rotate in a counterclockwise direction. The case vehicle continued in a counterclockwise rotation, ran off the roadway and came to final rest in a ditch facing in a easterly direction--having rotated approximately 180-degrees. The other vehicle rolled over onto its roof and then back onto its wheels. The other vehicle came to final rest east of the case vehicle facing in an easterly direction and on the shoulder of the westbound travel lane.

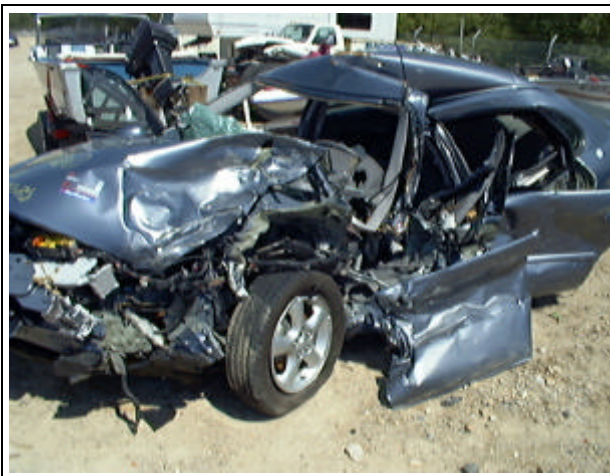
The case vehicle sustained severe damage to the front bumper, hood, grille area, front left fender, left side door, the windshield, left side windows disintegrated, and the roof buckled. The battery and the fuse box in the engine compartment were also damaged. There was intrusion to the driver's compartment area from the driver's door, A and B pillars, toe pan, instrument panel and the roof side rail. The case vehicle was subsequently declared a total loss by the insurance company and sold as salvage. The other vehicle sustained severe damage to the front bumper, hood, grille, front left fender, windshield, and the roof buckled. Both vehicles were towed from the scene due to damage.

The case vehicle was assigned a Collision Deformation Classification (CDC) of 12FDEW4 and a Principle Direction of Force (PDOF) of 350 degrees. The combined direct and induced damage width was 108.0 cm (42.5 in.) [CRASH L = 148 cm (58.3 in.)], and the maximum crush depth was 78.0 cm (30.7 in.) located at C₁. The Delta V for the case vehicle was computed using WinSmash version 2.12. A CDC of 12FDEW4 was used for the case vehicle and CDC of 12FLEE6 for the other vehicle estimated from the police photographs. WinSmash calculated a total delta v of 66.0 km/h (41.0 mph), a longitudinal delta v of -65.0 km/h (-40.4 mph) and a latitudinal delta v of 11.5 km/h (7.1 mph) for the case vehicle. The other vehicle sustained a total delta v of 63.0 km/h (39.1 mph), a longitudinal delta v of -62.0 km/h (-38.6 mph) and a latitudinal delta v of 10.9 km/h (6.8 mph). The results fit the collision model for the case vehicle and appear reasonable. This is a borderline reconstruction for the other vehicle.

Figure 3. Exterior damage to driver's side of case vehicle.

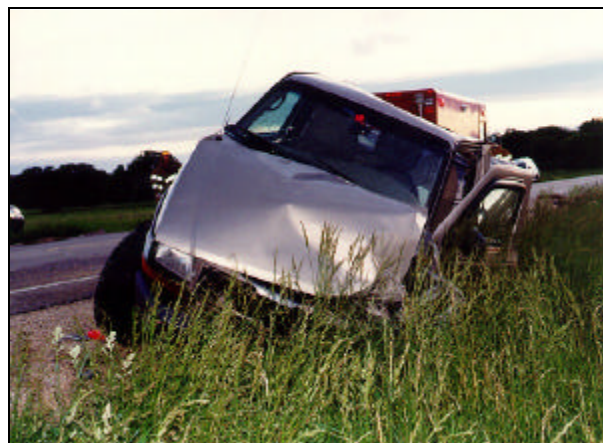
Description: 1998 Ford Ranger XL 4x4 Pickup-Super Cab
 VIN: 1FTZR15X6WPXXXXXX
 Odometer: 56,842 km (35,321 miles)
 Engine: 4.0L, 6 cylinder
 Reported Defects: None
 Cargo: Unknown
 Damage Description: Severe off-set frontal damage. Front bumper, grille, hood, and front left fender. The roof buckled and the rear backlight glazing disintegrate. The roof appears to have intruded vertically into the driver's passenger compartment area. Vehicle towed from scene due to damage.

CDC :
 Impact 1 v. Case Vehicle 12FLEE6 (Estimated from police photographs)
 Impact 2--Rollover 00TPD02 (Estimated from police photographs)

Figure 4. Other vehicle.

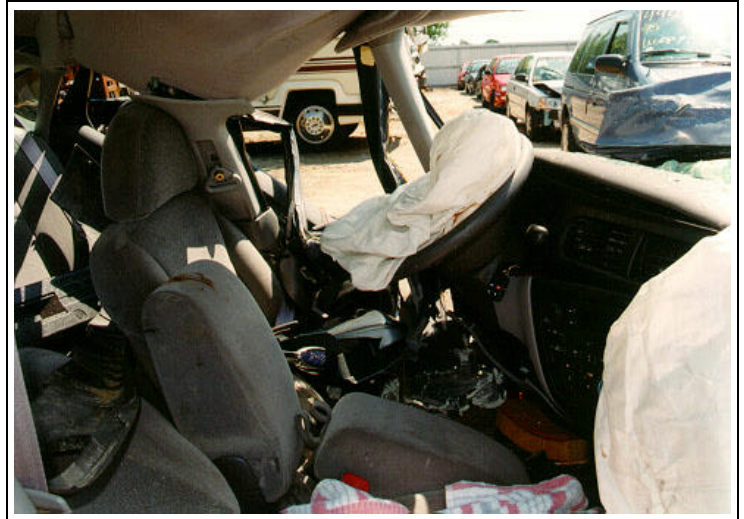
Figure 5. Intrusion into driver's compartment.

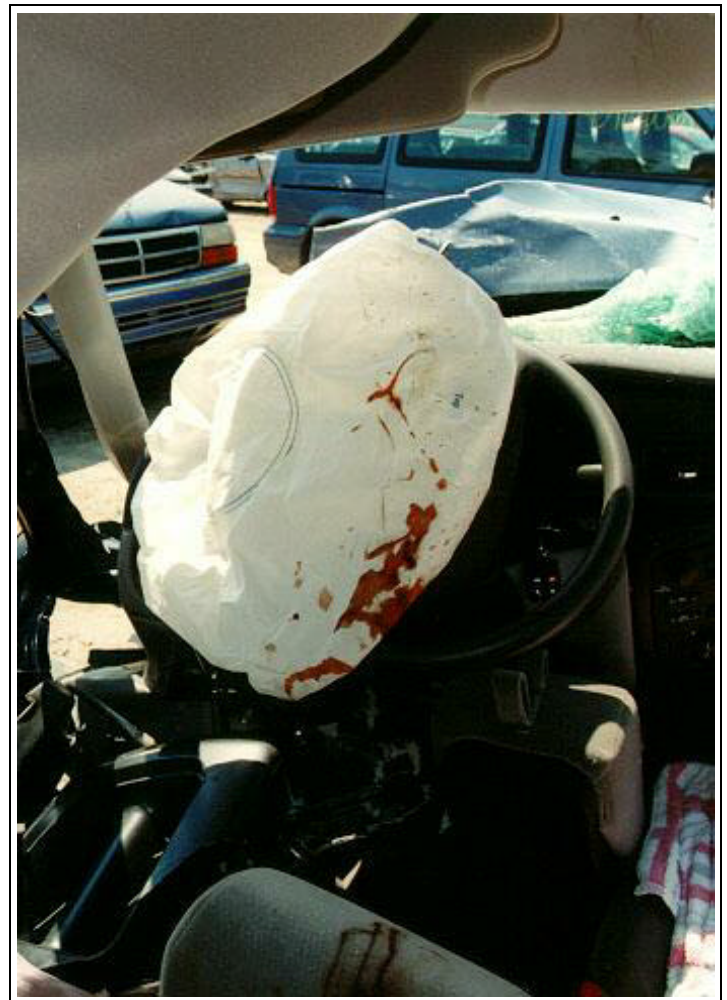
The case vehicle steering wheel mounted driver's air bag was circular and measured 46 cm (18.1 in.) in diameter. It was equipped with two tethers and two vent holes at 11 and 01 o'clock positions. There was blood all about the front and rear top right quadrant of the air bag. The dual module covers opened in an "H" configuration. There were no indications of any damage to driver's air bag or the covers. The case vehicle front right passenger's air bag was rectangular and measured 38 cm (14.9 in.) high by 57 cm (22.4 in.) wide. It was equipped with two vent ports at 10 and 02 o'clock positions and did not have any tethers. There were blood drops on the face of the lower quadrant. There were also black smudges on the face of the air bag that were caused by the module cover. The single flap module cover opened properly and was not damaged.

Figure 6. Blood on Vehicle 1 driver's air bag.

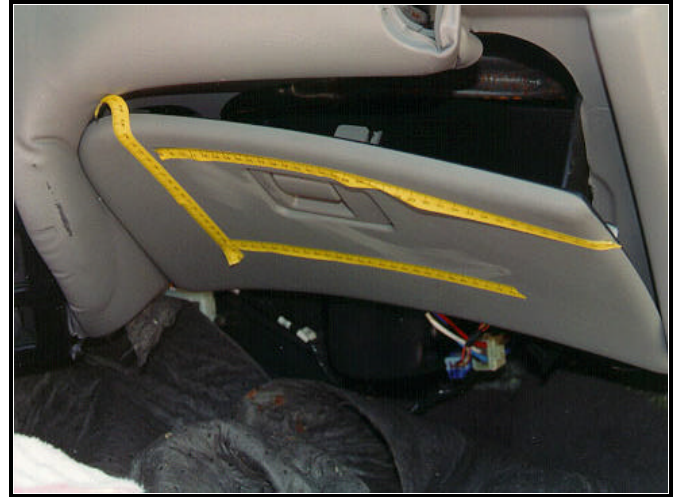
Figure 7. Scuff mark to glove box from contact with front right occupant's legs.

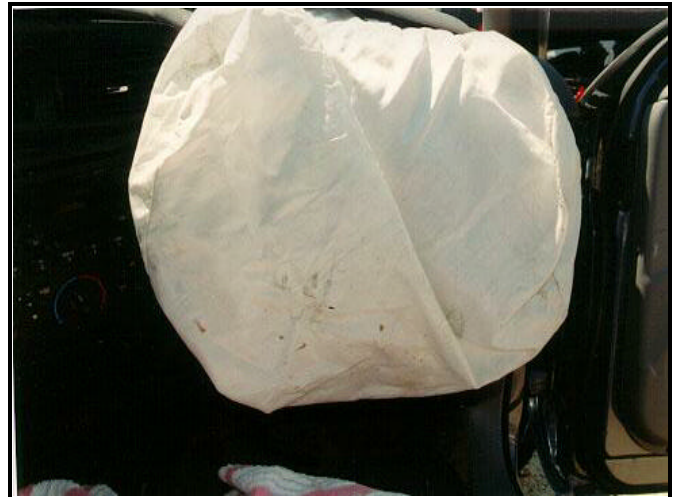
Figure 8. Front right passenger air bag.
