On-scene Investigation / Vehicle to Vehicle
Dynamic Science, Inc. / Case Number: DS00-010
2000 Ford Taurus
Missouri
June, 2000

Dynamic Science, Inc. Accident Investigation Case Number: DS00-010

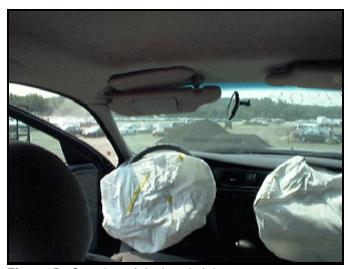
The driver's air bag was circular and measured 45 cm (17.7 in.) in diameter. It was equipped with two tethers and two vent holes. There appeared to be eight horizontal folds and possibly five vertical folds. There was black smudges on top left quadrant and an unknown yellow-colored transfer on the top right quadrant. The module cover opened in an "H" configuration. There were no indications of any damage to the cover.

The front right occupant's frontal air bag was rectangular and measured 58 cm (22.8) laterally. It was equipped with two vent ports and did not have any tethers. On the face of the air bag there was cover-related scuffing. The single flap module did not sustain any damage.

Figure 5. Overview of deployed air bags

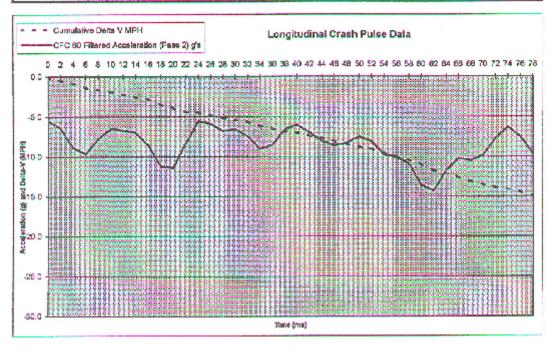
Longitudinal Cumulative Delta-V

The case vehicle also veered to the right (possibly after over-correcting to the left), crossed the adjacent lane, and also struck the concrete barrier with its front end (12FDEW1). The case vehicle sustained a longitudinal delta v of -19.2 km/h (-11.9 mph)². Maximum crush was located at C₆ and measured 17.5 cm (6.9 in.). The EDR reported a longitudinal cumulative delta V of -23.9 km/h (-14.9 mph) at the 78 ms mark.
