**TRANSPORTATION SCIENCES
CRASH RESEARCH SECTION**

**ADVANCED OCCUPANT PROTECTION SYSTEM STUDY
2000 FORD TAURUS INVESTIGATION**

VERIDIAN CASE NO. CA00-013

CRASH DATE - MARCH 2000

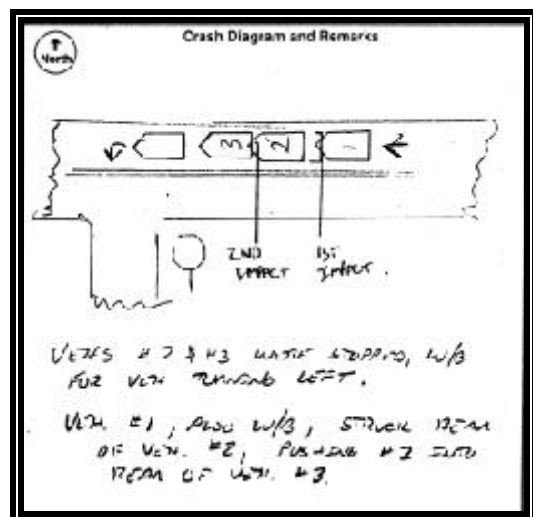
This three-vehicle crash occurred during the early evening hours of March, 2000. It was dusk at the time of the crash and the weather was not a factor. The road surface was dry. At the scene, the primary roadway was configured with two lanes, east/west in direction. A two lane north/south road intersected from the south, forming a 3-leg intersection. The intersection was controlled by a stop sign for northbound traffic on the intersecting roadway. The speed limit in the area of the crash was 64 km/h (40 mph). **Figure 1** is a diagram of the crash scene.

Figure 1: Crash scene diagram.

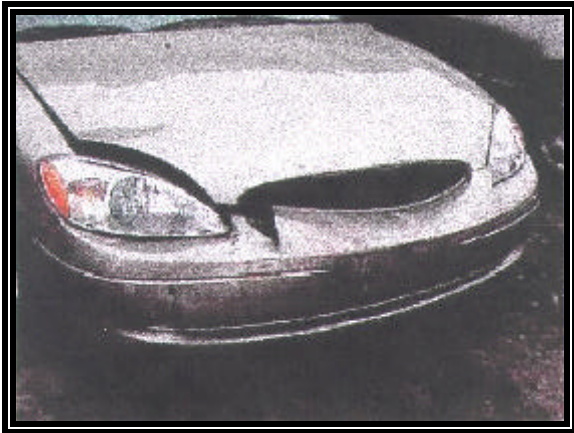
The vehicle had been partially repaired by the time of inspection due to the delayed crash notification. **Figure 2** is a view of the frontal damage taken during the insurance appraisal of the vehicle. The impact damage to the Taurus was confined to vehicle's structures forward of the radiator support plane. The direct contact damage began 20 cm (8 in) left of center and extended laterally 91 cm (36 in) to the right front bumper corner. The hood was slightly buckled and exhibited 6.3 cm (2.5 in) longitudinal scratches along its leading edge in the region of direct contact. The front fenders were not damaged in the impact. The Collision Deformation Classification (CDC) was 12-FZEW-01. The estimated delta V of the impact based on forensic analysis of the damage and SCI experience was 16 km/h (10 mph). The RCM measured, calculated and recorded a 10.6 km/h (6.6 mph) delta V which occurred at 78 msec. It should

Figure 2: Insurance photo taken of the frontal damage during appraisal.

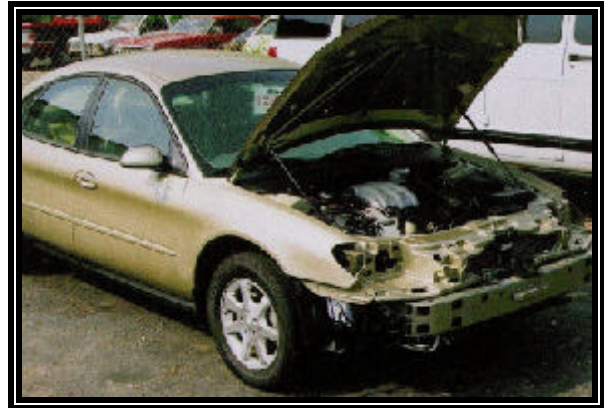
The components replaced included the following: impact bar, absorber, bumper fascia, grille, head lamp assemblies, upper and lower radiator supports, complete core, air conditioner condenser, fan, hood, battery, fuse box and the front air bag sensor. The repair record indicated the left frame rail was straightened as well. **Figure 3** is a right front view of the vehicle taken at the time of its inspection.

Figure 3: Right front view of the repaired Ford Taurus.

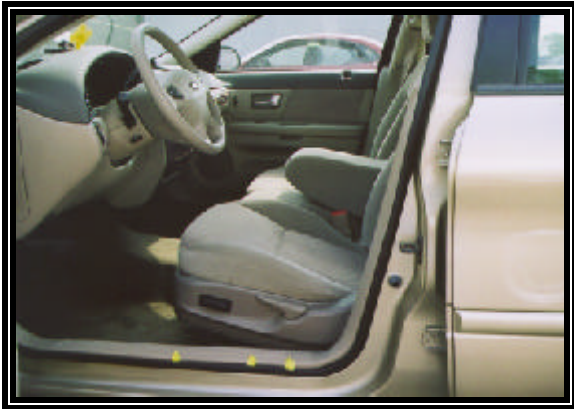
Figure 4 is a left interior view of the front occupant compartment. The driver's seat was adjusted in a mid-to-rear track position at inspection and measured 9.6 cm (3.8 in) forward of full rear. It could not be verified if this was the at-crash position. Adjustment of the track position was controlled electronically by a switch located on the forward outboard aspect of the cushion. The driver did report he typically positioned his seat mid-to rear track and this position was consistent with his stature. The foot controls were not adjustable.

Figure 4: Left interior view.

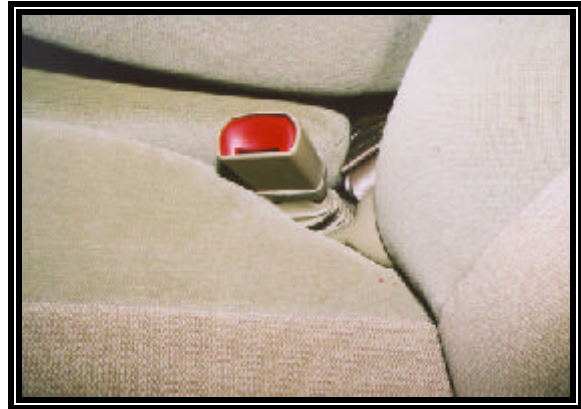
The vehicle was equipped with 3-point lap and shoulder belt systems in the front outboard seat positions. The front seat belt systems consisted of a continuous loop lap and shoulder belt webbing with a sliding latch plate. The vehicle sensitive/energy management retractors were located in the base of the B-pillars. The front restraints were also equipped with buckle mounted pretensioners. The driver's pretensioner fired as a result of the crash, **Figure 5**. The post-crash measurement of the pretensioner's piston was 60.3 mm (2.38 in). The restraint's upper anchorages (D-rings) were adjustable. The left front D-ring was adjusted to the full up position. Upon inspection, the driver's restraint webbing was stowed in the retractor and operational. No witness marks indicative of use during the crash were identified on the webbing or hardware surfaces. However, given the relatively minor magnitude of the crash belt evidence would not be expected.

Figure 5: View of the left buckle.

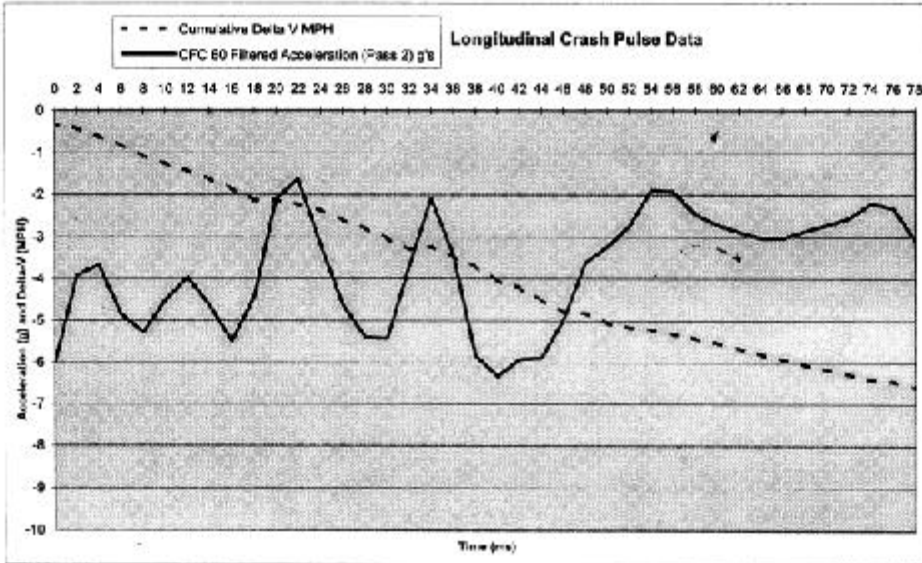
Longitudinal Cumulative Delta-V

Time (ms)	0	10	20	30	40	50	60	70	78
Delta-V (MPH)	0.3	-1.3	-2.3	-3.9	-4.6	-5.9	-5.5	-6.2	-6.6

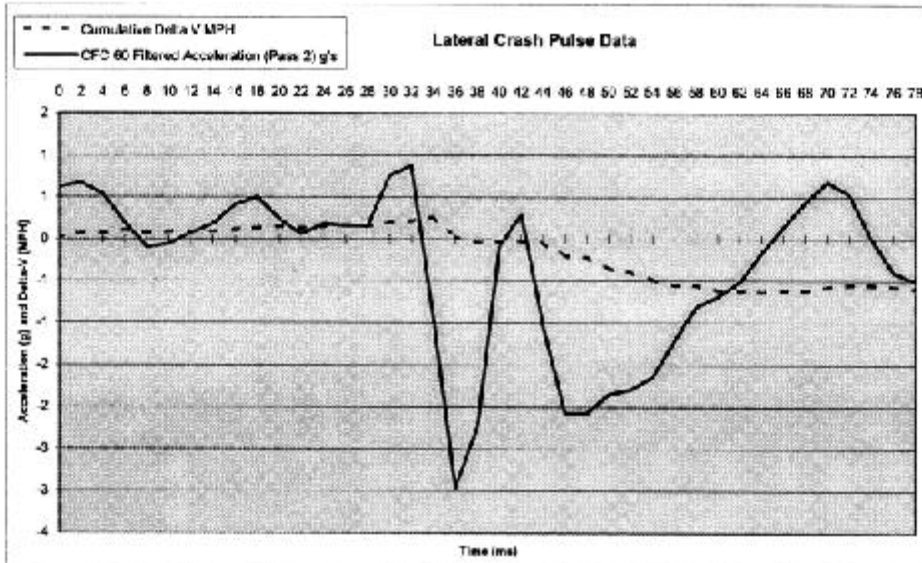
Lateral Cumulative Delta-V

Time (ms)	0	10	20	30	40	50	60	70	78
Delta-V (MPH)	0.0	0.1	0.2	0.2	0.0	-0.4
