On-scene Investigation / Vehicle to Vehicle
Dynamic Science, Inc. / Case Number: DS00-017
2000 Ford Taurus SE station wagon
Oregon
June, 2000

1. Report No. DS00-017		2. Government Accession No.		3. Recipient Catalog No.	
4. Title and Subtitle In-Depth Accident Investigation				5. Report Date September 27, 2001

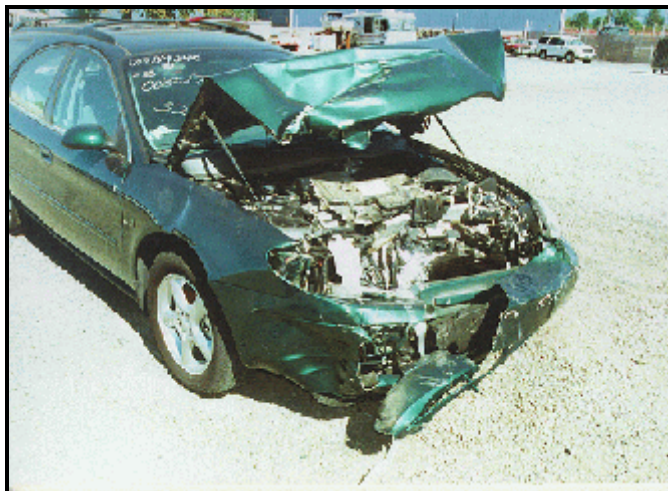
Figure 3. Right front, case vehicle.

The case vehicle sustained total damage to the front end and was declared a total loss by the insurance company. The police report indicated extensive front end damage at over \$1,000.00 to the Chevrolet. Both vehicles were towed from the scene.

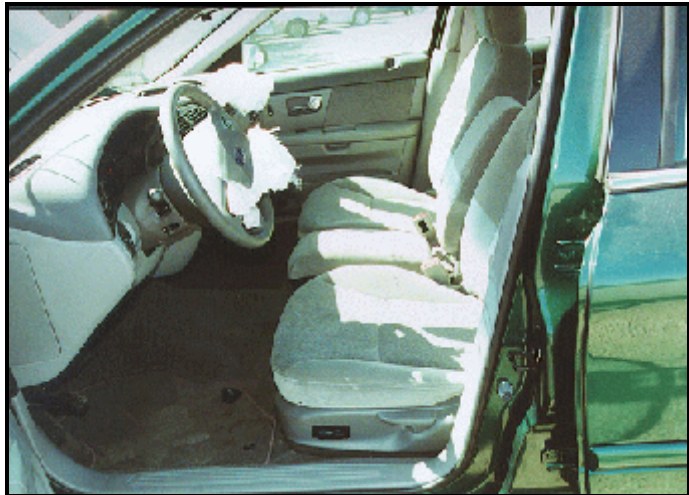
Figure 4. Driver's seat, case vehicle.

<u>Case vehicle</u>	Occupant 1
Age/Sex:	50/Male
Seated Position:	Front left
Seat Type:	Cloth covered, bucket seat-- adjusted to rear most track position
Height:	157 cm (74 in.)
Weight:	91 kg (200 lbs.)
Occupation:	Unknown
Pre-existing Medical Condition:	None noted
Alcohol/Drug Involvement:	None
Driving Experience:	> 30 years
Body Posture:	Normal, upright
Hand Position:	Both on wheel. Steering to the left.
Foot Position:	Right foot on brake, left on floor board.
Restraint Usage:	Lap and shoulder belt used
Air bag:	Driver's steering wheel mounted air bag deployed.

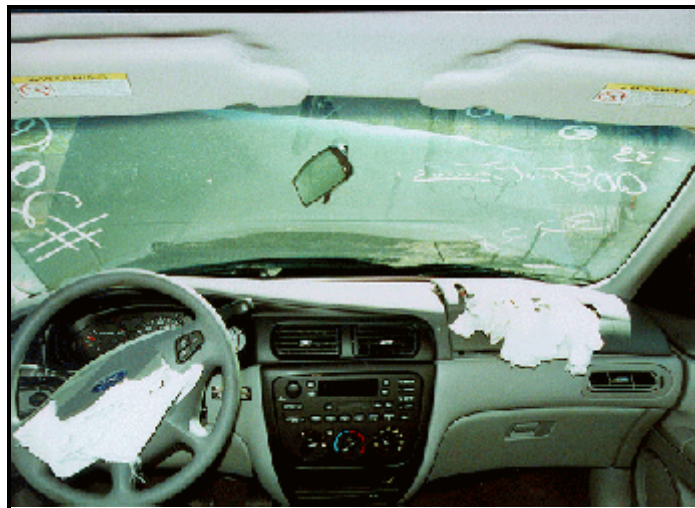
The 2nd seat back cushion was deformed forward. It appears that there was cargo behind the 2nd seat and it moved forward on impact. It does not appear that this played any role in the crash.

Figure 5. Interior, case vehicle.

The case vehicle was equipped with frontal air bags mounted in the steering wheel and top mounted in the instrument panel of the front right seat position. The driver's air bag had been cut off prior to the vehicle's inspection. The module cover opened in an "H" configuration. There were no indications of any damage to the covers. The front right occupant's frontal air bag had been cut off prior to its inspection. The single flap module did not sustain any damage.

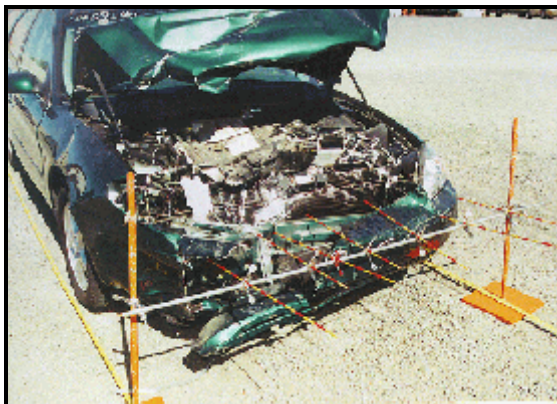
Description:	2000 Ford Taurus SE station wagon	
VIN:	1FAFP582XYGxxxxxx	
Odometer:	6,949 km/h (4,318 miles)	
Engine:	3.0L, 6 cyl.	
Reported Defects:	None	
Cargo:	None found during inspection, however damage to rear seat was likely as a result of some cargo striking the rear of the rear seat.	
Damage Description:	Moderate frontal crush to bumper, grille, and hood.	
CDC:	12FDEW1	
Delta V:	Total	31.9 km/h (19.8 mph)
	Longitudinal	-31.4 km/h (-19.5 mph)
	Latitudinal	-5.4 km/h (-3.4 mph)
	Energy	32,901 joules (24,266) ft-lbs

Figure 7. Front right, case vehicle.

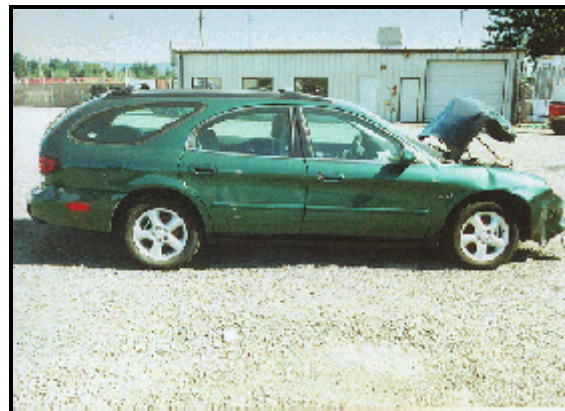
Figure 8. Right side, case vehicle.

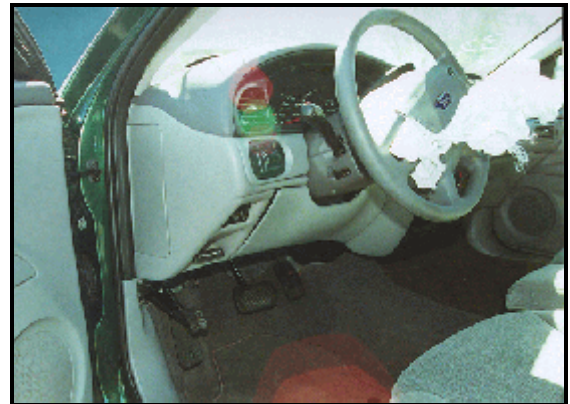
The driver of the case vehicle was seated in a normal, upright fashion. He was wearing glasses at the time of the crash. The glasses had plastic lenses and a metal frame. The driver was using the available lap and shoulder belt. The upper anchorage adjustment was in the full up position. The fabric-covered bucket seat was adjusted to rear most track position. The seat back angle was slightly reclined rearward. As the case vehicle crashed head-on into the Chevrolet, the driver of the case vehicle responded to the 10 degrees direction of principal force by moving forward. The driver's side seat belt pretensioner fired and tightened the seat belt. The driver sustained a minor contusion to his left shoulder from the seat belt. The driver moved forward and contacted the left instrument panel with his left leg—the rigid plastic knee bolster cover was displaced. There was no evidence of loading on the steering column; there was no indications of shear capsule movement. The driver engaged the deployed air bag with his face. This caused his glasses to move upward across the middle part of his forehead—causing a small contusion.

Figure 9. Displaced plastic knee bolster.

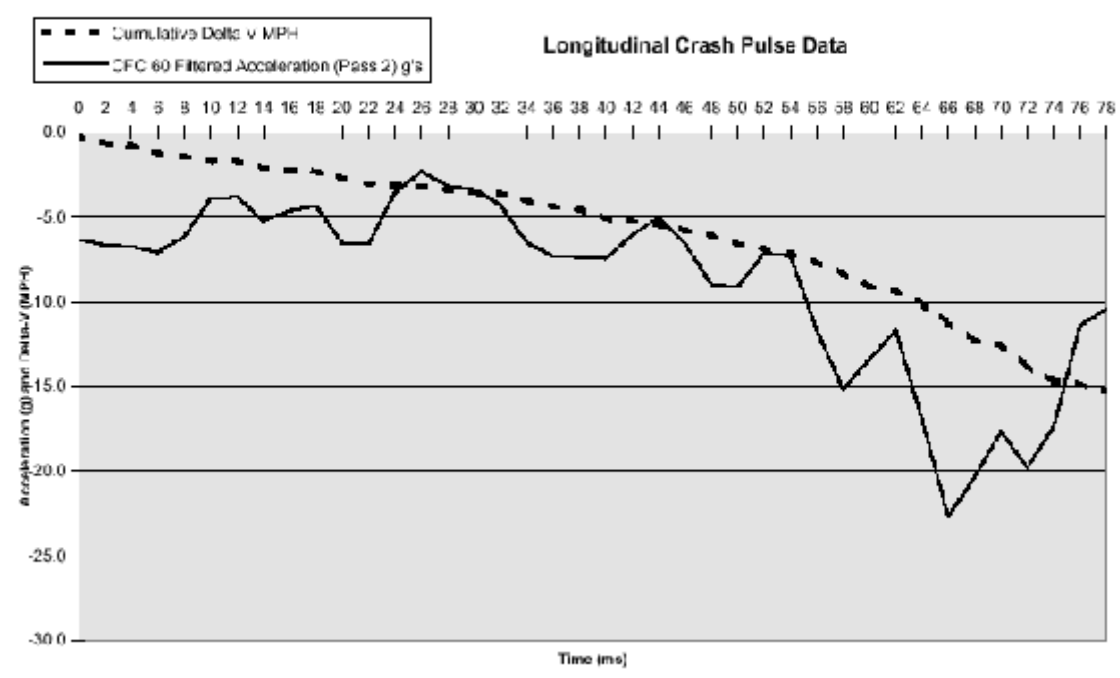
Longitudinal Cumulative Delta-V

At impact the case vehicle sustained a total Δv of 31.9 km/h (19.8 mph), a longitudinal Δv of -31.4 km/h (-19.5 mph) and a latitudinal Δv of -5.4 km/h (-3.4 mph) as computed by WinSmash. The downloaded Electronic Data Recorder (EDR) data indicates a cumulative longitudinal Δv of -24.6 km/h (-15.3 mph) and a cumulative lateral Δv of 3.5 km/h (-2.2 mph) at the 78 ms mark. It appears that the pulse had peaked and was declining at this point. The EDR report is included as an attachment to this report.

Time (ms)	0	10	20	30	40	50	60	70	78
Delta-V (MPH)	-0.2	-1.7	-2.7	-3.6	-5.1	-5.6	-9.1	-12.6	-13.3

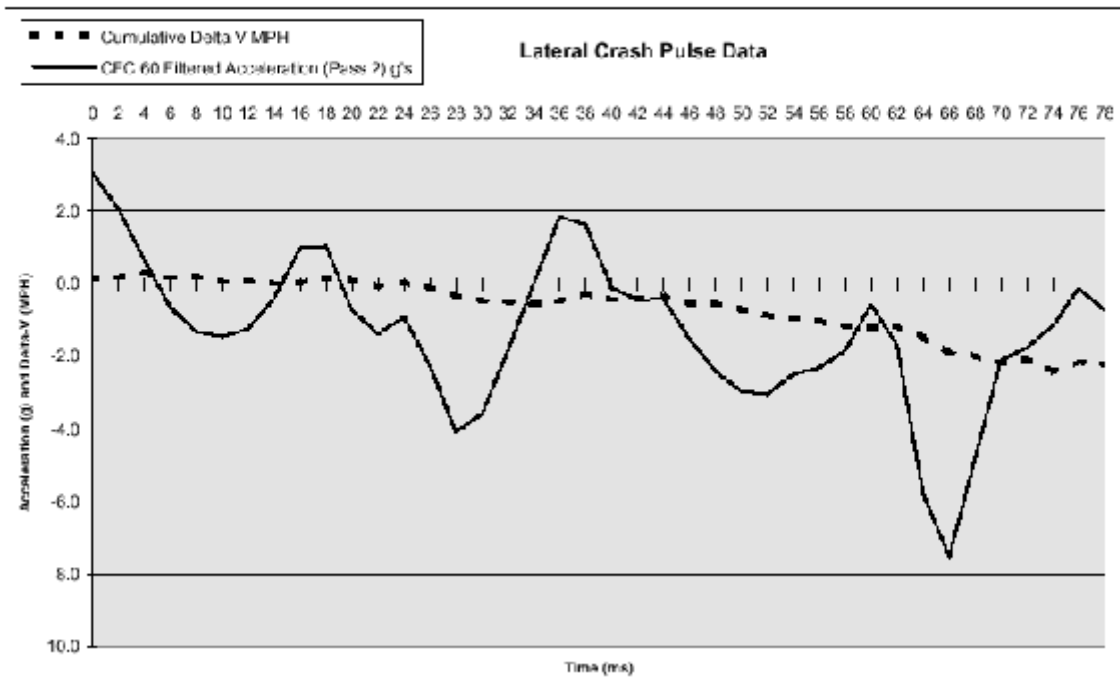
Lateral Cumulative Delta-V

Time (ms)	0	10	20	30	40	50	60	70	78
Delta-V (MPH)	3.2	0.3	0.1	-0.5	-0.4	-3.1	-1.2	-2.2	-2.7
