**ADVANCED OCCUPANT PROTECTION SYSTEM STUDY
2000 FORD TAURUS INVESTIGATION**

VERIDIAN CASE NO. CA00-019

LOCATION - TENNESSEE

CRASH DATE - JUNE 2000

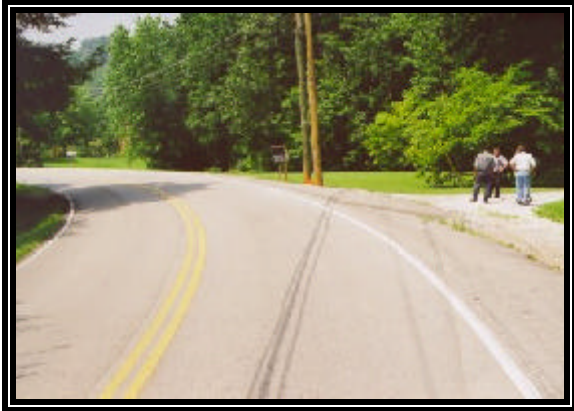
Figure 1: Trajectory view of the Ford.

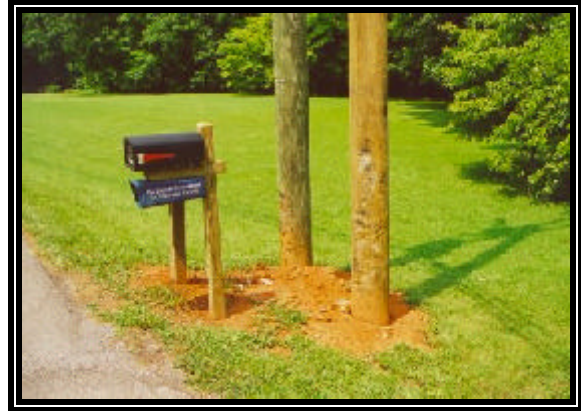
This single vehicle crash occurred during the afternoon hours of June, 2000. It was daylight at the time of the crash and the weather was not a factor. The road surface was dry. At the scene, the roadway was predominately north/south in direction and was configured with two asphalt lanes. There was a 114 m (375 ft) radius left curve for northbound traffic. The northbound grade measured -3%. Private residences bordered both sides of the road. At the curve's apex, the east (right) road shoulder was asphalt and measured 1.3 m (4.2 ft). The shoulder changed to gravel and then tapered to grass. A gravel driveway with an asphalt apron intersected from the east and was located immediately prior to the point of impact. Two mailboxes and two utility poles were located north of the driveway apron and approximately 3 m (10 ft) east of the fog line. **Figure 1** is a trajectory view of the Ford Taurus approximately 30 m (100 ft) south of the utility poles. **Figure 2** is a view of the point of impact.

Figure 2: Point of impact.

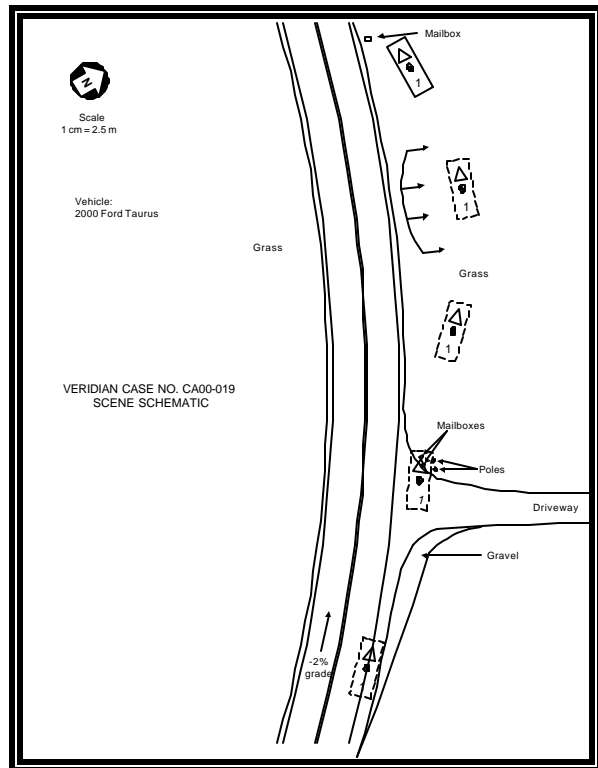
Figure 3 is a schematic of the crash. For unknown reasons, the driver failed to negotiate the left curve and drifted off the right side of the road. The Ford traveled across the driveway apron, at the curve's apex, and struck the mailboxes and utility poles north of the driveway. The impact sheared the mailbox support posts at the ground level. The mail boxes then stuck the hood and fractured the windshield. The right front fender of the Taurus first contacted the utility poles in swiping contact. This contact began immediately forward of the right front axle. As the Taurus continued its northeastward trajectory, the vehicle's engagement with the pole increased. The Principle Direction of Force during this impact was in the 1 to 2 o'clock sector at maximum engagement. The frontal air bags did not deploy in the crash. The Taurus's contact with the utility pole continued to the area of the C-pillar. After disengagement from the pole, the Taurus continued northeastward into the front yard of a private residence. The home owner

Figure 3: Crash schematic.

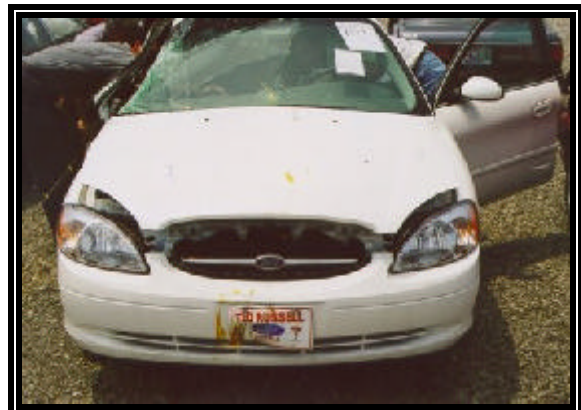
Figure 4 is a front view of the Ford Taurus. The front plane sustained 18 cm (7 in) of direct contact damage as a result of the mailbox impact. The direct contact began 1.3 cm (0.5 in) left of center and extended to the right. There was no measurable bumper crush as a result of the impact. The mailbox then contacted the hood approximately 5 cm (2 in) left of center and 30 cm (12 in) rearward of the its leading edge. This contact was identified by a yellow paint transfer. The mailbox then struck and fractured the lower aspect of the windshield. The windshield fracture was located approximately on the vehicle's center line. The Collision Deformation Classification (CDC) of this

Figure 4: Front view of the Taurus.

impact was 12-FCEN-01.

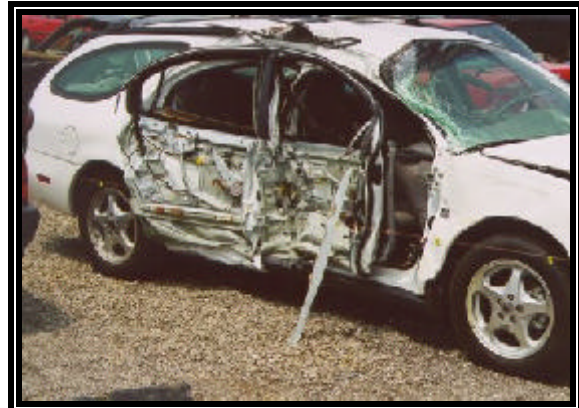
The right side plane sustained a 305 cm (120 in) of combined direct and induced damage that began 33 cm (13 in) forward of the right front axle, **Figure 5**. The direct contact with the utility poles was sideswiping in nature, rather than direct impact. The crash pulse had a long duration with a (relatively) low magnitude of deceleration. The direct contact damage began 13 cm (5 in) forward of the right front axle and extended rearward 284 cm (112 in). The (direct and induced) damage ended 3.8 cm (1.5 in) forward of the right rear axle. The crush profile measured along the trim elevation measured as follows: C1=0, C2=17.3 cm (6.8 in), C3=29.2 cm (11.5 in), C4=16.5 cm (6.5 in), C5=3.8 cm (1.5 in), C6=0. Maximum crush occurred at C3 and was located approximately 5 cm (2 in) forward of the B-pillar. Contact with the poles buckled the exterior panels of the right doors and displaced them from the vehicle. The right windows disintegrated on impact and the right aspect of the windshield was fractured. There was no measurable change in the wheelbase dimension. The CDC was 01-RYAW-03. The total delta V calculated by the Barrier Algorithm of the WINSMASH model was 25.7 km/h (16 mph). The longitudinal and lateral components were -19.6 km/h (-12.2 mph) and -16.6 km/h (-10.3 mph), respectively.

Figure 5: Right front view.

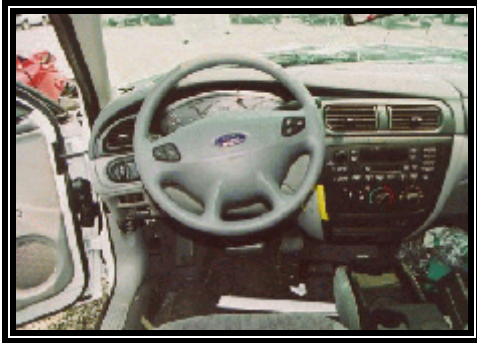
Figures 6 and 7 are views of the front interior. The electrically adjustable driver's seat was adjusted to a mid-to-rear position and measured 20 cm (8 in) rear of full forward. The electrical system was intact and the vehicle had been driven, therefore it could not be verified if this was the at-crash position. The foot controls were adjustable and in the full rear position.

Figure 6: Interior view of the driver's position.

There was no intrusion or interior damage related to the exterior forces of the crash. The driver knee bolster was not damaged. A single scuff mark from probable right knee contact was identified on the left aspect of the lower central instrumental panel, refer to **Figure 6**. The area measured approximately 5 cm x 5 cm (2 in x 2 in). It was located 15 cm (6 in) left of the vehicle's center line and 30 cm (12 in) below the top of the instrument panel. The center mirror was displaced down and right from probable head contact. The center console was down and exhibited indications of contact from the driver's right hip. There was no other evidence of occupant contact on the vehicle's interior surfaces.

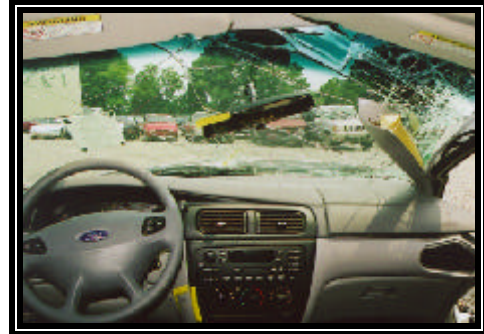
Figure 7: View of center and right interior.

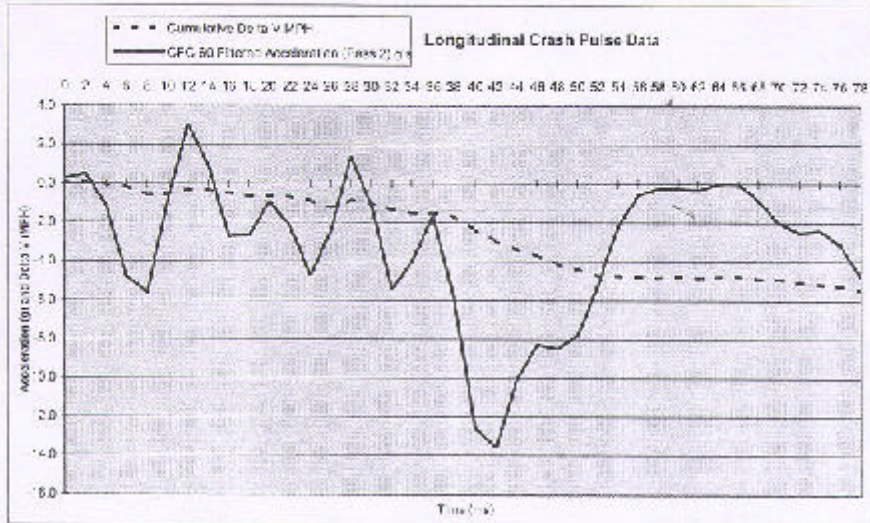
Longitudinal Cumulative Delta-V

Time (ms)	0	10	20	30	40	50	60	70	78
Delta-V (MPH)	2.1	0.5	-0.6	-1.5	-2.5	-4.4	-4.9	-4.9	-5.5

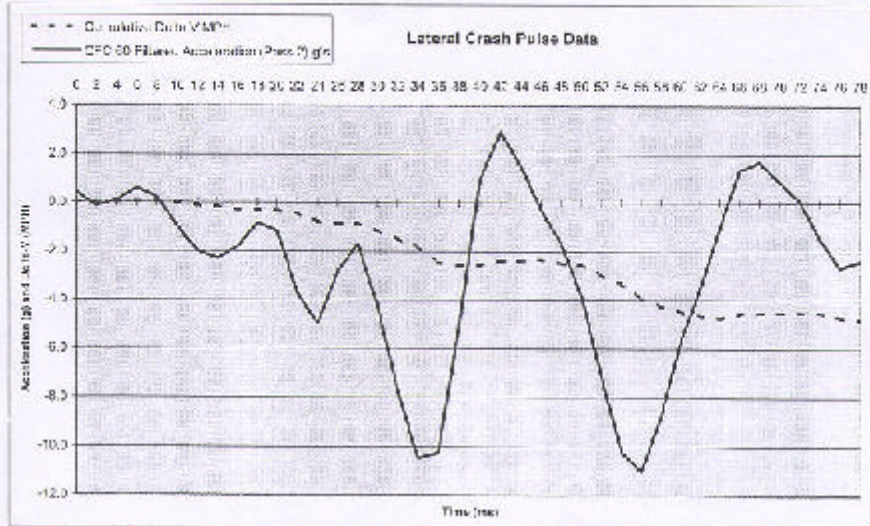
Lateral Cumulative Delta-V

Time (ms)	0	10	20	30	40	50	60	70	78
Delta-V (MPH)	0.0	1.0	-0.3	-1.2	-2.5	-3.8	-4.5	-4.5	-4.5
