On-scene Investigation / Vehicle to Vehicle Dynamic Science, Inc. / Case Number: DS00-019 2000 Ford Taurus Illinois July, 2000 This document is disseminated under the sponsorship of the Department of Transportation in the interest of information exchange. The United States Government assumes no responsibility for the contents or use thereof.

Technical Report Documentation Page
1. Report No.	2. Government Accession No.		3. Recipient Catalog No.
DS00-019			
4. Title and Subtitle			5. Report Date
In-Depth Accident Invest	tigation		January 29, 2001

Dynamic Science, Inc. Accident Investigation Case Number: DS00-019

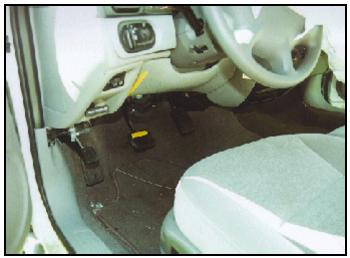
The driver of the case vehicle was seated in a normal, upright position and wearing the available lap and shoulder belt. The seat track track position is not known. She was wearing a sweatshirt and jeans. Prior to the crash, she was steering the case vehicle and braking in an effort to avoid the collision. As the case vehicle crashed head-on with the Chevrolet, the driver of the case vehicle responded to the 10E direction of principal force by moving essentially straight forward. Both of the driver's knees struck the lower instrument panel and cracked and deformed the rigid plastic knee bolster covering and the knee bolster. She also interacted with the driver's air bag and steering column in some fashion. The right shear module measured 2.5 cm (1 in) of column stroke. The driver loaded the lap and shoulder belt as she went forward–causing the contusions to her chest and hips. The brake pedal was deformed by the driver's right foot during braking and during the impact itself. There were no injuries reported as a result of this contact. The rear view mirror was knocked off during the collision, possibly by the driver's right hand as it was flung by the driver's air bag but there was no resultant injury.

Figure 9. Driver's seat position-knee contact to lower instrument panel

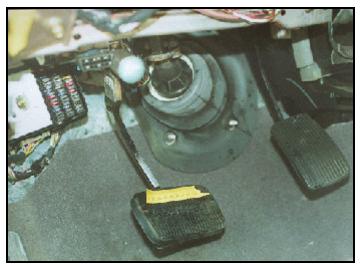
The case vehicle was also equipped with adjusted foot controls. The brake pedal had been displaced laterally to the left 2.5 cm (1.0 in), and this was probably due to heavy braking. The front barrel was checked and measured 5 cm (2.04 in).

Figure 10. Deformed brake pedal

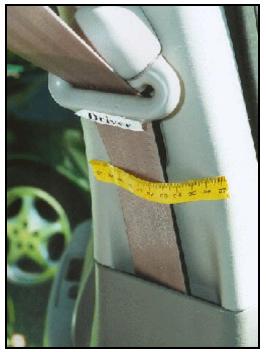
Figure 11. Belt loading marks-driver's seat belt

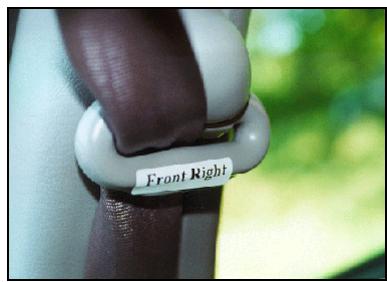
The front right occupant of the case vehicle was seated in a normal, upright position and wearing the available lap and shoulder belt. The seat track was adjusted to the rear-most track position. He responded to the headon crash with the Chevrolet by moving straight forward. This occupant loaded the lap and shoulder belt as he went forward–causing the contusions to his chest, shoulder, and abdomen. As the front right passenger's air bag deployed he likely contacted it to some degree, though there was no evidence of any specific contact.

Figure 12. Belt loading marks-front right passenger
