**ADVANCED OCCUPANT PROTECTION SYSTEM STUDY  
2000 FORD TAURUS INVESTIGATION**

**VERIDIAN CASE NO. CA00-038**

**LOCATION - MICHIGAN**

**CRASH DATE - SEPTEMBER 2000**

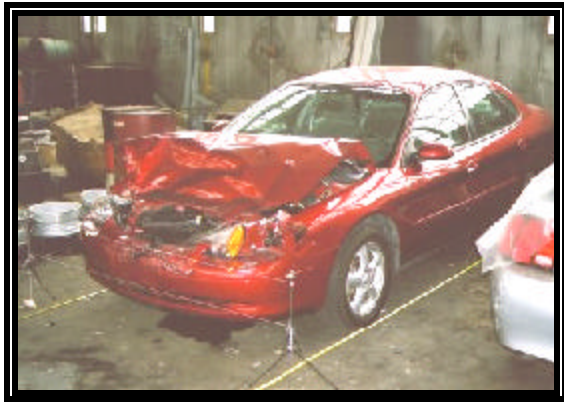
The front plane of the Ford Taurus sustained 157 cm (62 in) of direct contact damage that extended across the vehicle's full frontal width, **Figures 3 and 4**. This damage pattern was above the level of the front bumper and was consistent with the dynamics of a braking vehicle and an under-ride type impact. There

was minimal direct bumper to bumper contact. The only damage to the front bumper system were longitudinal scratches to the top (horizontal) surface of the fascia. The direct damage consisted of deformation to the hood and structures within the engine compartment. The vehicle's electrical system was intact. The crush profile measured across the upper radiator support was as follows: C1=0, C2=4.4 cm (1.8 in), C3=16.5 cm (6.5 in), C4=14.0 cm (5.5 in), C5=5.0 cm (2.0 in), C6=0. The maximum crush was 19.0 cm (7.5 in) and was located 11.4 cm (4.5 in) left of the vehicle's centerline. The contact damage on the surface of the hood extended rearward 79 cm (31 in) from the front of the Taurus. There was no change in the vehicle's wheelbase dimensions. The operation of the right front door was restricted by the rearward displacement of the right fender. The remaining doors were operational. The Collision Deformation Classification (CDC) was 12-FDEW-01. The Damage Only Algorithm of the WINSMASH model calculated a total delta V of 13.8 km/h (8.6 mph) for the Taurus in this impact. The longitudinal and lateral components were -13.8 km/h (-8.6 mph) and 0 km/h, respectively. The calculated Barrier Equivalent Speed was 13.8 km/h (8.6 mph). The results of the WINSMASH reconstruction appeared reasonable.

Figure 3: Left front view of the Taurus damage.

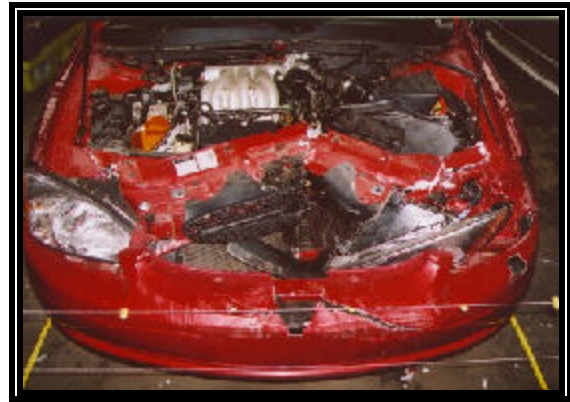
Figure 4: View of the damaged front plane.

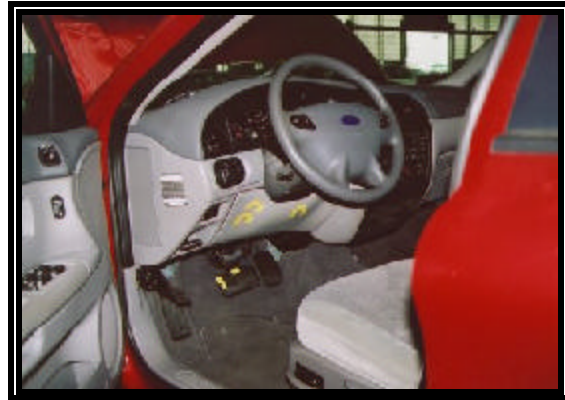
**Figure 5** is a left interior view of the front occupant compartment. The electrically adjustable driver's seat was adjusted in a mid-to-rear position at inspection that measured 18.8 cm (7.4 in) rear of full forward. The total seat track travel was 25 cm (10 in). It was not verified that this was the at-crash track position, as the vehicle was still operable and probably driven prior to storage.

**Figure 5:** Left interior view.

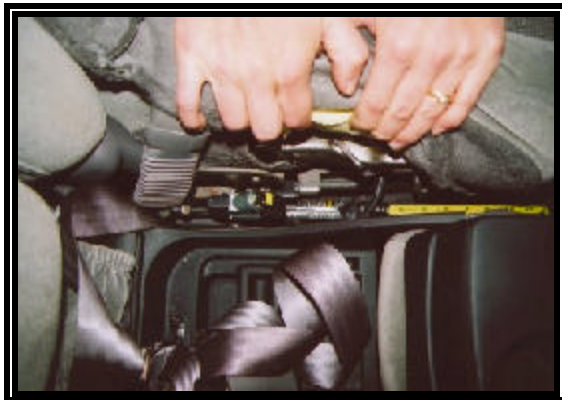
Upon inspection, the driver's restraint webbing was stowed in the retractor and operational. The left front D-ring was adjusted to the full up position. Examination of the webbing and latch plate hardware revealed no evidence of use during the crash. Inspection of the surface of the D-ring similarly was unremarkable. The driver's buckle pre-tensioner had not fired, **Figure 6**. The post-crash measurement of the pre-tensioner's barrel was 110 mm (4.3 in). Inspection of the driver's belt system indicated the driver was unrestrained at the time of the crash.

**Figure 6:** View of the left buckle pretensioner.

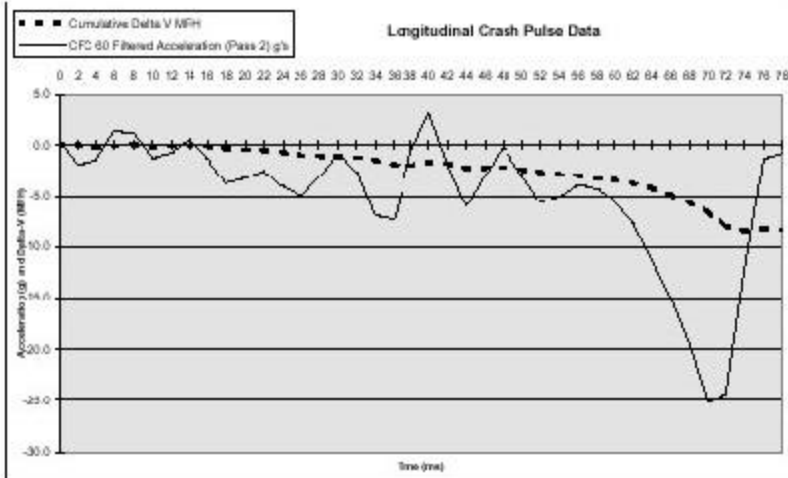
### Longitudinal Cumulative Delta-V

was no command to deploy the pre-tensioners or air bags. Also there were no diagnostic fault codes present when the crash occurred. The 78 millisecond longitudinal delta V was approximately 13.7 km/h (8.5 mph) and appeared to have reached a plateau. It should be noted that this was not the total delta V of the impact, only the recorded delta V at that time interval. The typical duration of a vehicle-to-vehicle impact of this nature is greater than 78 milliseconds.

Time (ms)	0	10	20	30	40	50	60	70	78
Delta-V (MPH)	0.1	-0.1	-0.2	-1.1	-1.6	-2.3	-3.4	-6.7	-9.5

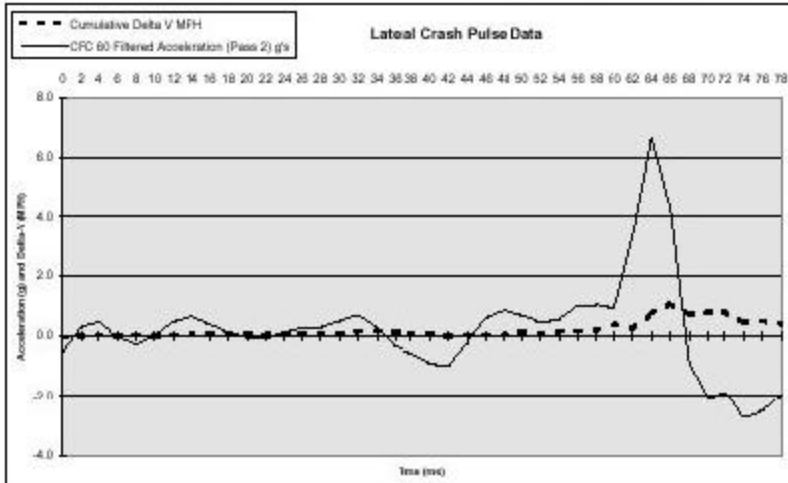
### Lateral Cumulative Delta-V

Time (ms)	0	10	20	30	40	50	60	70	78
Delta-V (MPH)	0.0	0.0	0.1	0.1	0.1	0.3	0.4	0.7	0.4
