ON-SITE ADVANCE OCCUPANT PROTECTION SYSTEMS INVESTIGATION

CASE NUMBER - IN01-006
LOCATION - ILLINOIS
VEHICLE - 2001 FORD TAURUS SEL
CRASH DATE - March, 2001

March 13, 2003

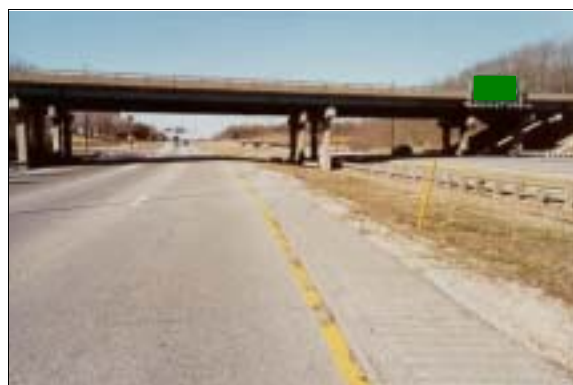
Figure 1: Case vehicle's northerly travel path in inside, southbound lane of southbound roadway; Note: southbound roadway has a curve right horizontal alignment (case photo #03)

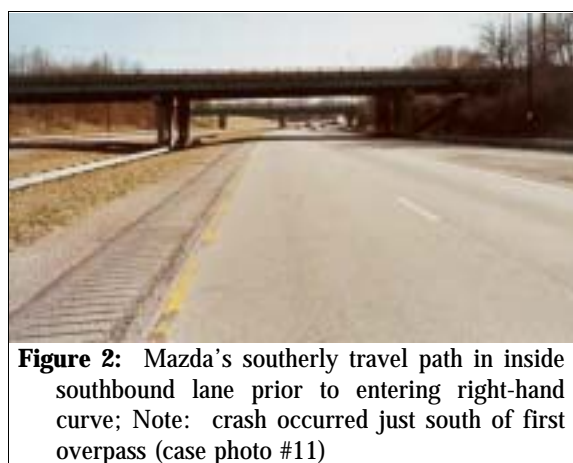
Figure 2: Mazda's southerly travel path in inside southbound lane prior to entering right-hand curve; Note: crash occurred just south of first overpass (case photo #11)

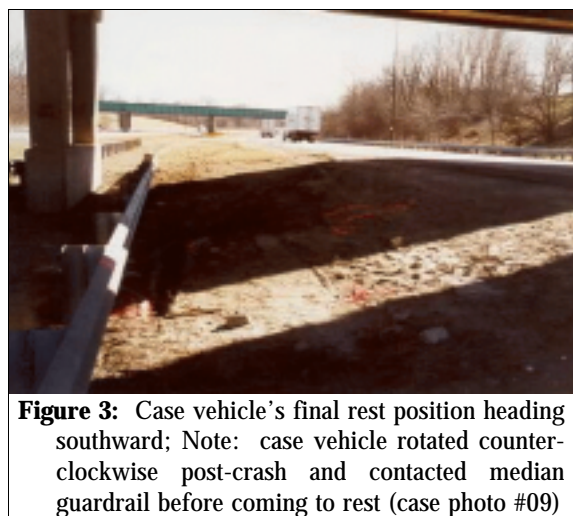
Figure 3: Case vehicle's final rest position heading southward; Note: case vehicle rotated counter-clockwise post-crash and contacted median guardrail before coming to rest (case photo #09)

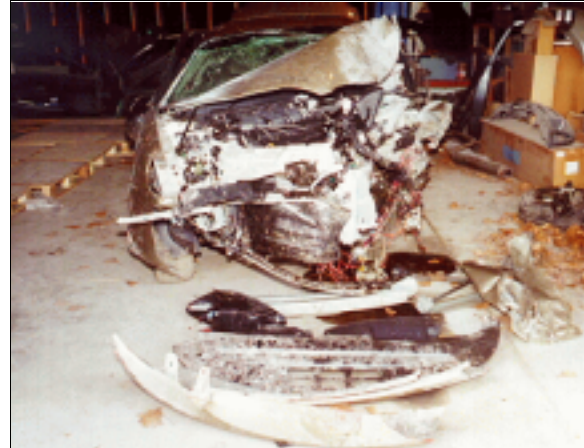
Figure 4: Case vehicle and damaged components; Note: direct frontal damage was primarily offset toward front left (case photo #13)

The case vehicle's contact with the Mazda involved the front left half (Figures 4 and 5 above). Direct damage began 62 centimeters (24.4 inches) to the left of the front right bumper corner and extended an additional 65 centimeters (25.6 inches) to the front left bumper corner. Maximum crush was measured as 166 centimeters (65.4 inches) from the front bumper to the post-crash left front axle end (i.e., at C₁). Residual maximum crush was measured as 87 centimeters (34.3 inches) at C₁. Direct contact damage along the case vehicle's left side ended just rearward of the left "B"-pillar's forward seam (Figure 11), a distance of 247 centimeters (97.2 inches). Direct damage along the case vehicle's left side included separating the left front wheel at the axle end, deflecting the forward end of the left rocker panel inboard 35 centimeters (13.8 inches), and shoving the bottom portion of the left upper "A"-pillar rearward 38 centimeters (15.0 inches). The wheelbase on the case vehicle's left side was shortened 63 centimeters (24.8 inches) while the right side was extended 12 centimeters (4.7 inches).

The front bumper fascia, air dam, and front bumper reinforcement bar were separated from the case vehicle (Figure 4 above). The front grille and the front left headlamp assembly are missing and the left side of the radiator is folded rearward. Also impacted was the left side of the frame's forward cross-member. The left fender was pushed into the lower left "A"-pillar, separating the left front wheel assembly and a portion of its suspension system. The hood was rotated to the left and its left half was displaced rearward and tented near its left side mid-point. Sheet metal covering of the left front door was separated. The right headlight and turn signal assemblies, the hood, the right fender and the right front and rear doors all sustained induced damage as well. Remote buckling was also found on the left roof near the left "B"-pillar. The windshield's glazing was cracked and both left side window glazings were disintegrated. The right front window glazing was broken out by rescue personnel.

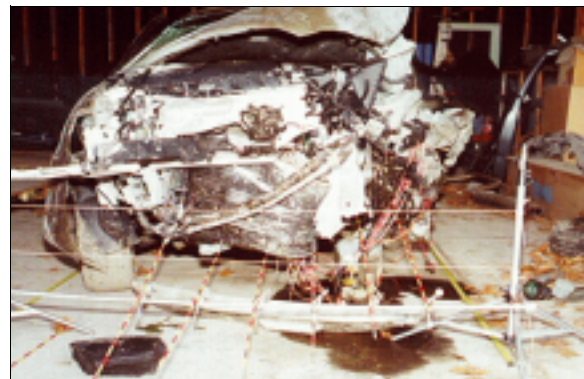
Figure 5: Case vehicle's front left damage with contour gauge present (case photo #14)

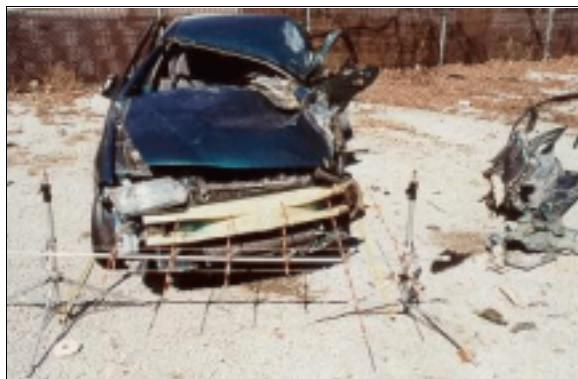
Figure 6: Mazda's narrow front left corner damage viewed from front; Note: front bumper fascia missing and driver's door toward right of photo (case photo #56)

The Mazda's contact with the case vehicle involved its front left corner (**Figures 6 and 7** above). Direct damage began at the front left bumper corner and extended, a measured distance of 18 centimeters (7.1 inches), along the front bumper toward the right. The Field L extended from bumper corner to bumper corner, a measured distance of 128 centimeters (50.4 inches). Residual maximum crush was measured as 73 centimeters (28.7 inches) at C_1 . Direct contact damaged extend down the Mazda's left side, beyond the left rear wheel (**Figure 17**), and was measured as 387 centimeters (152.4 inches). The wheelbase on the case vehicle's left side was shortened 57 centimeters (22.4 inches) while the right side was unaltered from the crash. The left front tire was missing and the left front wheel and suspension were driven backwards into the driver's seating area (**Figure 7** above). The left rear tire was physically restricted and deflated (**Figure 17**).

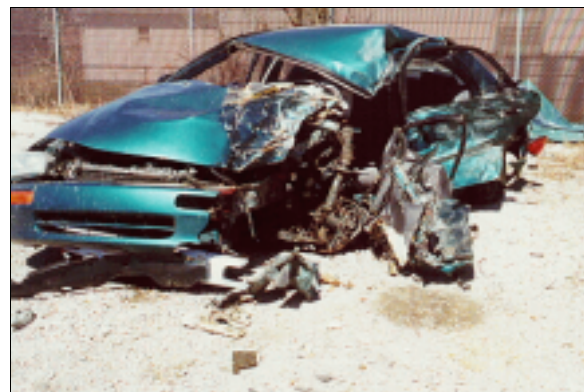
Figure 7: Mazda's frontal impact showing narrow end engagement and extensive damage and penetration to left side (case photo #62)

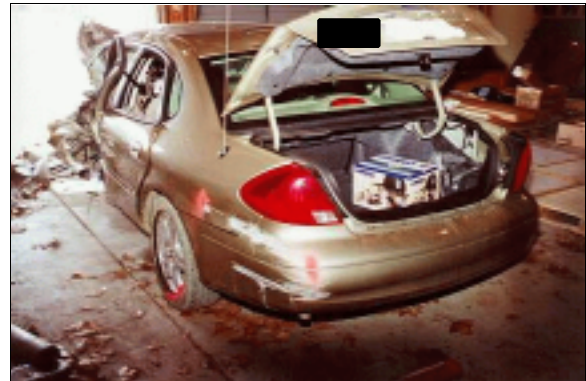
Figure 8: Case vehicle's back left sideswipe damage from contact with the median guardrail (case photo #24)

The second impact to the case vehicle occurred from contact with the median's "W"-beam guardrail and resulted in sideswipe-type direct damage to the left quarter panel at the height of the rear bumper fascia (Figure 8 above). Direct damage began at the back left bumper corner and extended 10 centimeters (3.9 inches) along the back bumper toward the right. Maximum crush was measured as 6 centimeters (2.4 inches). The direct contact damage associated with this impact

also began at the back left bumper corner and extended a measured distance of 64 centimeters (25.2 inches) forward toward the left rear wheel. The case vehicle's back bumper fascia and left fender were directly contacted.

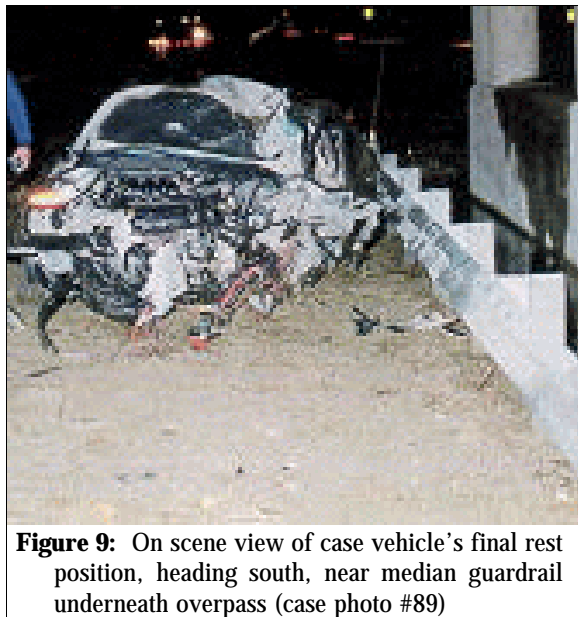
Figure 9: On scene view of case vehicle's final rest position, heading south, near median guardrail underneath overpass (case photo #89)

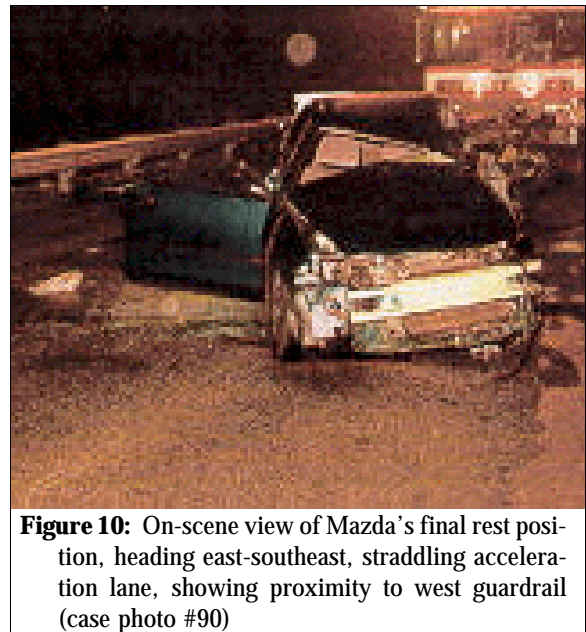
Figure 10: On-scene view of Mazda's final rest position, heading east-southeast, straddling acceleration lane, showing proximity to west guardrail (case photo #90)

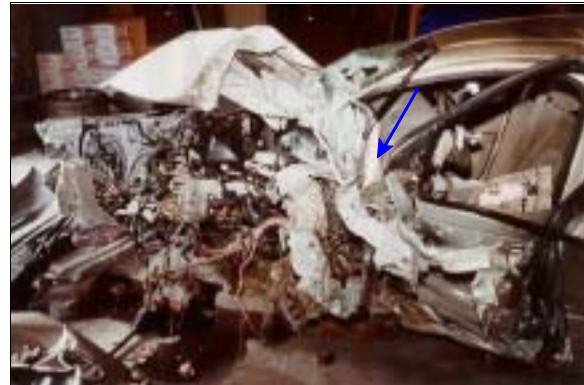
Figure 11: Damage extends down case vehicle's left side as a result of frontal impact; Note: arrow locates lower portion of left upper "A"-pillar (case photo #21)

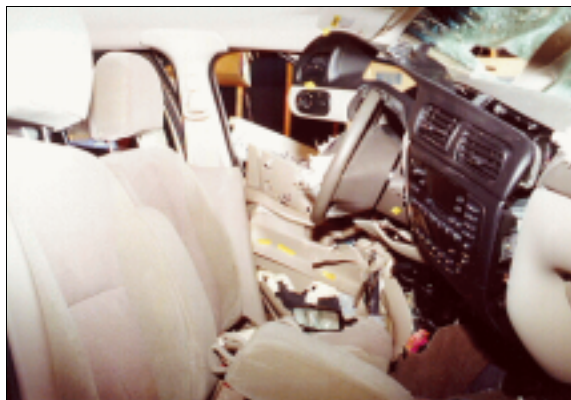
Inspection of the case vehicle's interior revealed eight additional locations of occupant contact and/or injury evidence. The left instrument panel contained a scrape mark and body fluid. The top left corner of the left instrument panel had blood splatters, while the underneath side of the steering column and the right side of the left instrument panel displayed scrapes. Furthermore, a long scrape mark was discovered on the lower portion of the interior panel of the driver's door, and a small body fluid smear was detected on the left side of the steering wheel rim. In addition, the roof fabric above the driver's seat had a scrape mark and hair strands. There was extensive intrusion to the driver's seating area including toe and floor pans, left front door panel and rocker panel, and left instrument panel area (**Figure 12**). Finally, the steering column was loose, post-crash, indicating shear capsule separation.

Figure 12: Case vehicle's front seating area viewed from right showing distortion of instrument panel and intrusion into driver's seating area; Note: contact evidence on driver's door and remnant of front right passenger air bag (case photo #42)

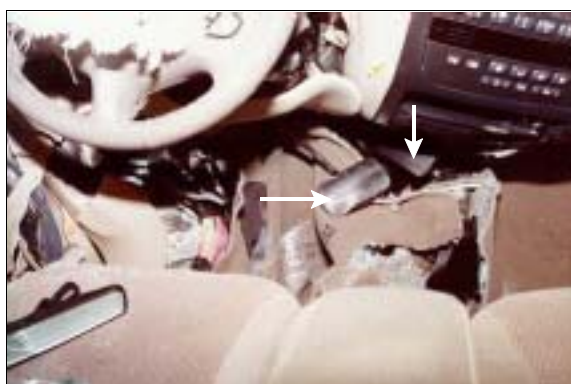
The electronically adjustable brake and accelerator pedals were examined (**Figure 13**) as well as the pretensioners. Post-crash, the brake pedal was extended towards the driver's seat by 9 centimeters (3.5 inches) and the accelerator pedal by 7 centimeters (2.8 inches). Given the height [185 centimeters (73 inches)] of the case vehicle's driver, it is highly unlikely he would have found it necessary to have extended the pedals. Rather, the severe lateral intrusion to the driver's toe pan and floor pan areas likely lifted and shifted (to the right) the pedals with sufficient force to expand the arm travel of both. An attempt was made to examine the safety belt pretensioners; however, because of the severe intrusion, the likely actuation of the driver's pretensioner was not verified or measured.

Figure 13: Case vehicle's adjustable brake (left) and accelerator (right) pedals; Note: severe toe and floor pan deformation and arrows locating pedals (case photo #40)

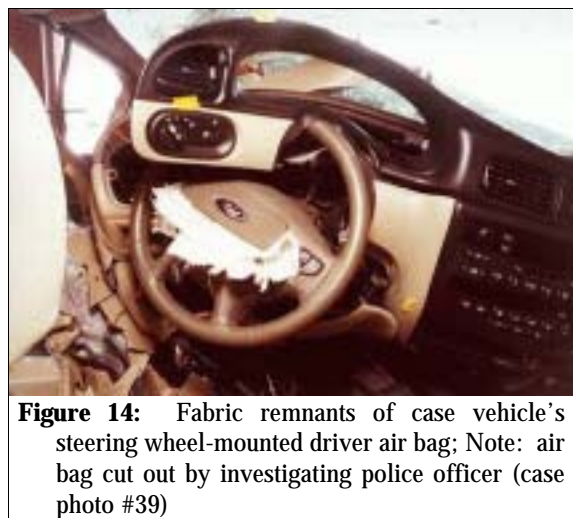
The case vehicle was equipped with a Supplemental Restraint System (SRS) that contained redesigned frontal air bags at the driver and front right passenger positions. Both frontal air bags deployed as a result of the frontal impact with the Mazda. Both the case vehicle's driver and front right passenger air bags were cut out by the investigating police officer and shipped to a laboratory for analysis. The case vehicle's driver air bag was located in the steering wheel hub (**Figure 14**). The module cover flaps were in an asymmetrical, trapezoidal configuration, with the upper cover flap measuring 17.0 centimeters (6.7 inches) horizontally along its lower horizontal seam, 15.5 centimeters (6.1 inches) along its top horizontal seam, and 8 centimeters (3.1 inches) vertically. The lower cover flap measured 17.0 centimeters (6.7 inches) along its top horizontal seam, 12.5 centimeters (4.9 inches) along its bottom horizontal seam, and 5 centimeters (2.0 inches) vertically. An inspection of the air bag module's cover flaps revealed that the cover flaps opened at their designated tear points and there appeared to be neither damage nor contact evidence on the surface of either flap. This contractor discovered what appeared to be remnants of two tethers, each 6 centimeters (2.4 inches) in width, located inside the steering wheel hub. With the air bag fabric removed, the existence, number, and size of vent ports could not be assessed nor could the shape or size of the driver's air bag be described. Comments by the investigating police officer indicated that there were blood stains on the fabric of the driver's air bag, but their exact locations are unknown.

Figure 14: Fabric remnants of case vehicle's steering wheel-mounted driver air bag; Note: air bag cut out by investigating police officer (case photo #39)

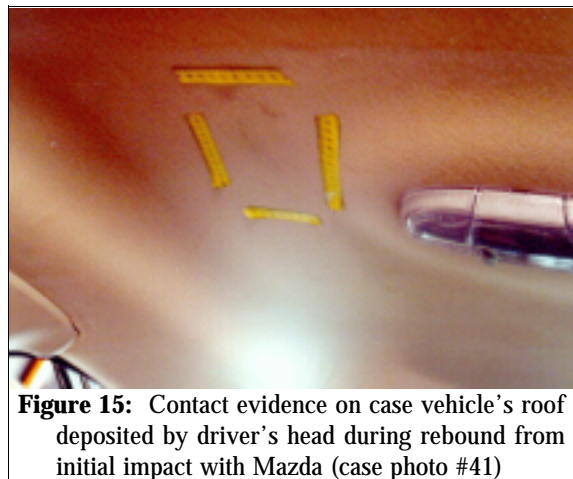
Figure 15: Contact evidence on case vehicle’s roof deposited by driver’s head during rebound from initial impact with Mazda (case photo #41)

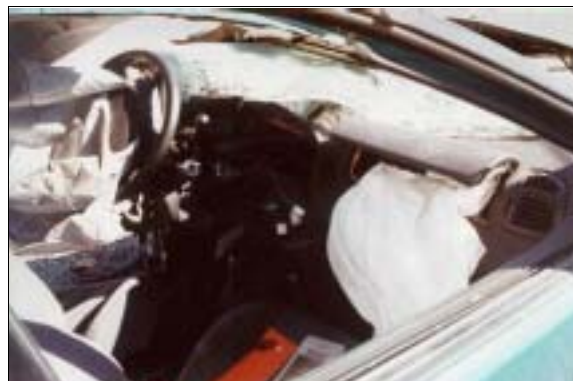
Figure 16: Mazda's deployed driver and front right passenger air bags viewed from right near "B"-pillar (case photo #85)

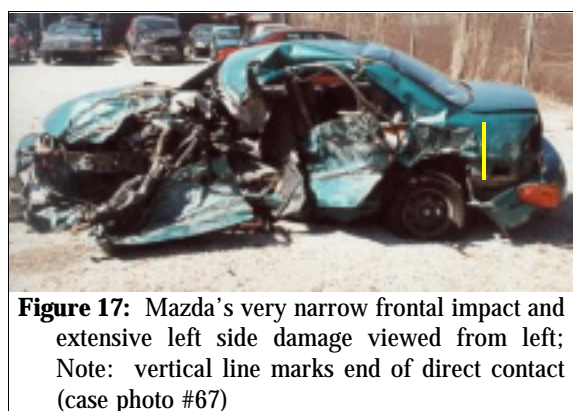
Figure 17: Mazda's very narrow frontal impact and extensive left side damage viewed from left; Note: vertical line marks end of direct contact (case photo #67)

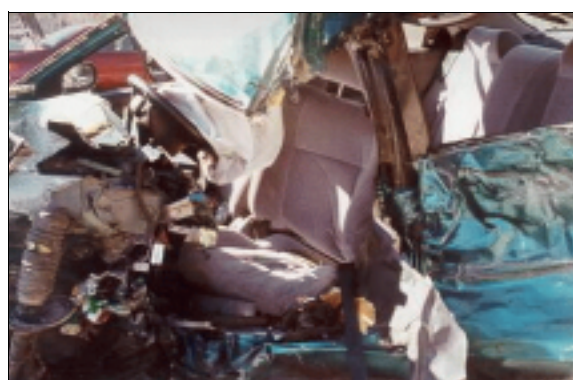
Figure 18: Mazda's driver seat viewed from left, showing deployed driver air bag; Note: driver was declared dead at the scene (case photo #82)

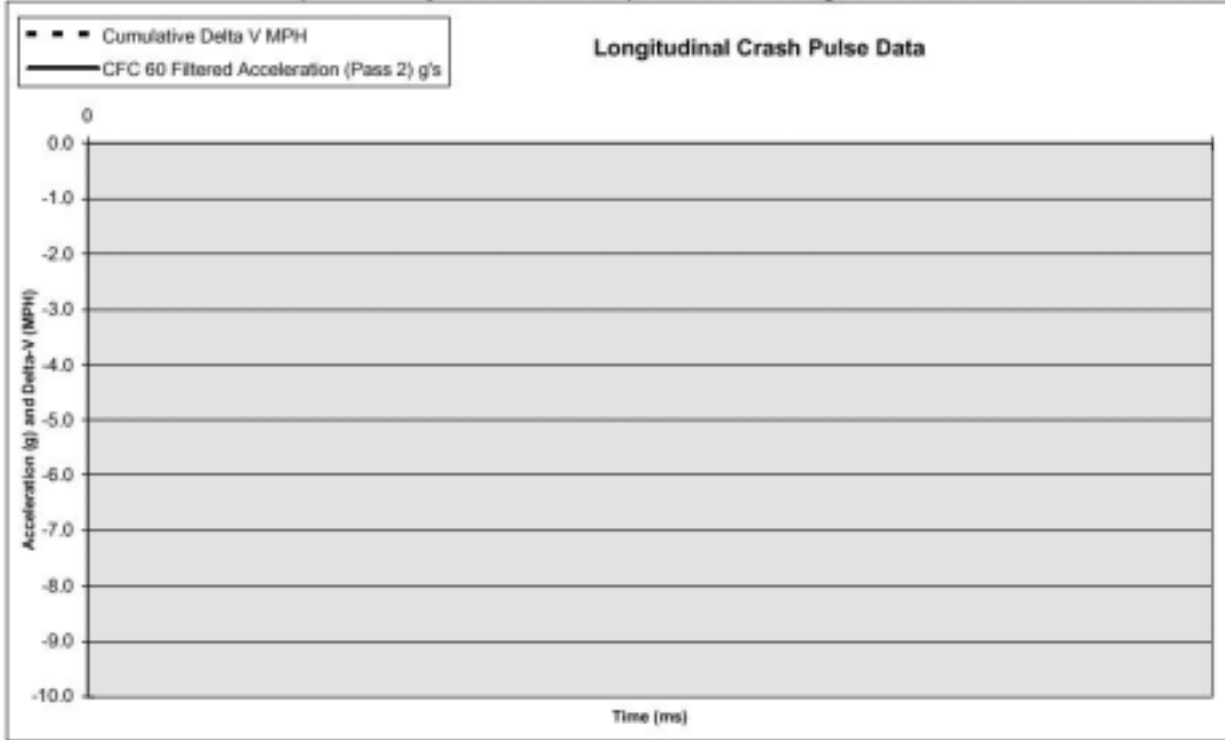
Note: Acceleration data and plots are only valid for frontal impact event recordings.

Figure 20: Cumulative Longitudinal Delta V versus Delta T

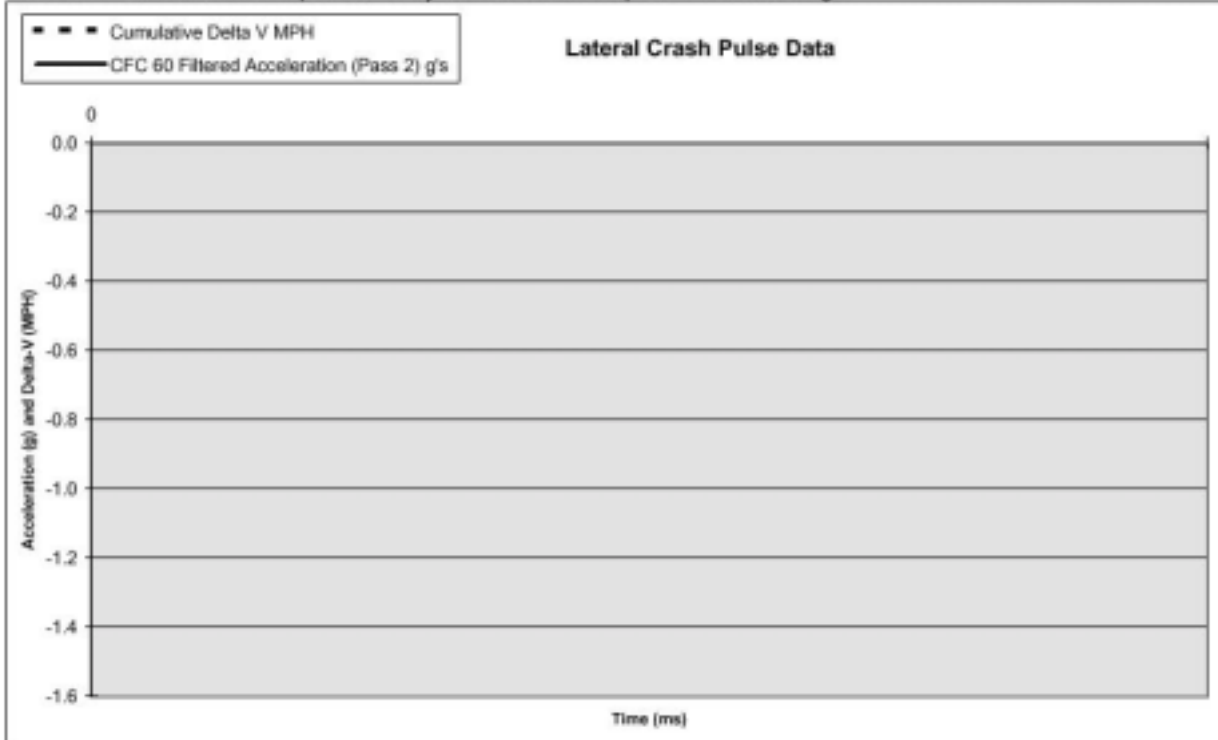
Note: Acceleration data and plots are only valid for frontal impact event recordings.

Figure 21: Cumulative Lateral Delta V versus Delta T
