Advanced Occupant Protection Systems On-scene Investigation
Dynamic Science, Inc. / Case Number: DS01-006
2000 Ford Taurus SES 4-door
California
December, 2000

# Dynamic Science, Inc. Accident Investigation Case Number: DS01-006

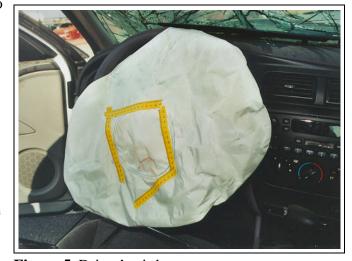
Figure 5. Driver's air bag.

The case vehicle driver's air bag was circular and measured 44 cm (17.3 in.) in diameter. It was equipped with two tethers and two vent holes at the 11 and 01 o'clock positions. The front center of the air bag there was a driver contact consisting of makeup and a lipstick imprint. The driver's air bag also had dirt from exposure. The dual module covers opened in an "H" configuration.

There were no indications of any damage to driver's air bag or the module covers. The case vehicle front right passenger's air bag was rectangular and measured 42 cm (16.5 in.) high by 48 cm (18.9 in.) wide. It was equipped with two vent ports at the 10 and 02 o'clock positions and was not tethered. There was dirt all over the air bag from exposure. There was no damage to the air bag. The single flap module cover opened properly and was not damaged. Both front seat positions of the case vehicle were equipped with seat belt buckle pretensioners. The front right pretensioner

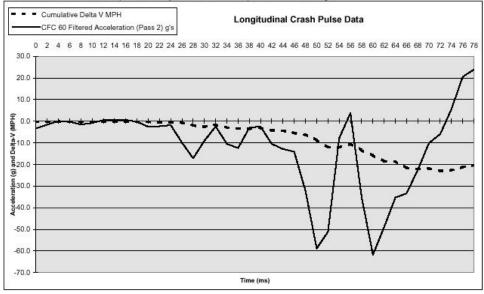
## Longitudinal Cumulative Delta-V

The downloaded EDR data indicates the highest cumulative longitudinal delta v of -21.9 km/h (-35.2 mph) at the 70 ms mark. The EDR report is included as an attachment to this report.

Time (ms)	0	10	20	30	40	50	60	70	78
Delta-V (MPH)	-0.2	-0.4	-0.3	-2.6	-3.1	-8.8	-15.9	-21.9	-20.3

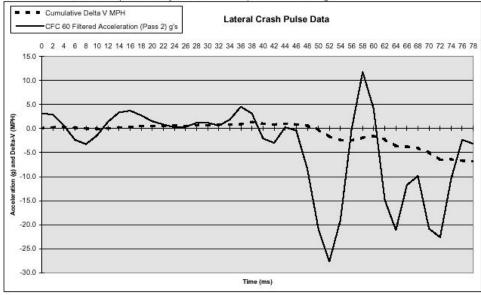
#### Lateral Cumulative Delta-V

Time (ms)	0	10	20	30	40	50	60	70	78
Delta-V (MPH)	0.1	0.0	0.5	0.7	1.0	-0.2	-1.5	-5.0	-6.8
