On-scene Investigation / Vehicle to Vehicle  
Dynamic Science, Inc. / Case Number: DS01-009  
2000 Ford Taurus SE  
Texas  
December, 2000

1. Report No. DS01-009		2. Government Accession No.		3. Recipient Catalog No.	
4. Title and Subtitle In-Depth Accident Investigation				5. Report Date	
				6. Performing Organization Report No.

**Dynamic Science, Inc.**  
**Accident Investigation**  
**Case Number: DS01-009**

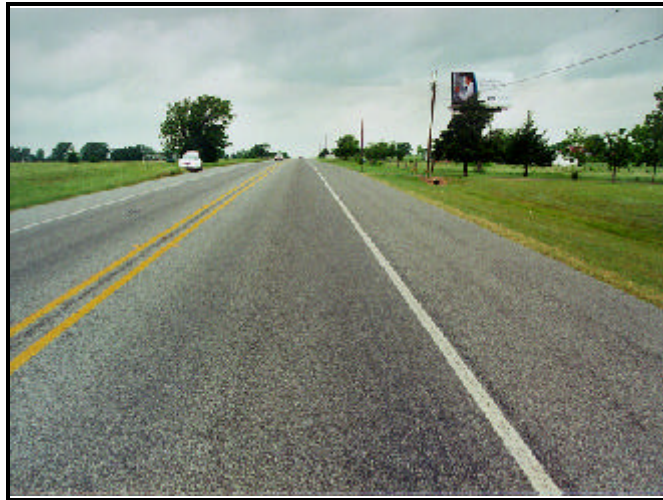
**Figure 1.** Approach to impact area for case vehicle--facing west.

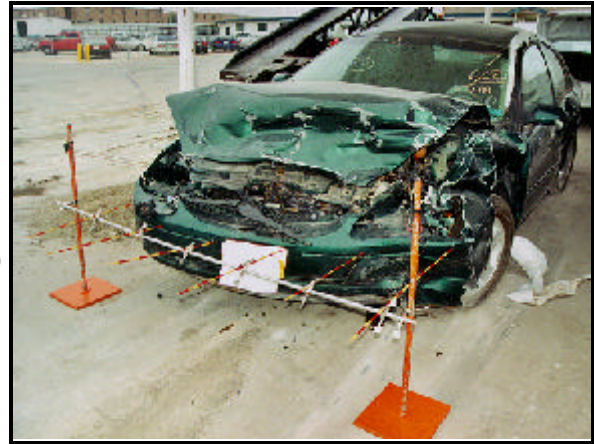
After impact, the case vehicle rotated slightly clockwise and the Mazda rotated counterclockwise. There was a second impact with the left side (09LZEW2) of the case vehicle side-slapping the rear right of the Mazda.

**Figure 2.** Exterior damage to case vehicle.

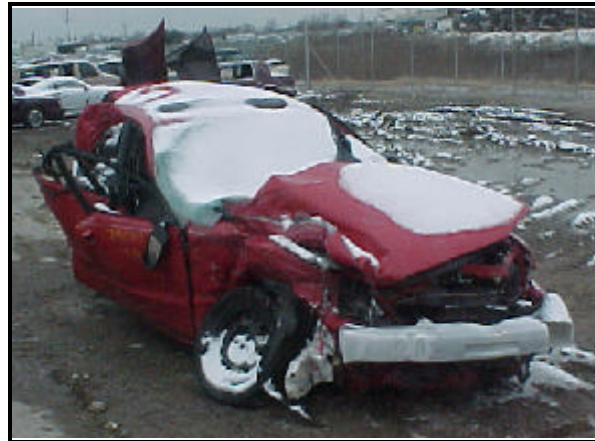
**Figure 3.** Exterior damage to Mazda.

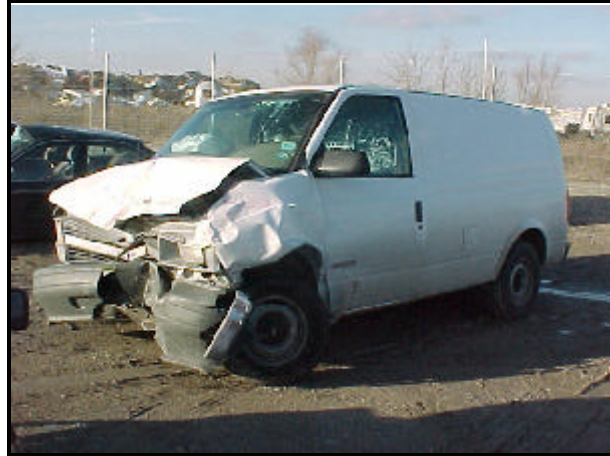
**Figure 4.** Exterior damage to Chevrolet.

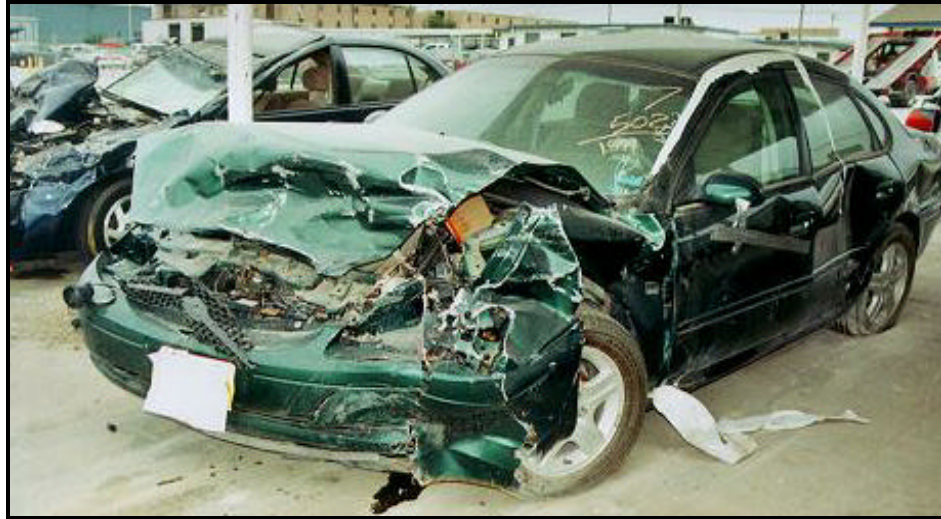
Description:	2000 Ford Taurus SE	
VIN:	1FAFP56S7YAxxxxxx	
Odometer:	18,364 km (11,411 miles)	
Engine:	3.0 L 6 cyl	
Reported Defects:	None	
Cargo:	None	
Damage Description:	Major front end damage, left door frame displaced, contact damage to left side from side slap impact, toe pan intrusion. Vehicle declared a total loss by insurance company.	
CDC:	Event 2, Impact 1: 11FYEW2 Event 3, Impact 2: 09LZEW2	
Delta V (Impact 1):	Total	32.6 km/h (20.3 mph)
	Longitudinal	-31.5 km/h (-19.6 mph)
	Latitudinal	8.4 km/h (5.2 mph)
	Energy	182,468 joules (134,607 ft-lbs)
Delta V (Impact 2):	Total	7.7 km/h (4.8 mph)
	Longitudinal	0 km/h (0 mph)
	Latitudinal	7.7 km/h (4.8 mph)
	Energy	6,626 joules (4,888 ft-lbs)

**Figure 7.** Front left, case vehicle

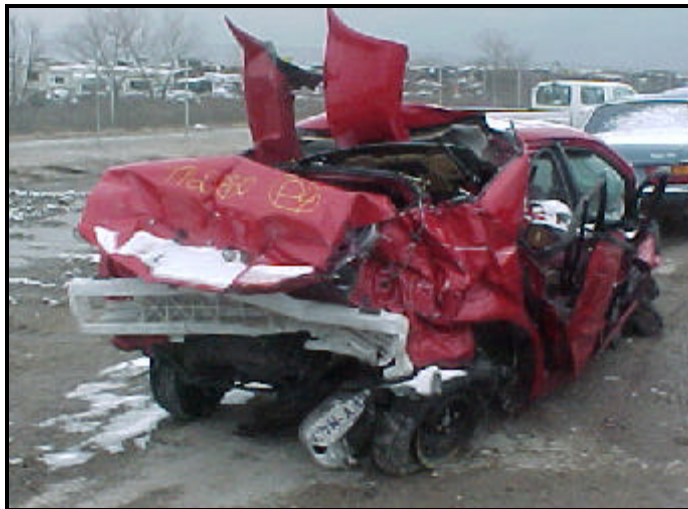
Description:	1999 Mazda Protege	
VIN:	JM1BJ2228X0xxxxxx	
Odometer:	Unknown	
Engine:	1.6 L	
Reported Defects:	None noted	
Cargo:	Unknown	
Damage Description:	Major damage to rear end and right front. Vehicle towed from scene and later declared a total loss.	
CDC:	Event 1, Impact 1: Unknown Event 2, Impact 2: 02RFEW3 Event 3, Impact 3: Unknown	
Delta V (Impact 2):	Total	41.1 km/h (25.5 mph)
	Longitudinal	-20.6 km/h (-12.8 mph)
	Latitudinal	-35.6 km/h (-22.1 mph)
	Energy	24,189 joules (17,852 ft-lbs)

**Figure 8.** Right rear, other vehicle (Mazda)

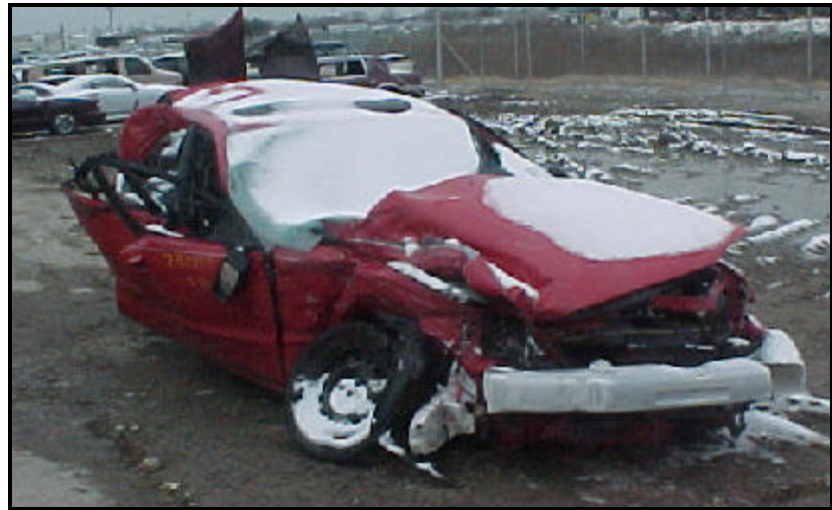
**Figure 9.** Right front, other vehicle (Mazda)

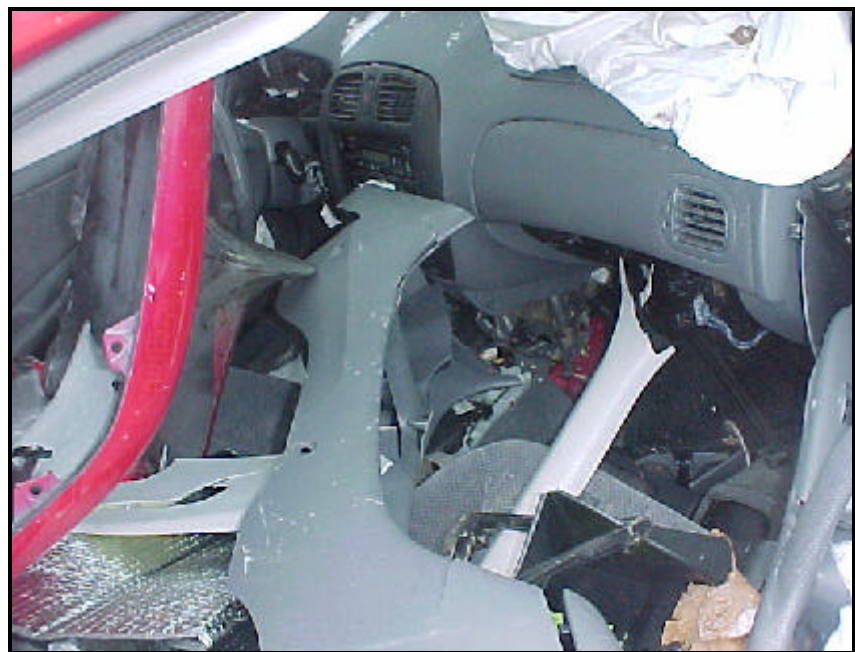
**Figure 10.** Interior view, other vehicle (Mazda)

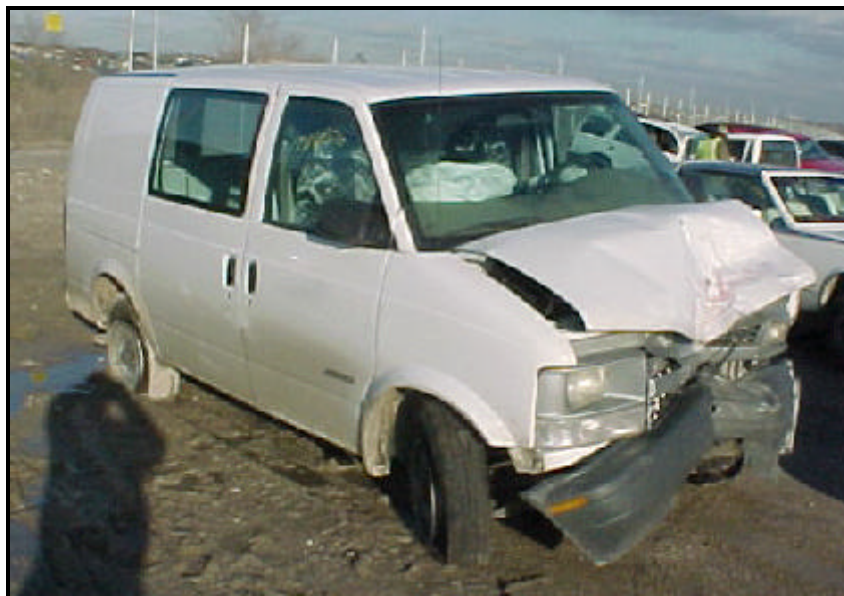
Description: 2000 Chevrolet Astro Van 4 x 2  
 VIN: 1GCDM19W0YBxxxxxx  
 Odometer: Unknown  
 Engine: 4.L V6  
 Reported Defects: None noted  
 Cargo: Unknown  
 Damage Description: Moderate damage to bumper, grille, hood.  
 Vehicle towed from scene and later declared a total loss.  
 CDC: Event 1, Impact 1: 12FYEW1  
 Delta V: Total Unknown  
 Longitudinal Unknown  
 Latitudinal Unknown  
 Energy Unknown

**Figure 11.** Front right, other vehicle (Chevrolet)

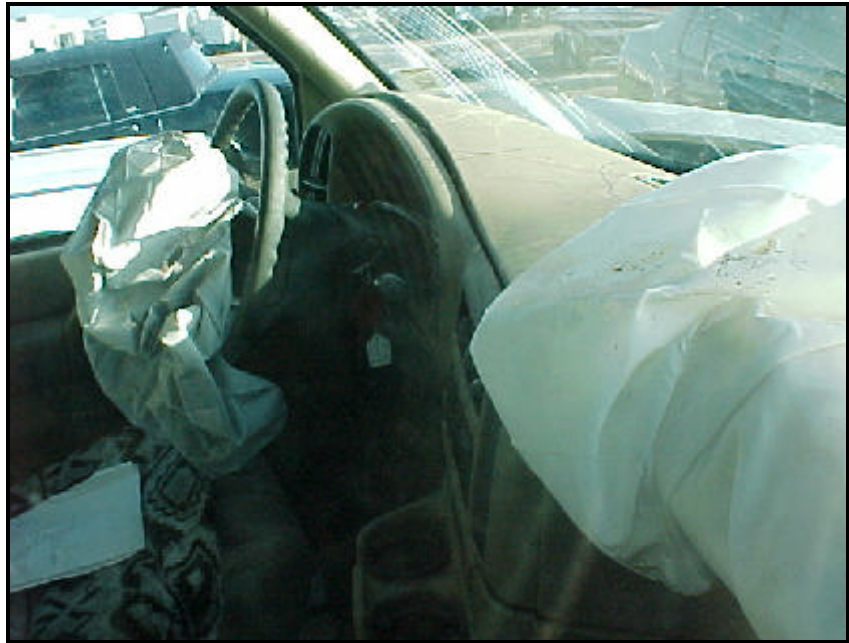
**Figure 12.** Interior view, other vehicle (Chevrolet)

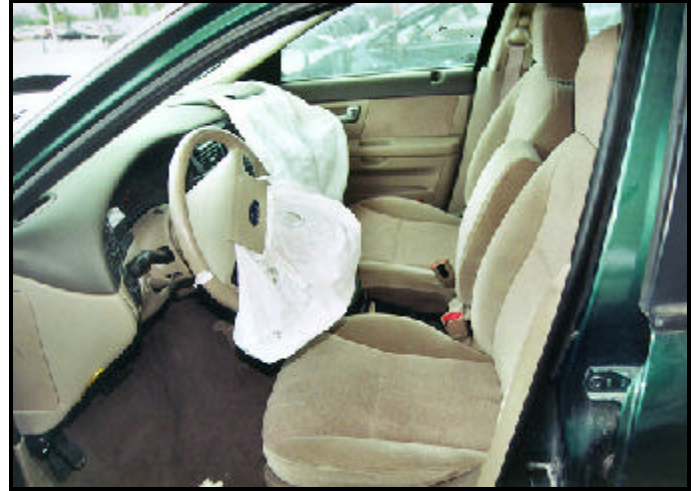
Figure 13. Driver's seated position

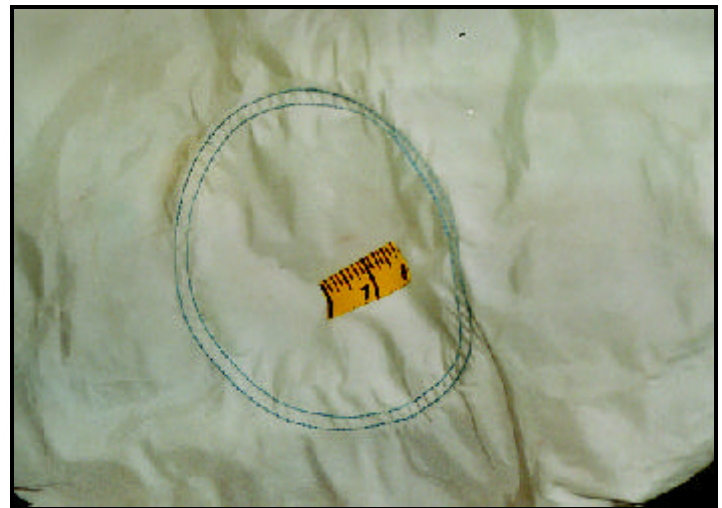
The case vehicle was equipped with a driver's and front right passenger's air bags. The driver's steering wheel mounted air bag was circular and measured 43 cm (16.9 in.) in diameter. It was equipped with two tethers and two vent ports. The vent holes were at the 11 and 1 o'clock positions. There was a red smear, likely lipstick, on the center of the driver's air bag. The dual module covers opened in a typical "H" configuration. There were no indications of damage to the covers. The front right passenger's top mounted air bag was rectangular and measured 56 cm (22 in.) by 46 cm (18.1 in.). It was equipped with two vent ports and did not have any tethers. On the face of the air bag there was cover-related scuffing. The single flap module cover did not sustain any damage.

Figure 14. Lipstick contact to driver's air bag

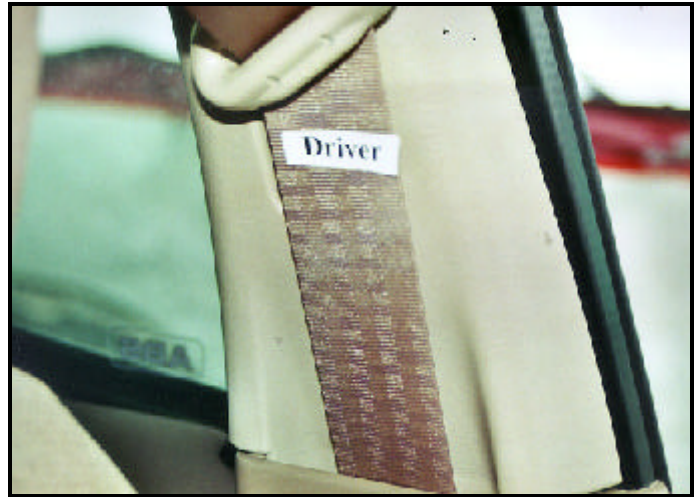
<u>INJURY</u>	<u>OIC CODE</u>	<u>ICD-9</u>	<u>SOURCE</u>
Driver:	Contusion, left shoulder	790402.1,2	923.0	Seat belt
	Contusion, left chest	490402.1,2	922.1	Seat belt
	Contusion, abdomen	590402.1,4	922.2	Seat belt
	Sternal fracture	450804.2,4	807.2	Seat belt
	Possible heart injury <sup>2</sup>	NA	NA

**Figure 15.** Seat belt loading marks on driver's belt

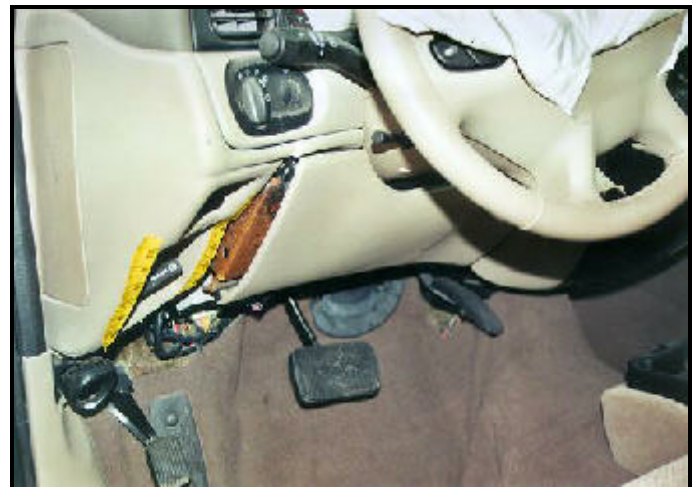
**Figure 16.** Knee contacts to lower instrument panel, lateral displacement of foot controls

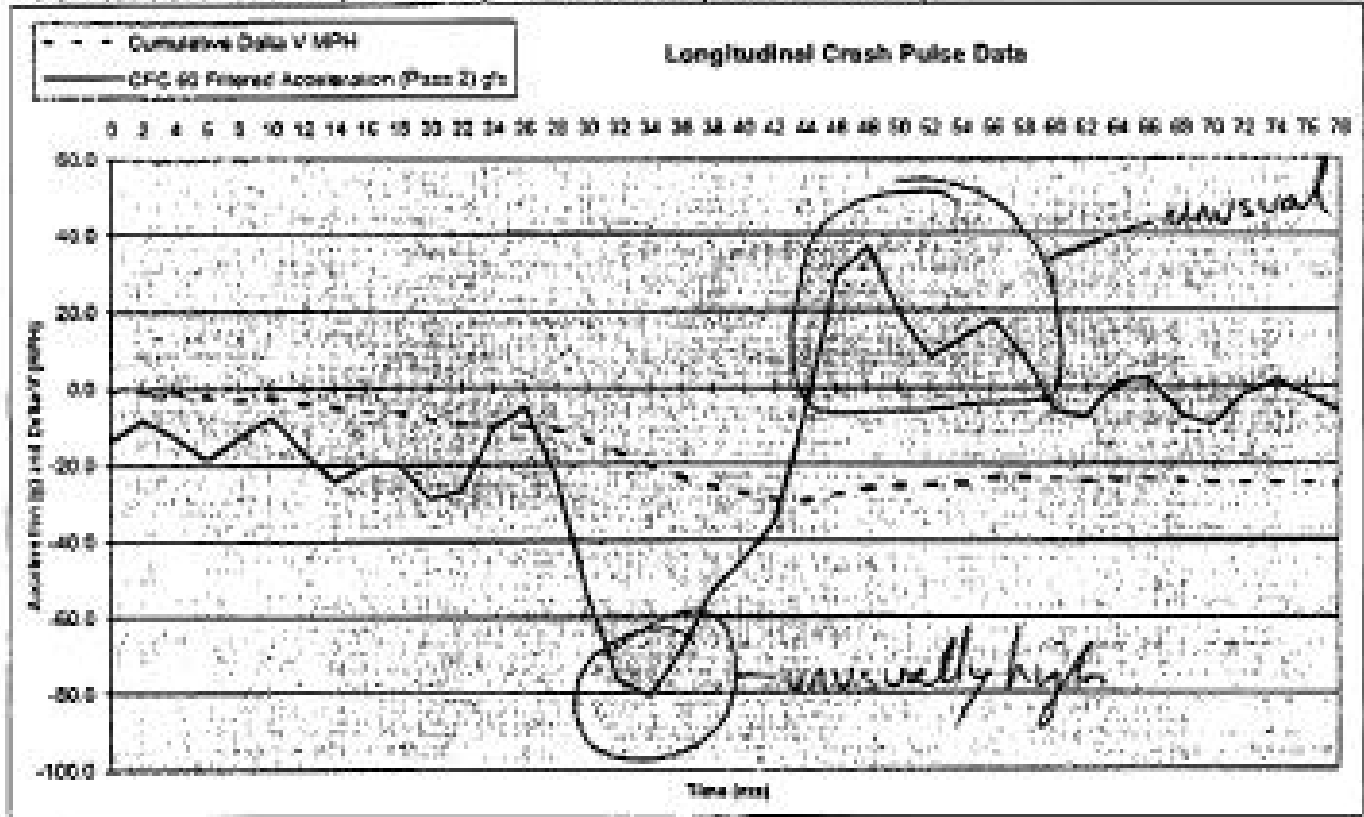
Longitudinal Cumulative Delta-V

According to Ford, there were two unusually high spikes in the data output that may have been influenced in some way by the subsequent side-slap impact.

Time (ms)	0	10	20	30	40	50	60	70	78
Delta-V (MPH)	-6.4	-9.3	-9.3	-12.4	-17.3	-22.7	-22.7	-22.3	-15.3

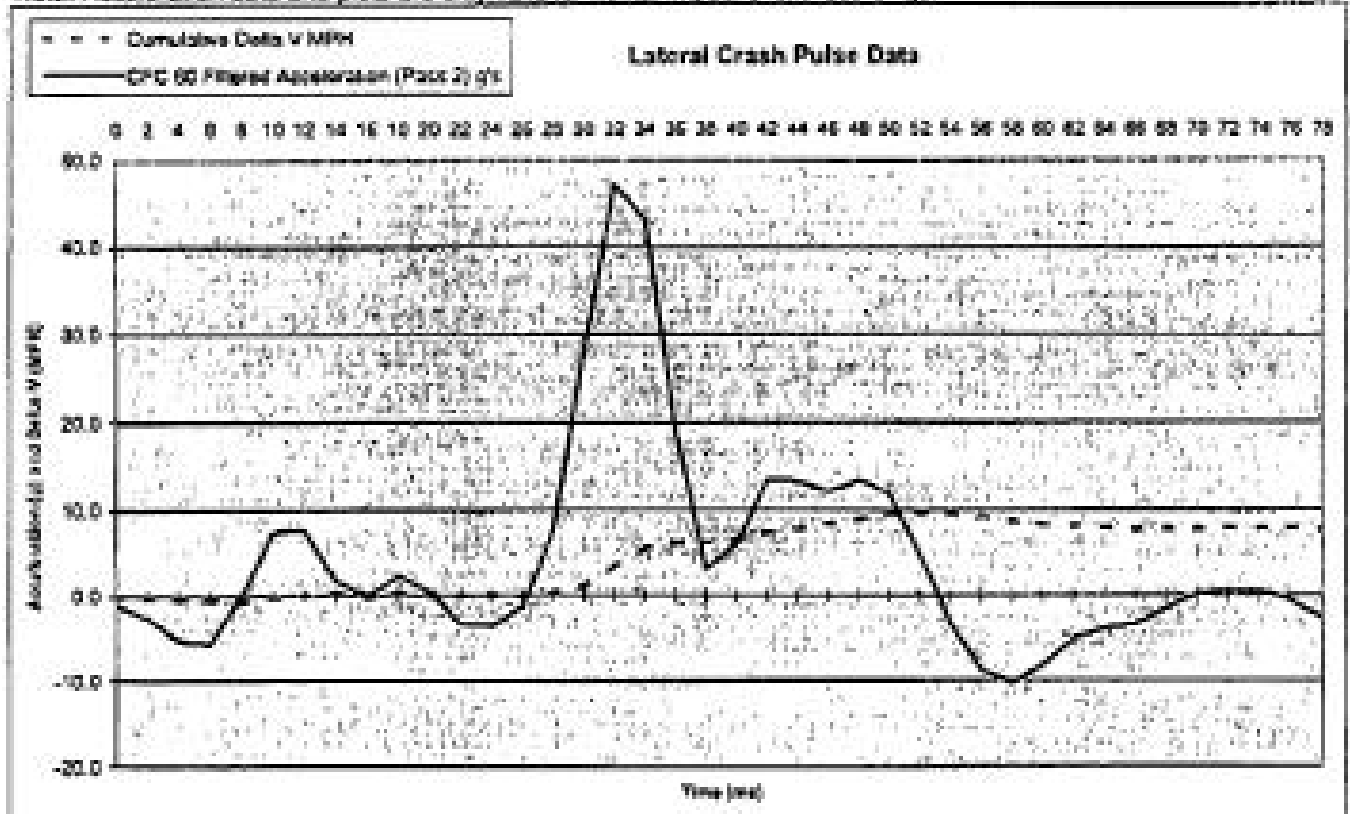
**Lateral Cumulative Delta-V**

Time (ms)	0	10	20	30	40	50	60	70	78
Delta-V (MPH)	0.0	+8.2	8.3	1.2	6.6	5.6	8.3	7.8	5.9
