**ADVANCED OCCUPANT PROTECTION SYSTEM STUDY  
2001 FORD TAURUS INVESTIGATION**

**VERIDIAN CASE NO. CA01-037**

**LOCATION - NEW YORK**

**CRASH DATE - JUNE 2001**

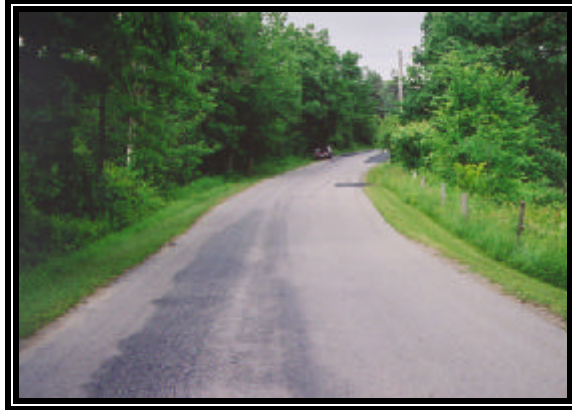
This single vehicle run-off-road/fixed object crash occurred during the evening hours of June, 2001. It was daylight at the time of the crash and the weather was not a factor. The road surface was dry. The subject roadway was a north/south two-lane asphalt road in a rural setting. There was a right curve for northbound traffic. The radius of curvature, near the point of impact, measured approximately 274 m (900 ft). The west road shoulder was grass, measured approximately 1.5 m (5.0 ft) in width and was approximately level. The shoulder then tapered into a 1 m (3 ft) deep ditch that ran parallel to the road. The ditch was centered 2.7 m (90 ft) from the north road edge. A 25 cm (10 in) diameter hardwood tree was growing in the ditch and was the point of impact. The unposted speed limit was 89 km/h (55 mph). **Figure 1** is a northbound trajectory view of the roadway.

**Figure 1:** Trajectory view of the Ford Taurus.

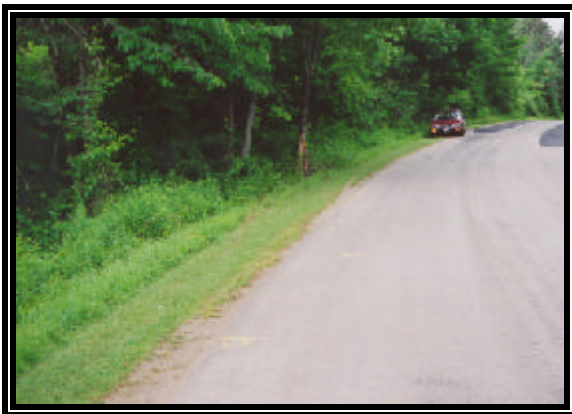
**Figure 2:** Trajectory view at the point of road side departure.

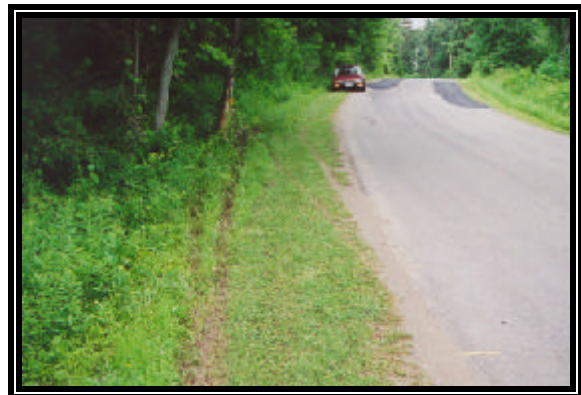
**Figure 3:** Yaw marks leading to the point of impact.

The impact with the tree stopped the vehicle's clockwise rotation and caused the vehicle to rotate counterclockwise during the separation phase of the impact. A yaw mark caused by the right rear tire during this rotation is depicted in the background of Figure 3. The Ford rotated approximately 180 degrees and came to rest facing south approximately 8 m (25 ft) north of the tree.

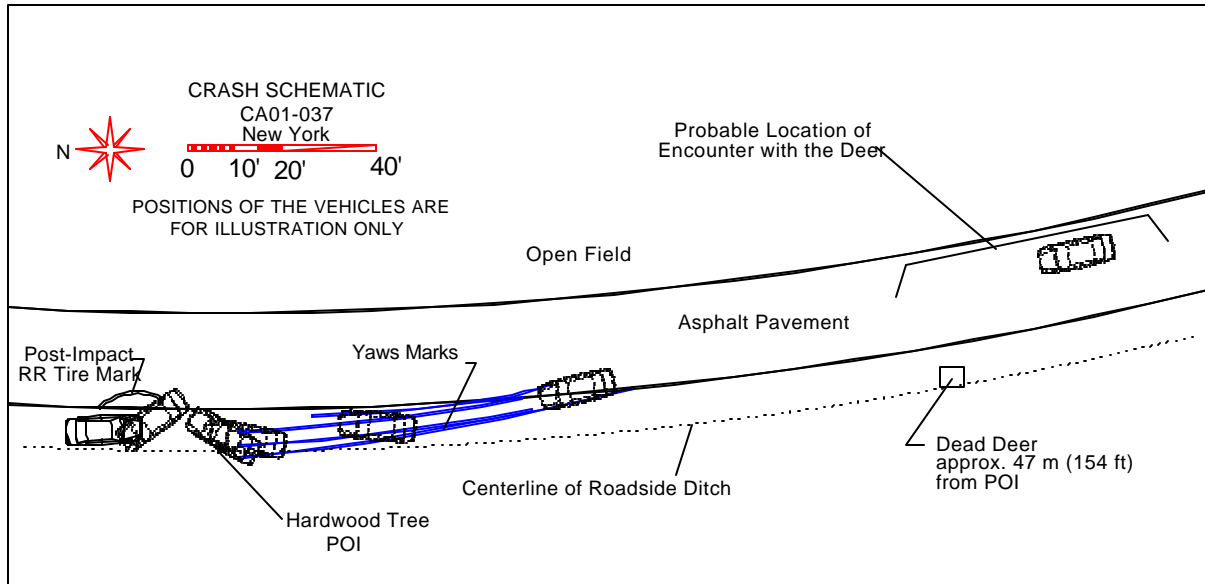
**Figure 4** is a schematic of the crash sequence. The front aspect of the vehicle's left side impacted the tree in a sideswiping orientation. The direct contact began approximately at the left front axle location and engagement with the tree continued along the vehicle's left side during its northward trajectory. The maximum engagement with the tree occurred at the left B-Pillar location. The vertical measurement of the direct contact to the tree measured 147 cm (58 in). The nature and dynamics of this prolonged sideswiping impact was not suitable for analysis via the WINSMASH model. The estimated delta V of the impact was 19 to 29 km/h (12 to 18 mph).

**Figure 4:** Crash schematic.

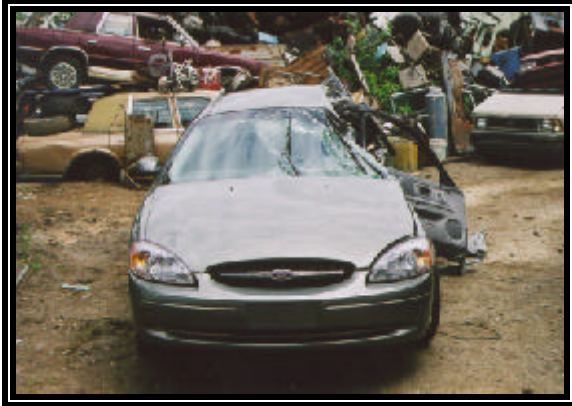
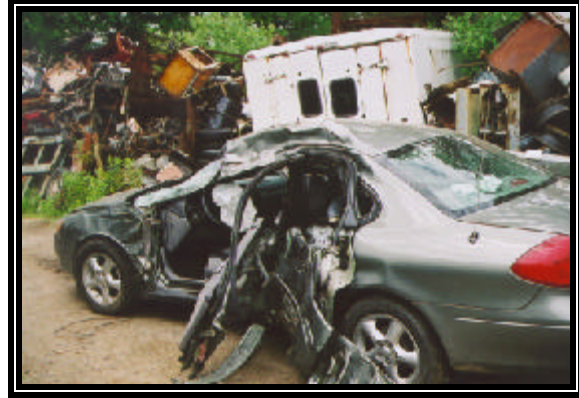
**Figures 5 and 6** are the front and left side views of the vehicle's damage. The combined length of the direct and induced left side damage measured 267 cm (105 in). The direct contact damage began on the left front fender, 30 cm (12 in) forward of the left front axle, and ended on the aft aspect of the left rear door, 39.4 cm (15.5 in) forward of the left rear axle. The crush profile measured along the trim elevation was as follows: C1=5.3 cm (2.1 in), C2=25.7 cm (10.1 in), C3=25.4 cm (10.0 in), C4=13.7 cm (5.4 in), C5=7.1 cm (2.8 in), C6=0. The impact shifted the left front and rear doors rearward into the B-pillar and C-pillar, respectively. Both left doors were jammed shut. The hinges of the left front door were cut during the extrication process and the door was opened rearward. The right side doors were operational.

The force of the crash caused approximately 30 cm (12 in) of lateral intrusion measured at the B-pillar. The interior B-pillar to B-pillar dimension measured 102 cm (40 in). The direct contact with the tree deformed and creased the left aspect of the roof into a vertical section. The exterior lateral dimension of the direct roof to tree contact measured 30 cm (12 in) at the A-pillar. The top aspect of the left A-pillar deformed vertically downward approximately 13 cm (5 in). The left side windows were closed at the time of the crash and disintegrated upon impact. The left side of the windshield was fractured by direct contact. There was no change in the wheelbase dimensions. The Collision Deformation Classification (CDC) was 11-LYAW-3. The nature and dynamics of this prolonged side-swiping impact was not suitable for analysis via the WINSMASH model. The delta V of this moderate severity crash was approximately 19 to 29 km/h (12 to 18 mph) based on SCI experience.

Figure 5: Ford Taurus front view.

Figure 6: Left side view.

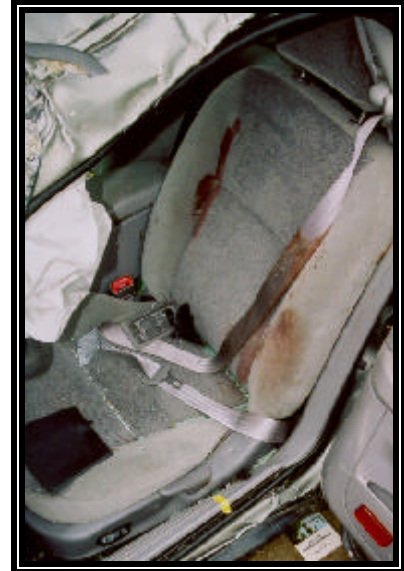
Upon inspection, the driver's restraint webbing was extended from the retractor and locked in place due to the deformation, **Figure 7**. The left front D-ring was adjusted to the lowest position and the webbing was gathered in the D-ring's corner from loading. Historical usage evidence was identified on the latch plate consistent with the age of the vehicle. The driver's buckle pretensioner had fired. The post-crash measurement of the pretensioner's piston barrel was 41 mm (1.6 in). The pre-crash specification of the barrel length measured 110 mm (4.3 in), therefore the fired pre-tensioner removed 69 mm (2.7 in) of slack from the belt system. All the evidence identified during the inspection indicated the driver was properly restrained at the time of the crash.

**Figure 7:** Driver's restraint system.

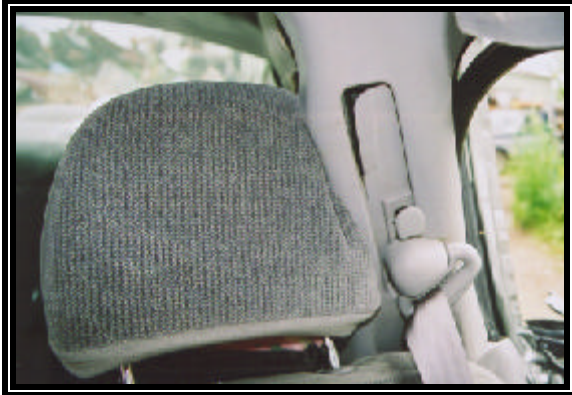
The driver seat was adjusted to a forward position and could not be moved due to the vehicle's deformation. Measurements taken from an exemplar vehicle indicated the seat was positioned 9.1 cm (3.6 in) rear of full forward. The forward position of the seat was recognized by the RCM, as noted above. The horizontal distance between the center of the steering wheel and the seat back measured 66 cm (26 in). The inboard aspect of the seat was in-contact with the center console indicating the seat had shifted to the right approximately 5 cm (2 in) during the crash sequence. The intruding left B-pillar was in direct contact with the outboard aspect of the seat back and was also in contact with the left aspect of the head restraint, **Figure 8**. During the crash sequence, the left side of the roof deformed and rolled down into a vertical section. **Figure 9** is an interior view of the deformed roof and headliner. The vertical height of the deformed headliner was 30 cm (12 in). There was no evidence of occupant contact to the headliner.

**Figure 8:** View of direct contact between the left B-pillar and driver's head restraint.

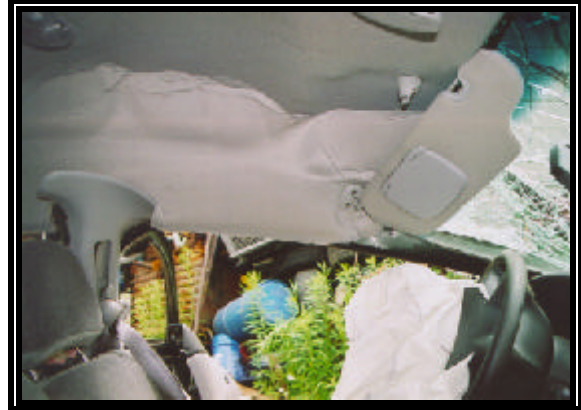
**Figure 9:** Interior view of the deformed headliner.

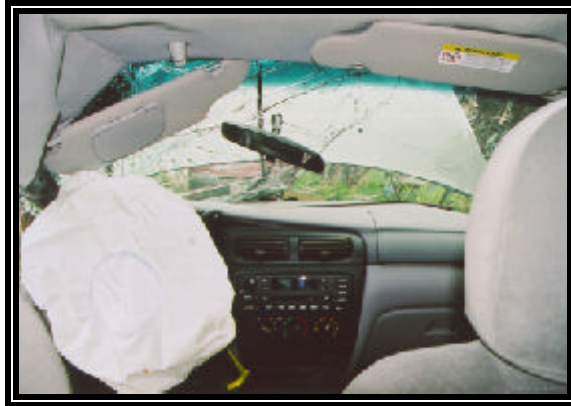
**Figure 10** is a view of the Taurus's front interior. The driver air bag module was designed in the typical manner in the center of the steering wheel. The driver air bag had deployed from the H-configuration module cover flaps. The cover flaps opened along the designated tear seams. The height of the upper and lower flaps measured 6.4 cm (2.5 in) and 4.6 cm (1.8 in), respectively. The width of the flaps measured 17.2 cm (6.8 in). The deployed driver air bag measured 53 cm (21 in) in diameter. It was tethered by four straps sewn to the face of the bag. The bag was vented by two 2.9 cm (1.1 in) ports located in the 10/2 o'clock position of the back side of the bag. There was no evidence of occupant contact to the air bag. A small blood spatter was observed on the face of the bag in the 3 o'clock sector and was a post-crash artifact. The face of the air bag membrane was lacerated by the disintegrated side glazing. The laceration measured approximately 1 cm (0.4 in) in diameter. The following nomenclature identified the air bag: P5206000-00E TXM002651803

Figure 10: Front interior view.

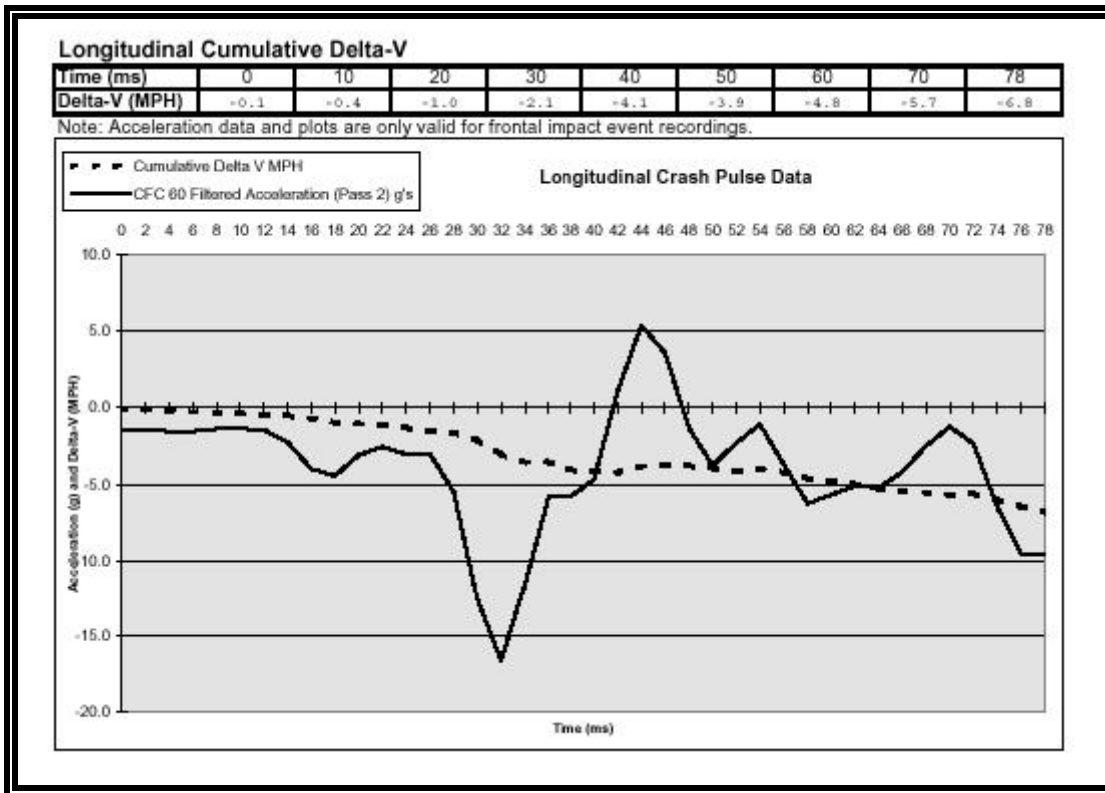
The RCM recorded the crash acceleration pulse for a duration of 78 milliseconds and calculated a delta V curve for that time frame. The 78 millisecond longitudinal delta V recorded by the RCM was approximately -10.9 km/h (-6.8 mph). The 78 millisecond lateral delta V was approximately 12.5 km/h (7.8 mph). Analysis of the acceleration pulse and velocity curves indicated that only a portion of this long duration crash event was recorded. The acceleration traces were still active and the velocity curves were still rising at the termination of the recording.

Figure 12: Longitudinal delta V.

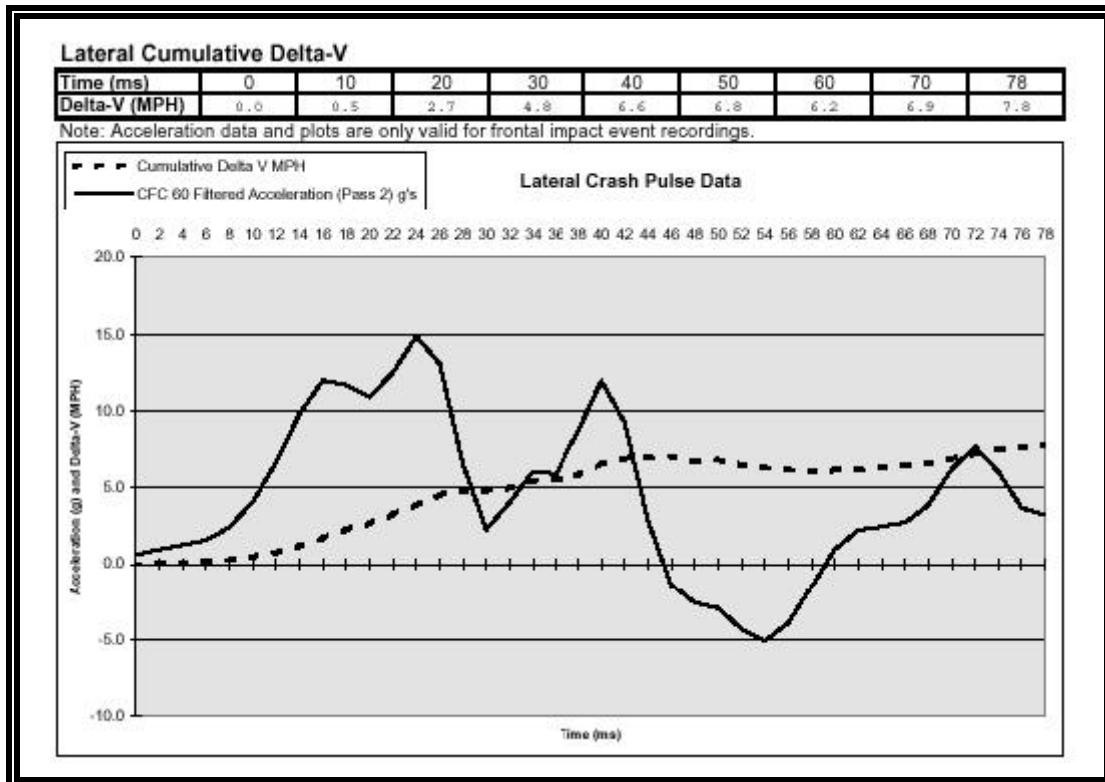
Figure 13: Lateral delta V.
