On-Site Certified Advanced 208 Compliant Crash Investigation Dynamic Science, Inc. / Case Number: DS03006 2003 Chevrolet K1500 Silverado extended cab pickup Arizona January, 2003 This document is disseminated under the sponsorship of the Department of Transportation in the interest of information exchange. The United States Government assumes no responsibility for the contents or use thereof.

# Dynamic Science, Inc. Accident Investigation Case Number: DS03006

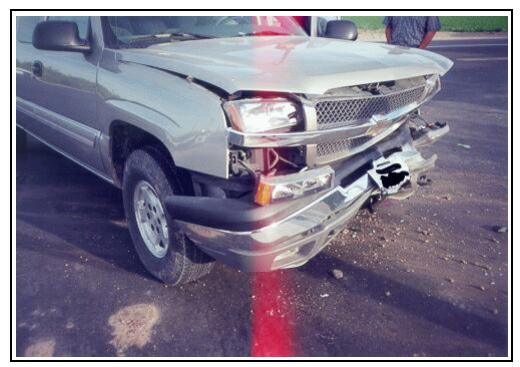
Figure 7. Front right, case vehicle

4x4 pickup. Vehicle equipped with Z71 off-road package. The Z71 Package includes: 46mm shock absorbers, off-road jounce bumpers and stabilizer bars, skid plate package, and a high-capacity air cleaner. VIN: 2GCEK19T931xxxxxx Odometer: Unknown 5.3L, V8 Engine: Reported Defects: None noted Cargo: Aluminum tool box (unknown weight) Damage Description: Moderate damage to front bumper, grille, hood from initial impact. Minor crush damage to left

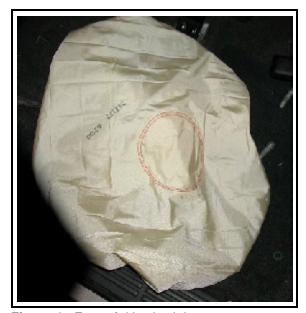
Figure 8. Face of driver's air bag

The case vehicle was equipped with frontal air bags mounted in the steering wheel and mid mounted in the instrument panel of the front right seat position. The driver's air bag deployed. With an unrestrained driver, the deployment threshold would necessarily be lower. The passenger air bag did not deploy. The driver's air bag module had been removed from the vehicle. The driver air bag module was located in the center hub of the steering wheel rim. The air bag module cover had an I-configuration. It was equipped with one tether and had two vent ports (11 and 1 o'clock positions). There was no contact evidence on the face of the air bag.

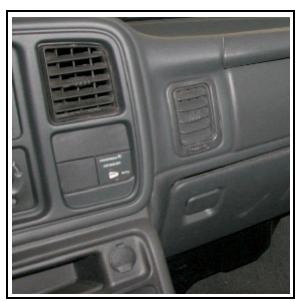
This vehicle was equipped with an advanced occupant protection system. The system consists of the SDM, dual stage front air bags, a front right passenger sensing system, and a driver's seat belt latch usage detector. The system is equipped with an air bag shutoff switch for the front right passenger air bag. The switch was set to AUTO at the time of the inspection. The system is controlled by the SDM. The SDM is located beneath the driver's seat. The primary function of the SDM is to control the deployment of the occupant protection systems. The system records the vehicle's forward velocity change. The SDM will record 100 milliseconds of data after the deployment criteria is met and up to 50 milliseconds of data before deployment criteria is met.

**Figure 11**. Passenger air bag cut off switch in AUTO position

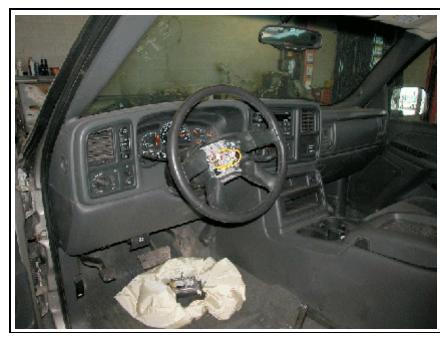
The 48-year-old driver of the case vehicle was seated in a normal, upright fashion in the fabric covered bucket seat. The seat had been removed prior to inspection and the seat track position is not known. He was not wearing the available 3-point integrated lap and shoulder belt. There were no indications of usage in this crash. The SDM indicated the seat belt was unbuckled. Prior to impact, his right foot was on the brake; the left was on the floor. Both hands were on the steering wheel.

Figure 13. Overview of driver's seated area

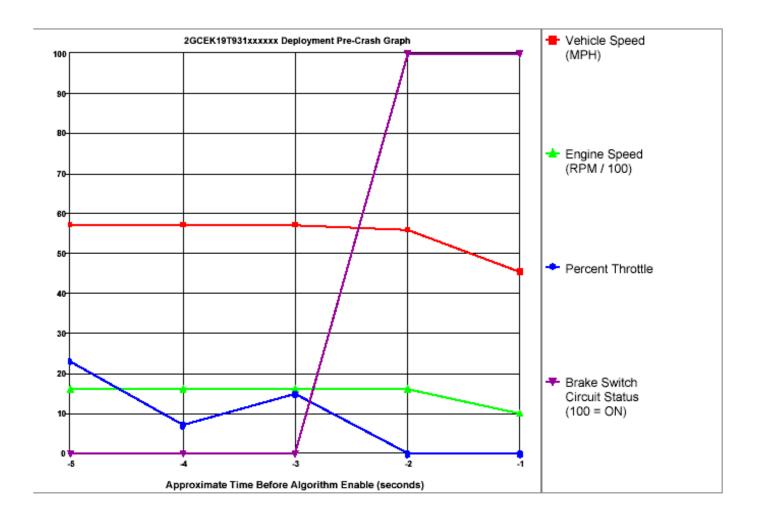
- 1. The driver's belt switch status was unbuckled.
- 2. The time from algorithm enable (AE) to maximum recorded velocity change was 112.5 milliseconds
- 3. This was a first stage deployment with the time from AE to deployment command criteria met being 17.5 milliseconds.
- 4. There was no second stage deployment.
- 5. The brake switch status was ON two seconds before algorithm enable.
- 6. The vehicle speed was 92 km/h (57 mph) five seconds before AE, decelerating to 72 km/h (45 mph) one second before AE.

Seconds Before AE	Vehicle Speed (MPH)	Engine Speed (RPM)	Percent Throttle	Brake Switch Circuit Status		
-5	57	1600	23	OFF		
-4	57	1600	7	OFF		
-3	57	1600	15	OFF		
-2	56	1600	0	ON		
-1	45	1024	0	ON

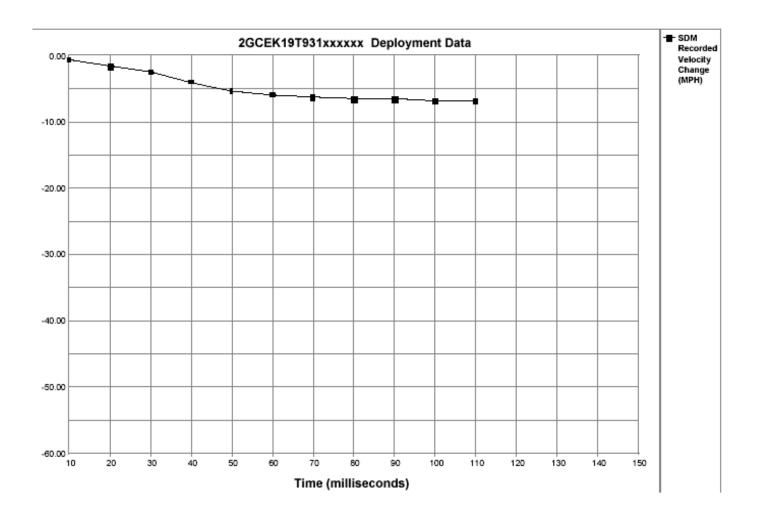
The downloaded data indicated that the case vehicle had a maximum recorded longitudinal velocity change of -11.29 km/h (-7.02 mph) at the 112 ms mark.

Time (milliseconds)	10	20	30	40	50	60	70	80	90	100	110	120	130	140	150
Recorded Velocity Change (MPH)	-0.62	-1.55	-2.48	-4.03	-5.27	-5.89	-6.20	-6.51	-6.51	-5.82	-682	N/A	N/A	N/A	N/A
