On Site Child Safety Seat Investigation / Vehicle v. Object
Dynamic Science, Inc. / Case Number: DS03010
1997 Ford Taurus LX four-door
Colorado
March, 2003

1. Report No. DS03010		2. Government Accession No.		3. Recipient Catalog No.	
4. Title and Subtitle On Site Child Safety Seat Investigation				5. Report Date April 15, 2004

**Dynamic Science, Inc.
Accident Investigation
Case Number: DS03010**

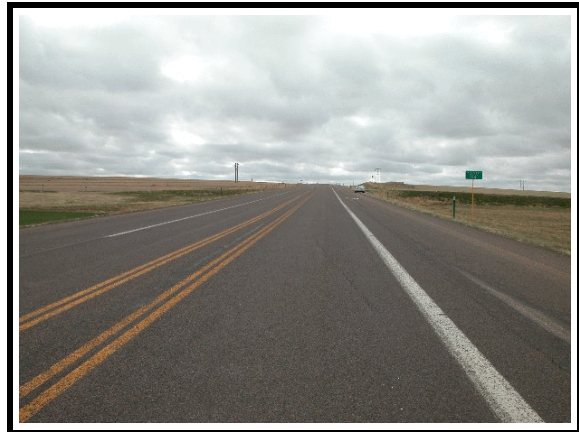
Figure 1. Approach to area of road departure (west)

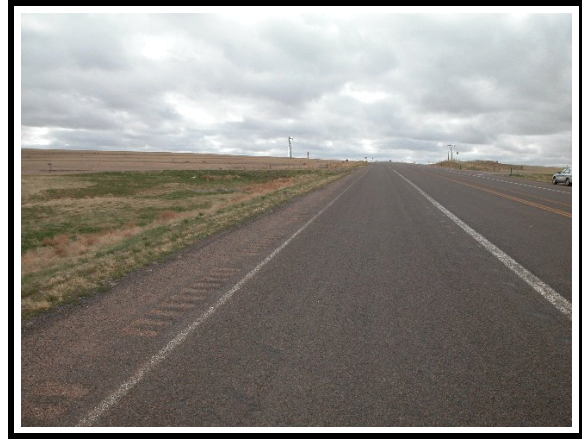
The case vehicle drifted to the left and departed the roadway. The vehicle traveled 48 m (157 ft) in a westbound direction before striking a 10 cm (4 in) wooden fence rail with its front left end (12FLEE3). The fence rail was pushed out of the ground. The ground is muddy and soft at this location. The case vehicle continued on for an additional 12 m (41 ft) before striking a metal culvert that was sunk into an embankment (12FDEW2).

Figure 2. Road departure (west)

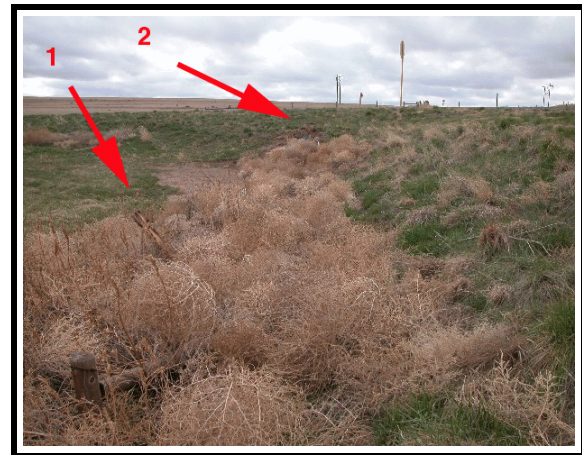
Figure 3. Impact with post, then culvert

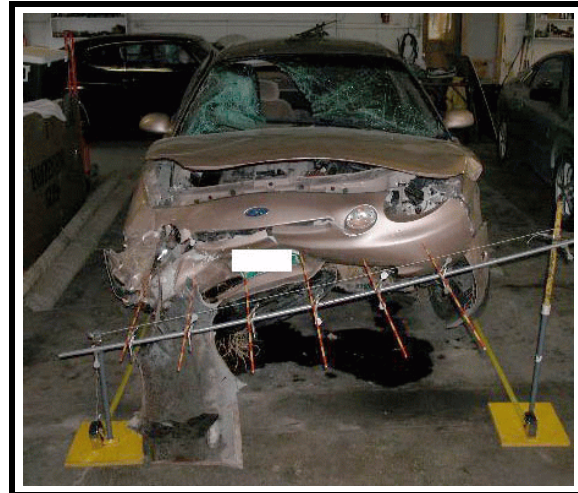
Figure 4. Front, case vehicle

Damage Description:	Major front end damage. Right side doors slightly jammed. Vehicle declared a total loss by insurance company.	
CDC:	Impact 1: 12FLEE3 Impact 2: 12FDEW2	
Delta V (Impact 2):	Total	32 km/h (20 mph)
	Longitudinal	-32 km/h (-20 mph)
	Latitudinal	0 km/h (0 mph)
	Energy	66,248 joules (48,862 ft-lbs)

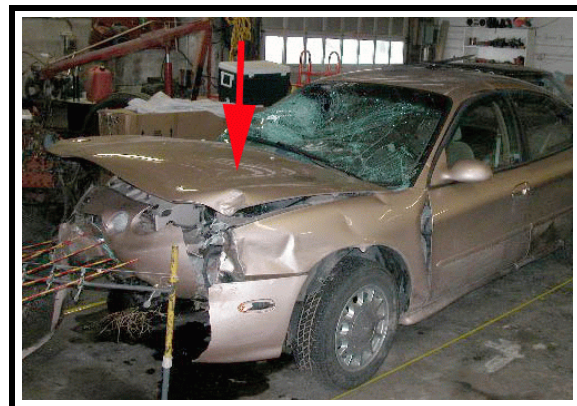
Figure 5. Front left—shows post impact to left corner

The case vehicle sustained 9.0 cm (3.5 in) of direct contact to the left corner from the initial impact with the fence post. For impact 2, the case vehicle sustained 122.0 cm (48.0 in) of direct contact damage across the front end beginning at the left front bumper corner. The residual crush measured along the bumper reinforcement bar was as follows: C1=0 cm (0 in), C2=13.0 cm (5.1 in), C3=29 cm (11.4 in), C4=35 cm (13.8 in), C5=37 cm (14.6 in), C6=32 cm (12.6 in). The maximum crush was located at C5. The principle direction of force (PDOF) was within the 12 o'clock sector and was an estimated 0 degrees. The impact energy was managed by the forward structures of the vehicle. The damaged components for this impact included the bumper fascia and reinforcement bar, upper and lower radiator supports, and hood. The left wheelbase was shortened by 3.0 cm (1.2 in), the right by 18 cm (7.0 in).

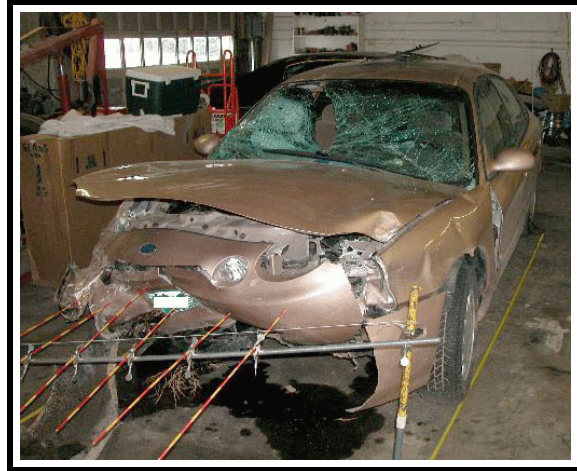
Figure 6. Front left, case vehicle

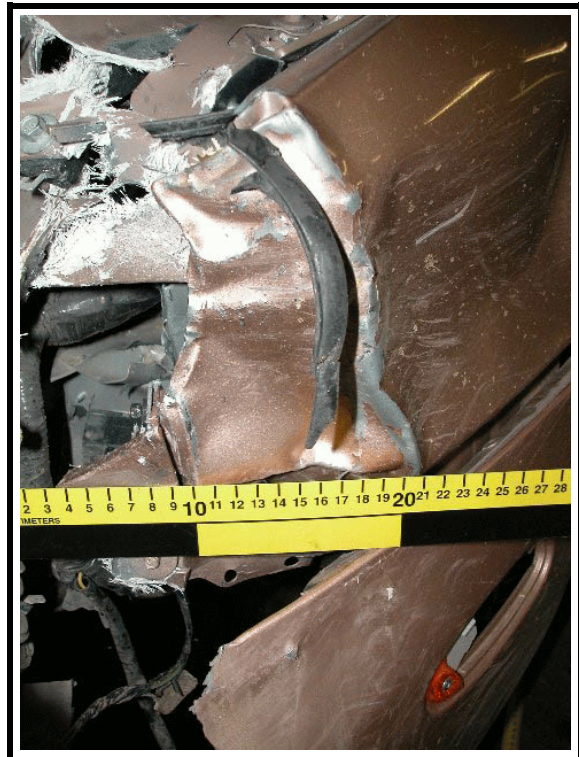
Figure 7. Close up of damage from initial impact

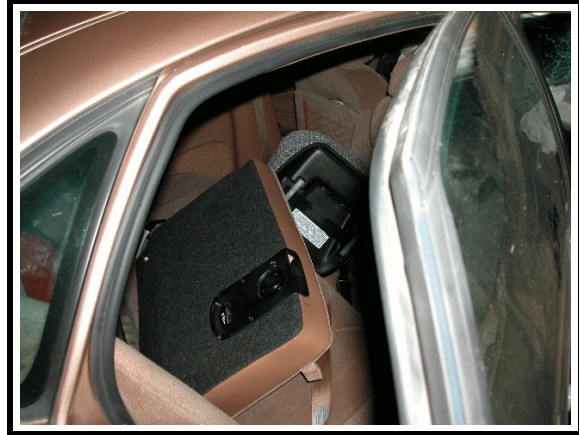
The right half of the rear bench seat back failed. The bottom left of this seat was held in place by a metal pin that is inserted into a hole in the left bottom of the seat back—forming a hinge. In normal operation, the seat rotates about the left and right hinges as this seat is folded down to allow access to the trunk area. According to the tow truck operator, the trunk contained a large heavy cardboard box. At impact, the box struck the base of the back of the seat. The bottom of the seat back was forced forward. The pin connecting the seat back remained in place, but did come out of the seat side hole. Post impact, the box was found resting on the back of the failed back seat after the crash. The contents of the box are not known, but it seems likely that the failure was load related. The locking mechanism was struck by an unknown object and was damaged.

Figure 8. Rear seat back failure

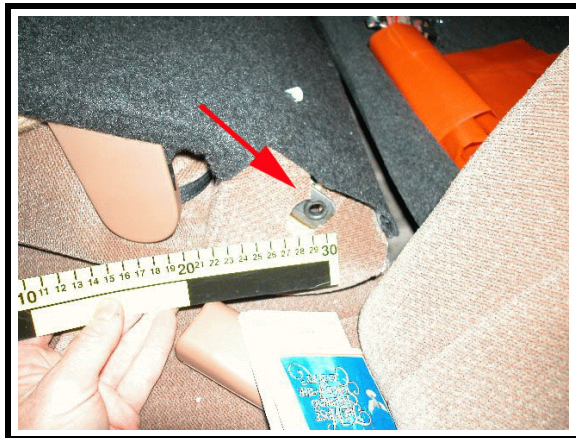
Figure 9. Bottom hinge failure

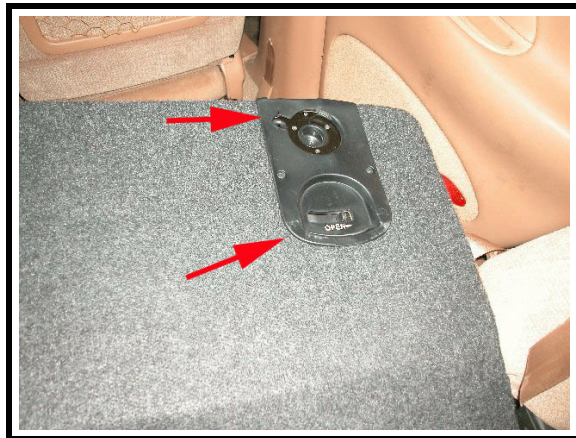
Figure 10. Contact to back seat locking mechanism

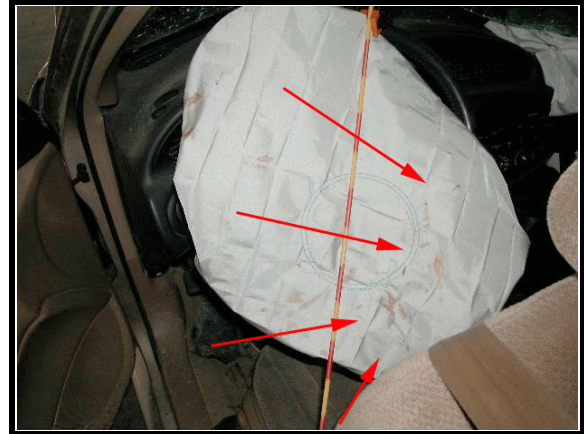
The driver and front right passenger air bags deployed during the second impact. The driver's air bag module was an "H" design and located in the center hub of the steering wheel rim. The top flap measured 15 cm (6 in) x 8 cm (3 in) high. The bottom flap measured 15 cm (6 in) wide x 5 cm (2 in) high. There was no contact evidence on the cover flaps. The diameter of the air bag measured 60 cm (24 in) in its deflated state. There was a single tether and the air bag was internally vented. There were blood smears to the entire bottom of the air bag face.

Figure 11. Driver's air bag. Arrows show blood smears.

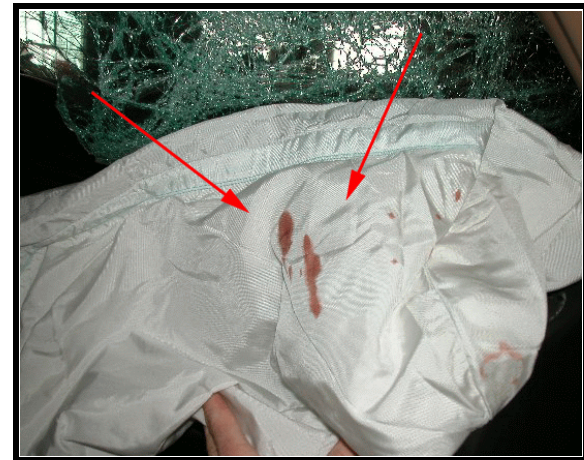
The front right passenger air bag was a top mount design located in the right aspect of the instrument panel. There was a single module cover that was vaguely rectangular in shape. It measured 44 cm (17 in) wide x 27 cm (11 in) high. The deflated air bag measured 56 cm (22 in) wide x 54 cm (21 in) high. The bag had a maximum excursion of 54 cm (21 in). The air bag was not equipped with vent ports or tethers. There were blood drops on the right bottom of the air bag face.

Figure 12. Front right passenger air bag. Blood drops marked by arrows.

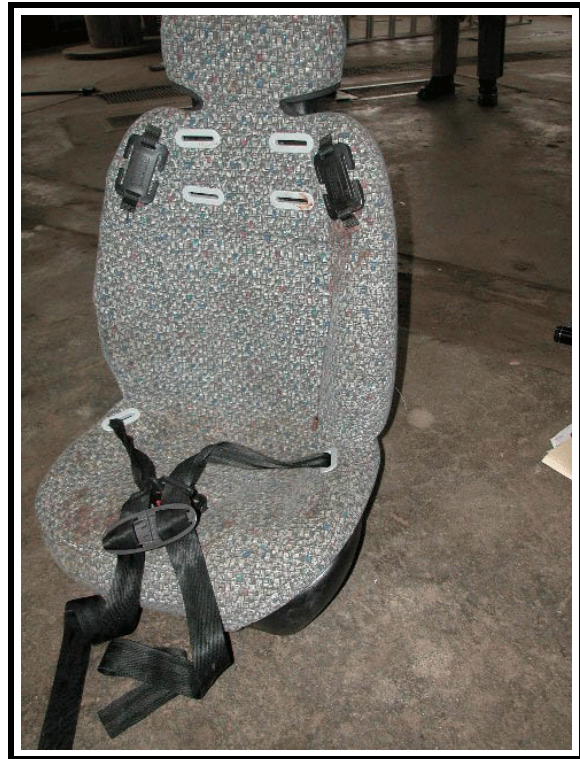
It appears that the child seat was anchored to the vehicle using the available lap belt. There were loading marks to the lap belt. It also appears that the child seat was not tightly anchored to the vehicle seat. The responding EMT indicated that the seat was found tipped over and leaning to the right with the base 15-20 cm (6-8 in) off the seat bottom.

Figure 13. Front, child safety seat

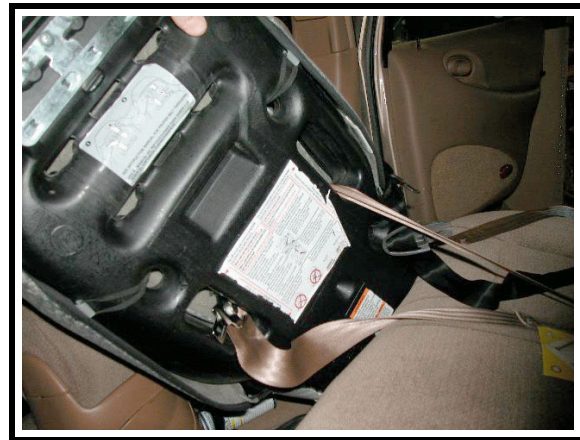
Figure 14. Position of child seat at time of inspection

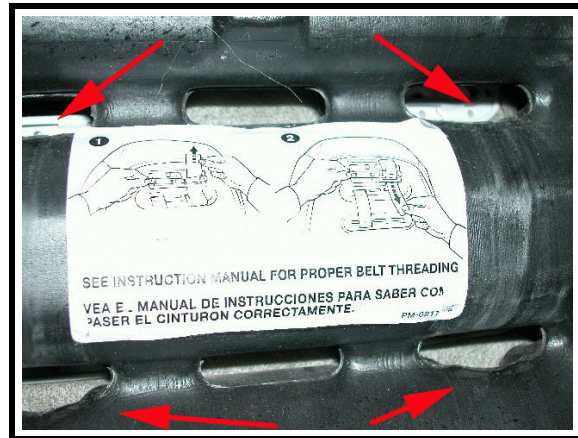
At the time of the inspection the 5-point harness was found to have been partially unthreaded. Both shoulder straps were no longer in their respective slots in the back of the child seat. There are loading marks to both the seat and harness that indicate that the harness was being used. However, it does not appear that the shoulder straps were secured properly. In normal usage the straps are passed from the front to rear through either the upper or lower horizontal slots in the seat back—dependent on the height of child. The straps are then threaded through the metal adjuster bar above the slots on the back of the seat (see Attachment 1). However, loading evidence found on the back of the child seat between the upper and lower slots would indicate that the straps had been routed from one slot to another in some fashion, and not correctly secured with the metal adjuster bar. The most likely configuration would have been the straps initially being routed through the bottom slot from the front, up to the top slot and back out to the front, and then back through the bottom slot before being incorrectly secured by the adjuster bar.

Figure 15. Loading marks to back of child seat

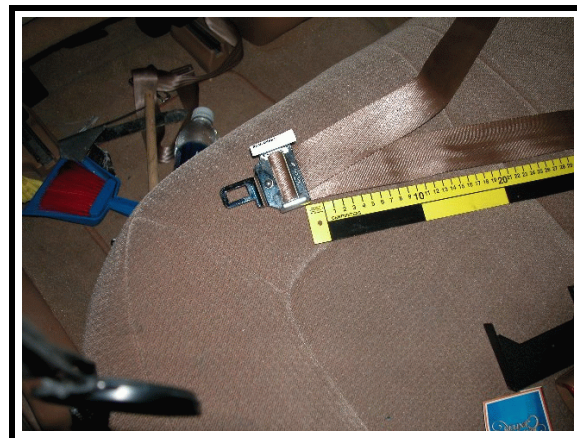
Figure 16. Load marks to lap belt

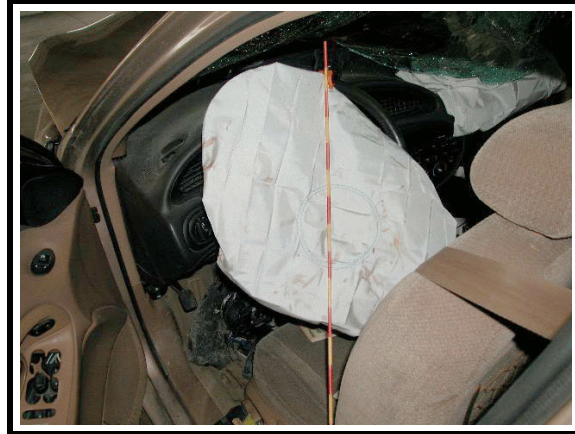
The 62-year-old female (157 cm/62 in, 59 kg/130 lbs) driver of the case vehicle had fallen asleep. She was seated in essentially an upright position on the fabric covered split bench seat. The seat had been adjusted to between the forward most and middle track position. The seat back was slightly reclined. She was wearing the available lap and shoulder belt. The manual shoulder belt upper anchorage was in the mid position. At impact 2, the driver's front air bag deployed. The driver responded to the 12 o'clock direction of force by exhibiting a forward trajectory and loading the manual restraint system—causing the chest and abdominal abrasions. Her face contacted the deployed air bag—causing the facial contusions. Her left knee contacted the lower instrument panel—causing an abrasion. There was some loading to the seat back from the rear seat occupants, but this does not appear to have had any negative effect to the driver. The driver exited the vehicle on her own.

Figure 17. Driver's air bag

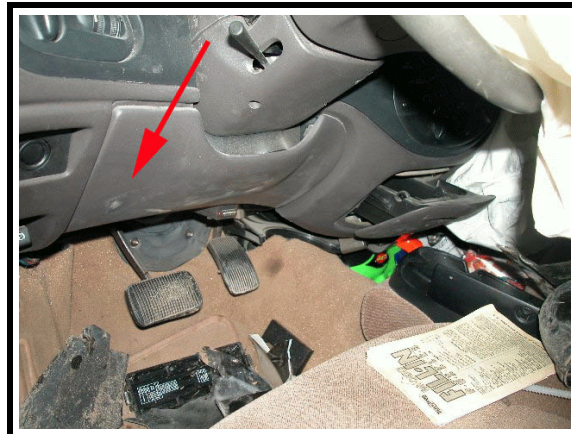
Figure 18. Left knee contact

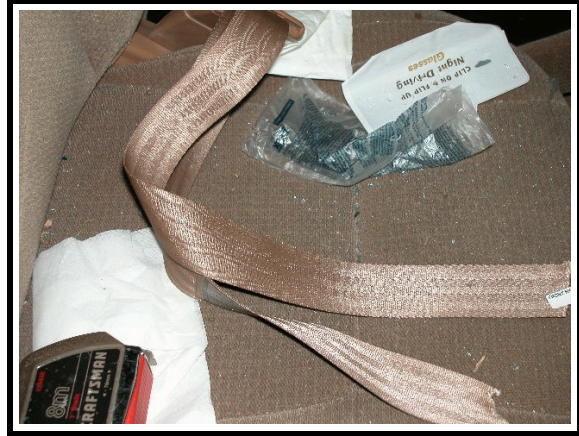
The 9-year-old front right male occupant (34 kg/75 lbs, height and weight unknown) was seated in essentially an upright position on the fabric covered split bench seat. The seat had been adjusted to between the rear most and middle track position. The seat back was slightly reclined. He was wearing the available lap and shoulder belt incorrectly. The shoulder belt had been placed under his right arm. The belt was equipped with a switchable retractor that was in ELR mode at the time of the crash. The manual shoulder belt upper anchorage was in the full down position. At impact 2, the front right passenger's front air bag deployed. This occupant responded to the 12 o'clock direction of force by exhibiting a forward trajectory and loaded the lap belt with his abdomen--causing an abrasion to the left side--and pitching forward. The pitching forward motion resulted in an L3 Chance fracture. This occupant engaged the deployed air bag with his face--causing the brain injuries and lip laceration. His right elbow engaged the right door side panel--causing a minor abrasion. This occupant also sustained a fracture of the 11th rib on the left side. This occurred as a result of the loading to the shoulder portion of the lap and shoulder belt, which was tucked under his arm. His seat belt was cut and he was removed by the responding EMTs.

Figure 19. Lap and shoulder belt, front right occupant

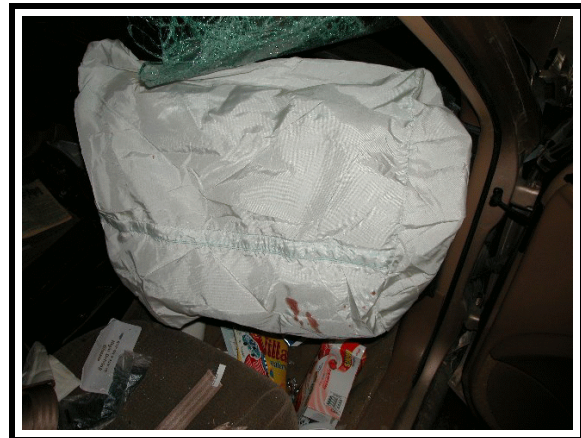
Figure 20. Front right passenger air bag

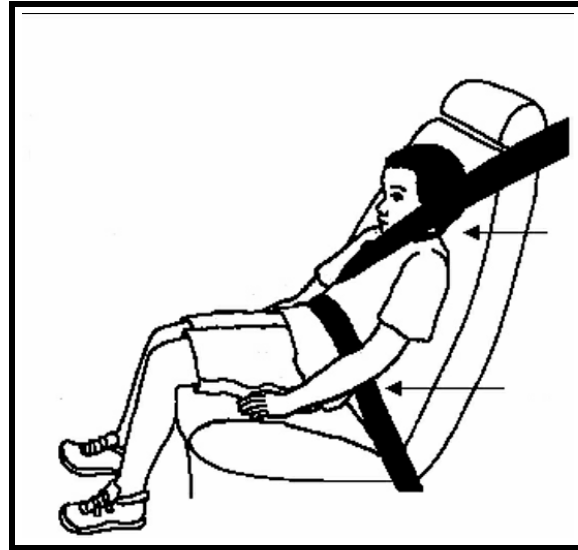
The 4-year-old rear left seat male occupant (113 cm/45 in, 20 kg/44 lbs) was seated in essentially an upright position on the fabric covered bench seat. The seat back was slightly reclined by design. He was wearing the available lap and shoulder belt. It was likely that the lap portion had been placed across his abdomen at the level of his umbilicus. His stature would have placed the shoulder belt toward the upper part of his chest near his neck. The belt was equipped with a switchable retractor that was in ELR mode at the time of the crash. At impact 2, this occupant responded to the 12 o'clock direction of force by exhibiting a forward trajectory and loaded the lap belt with his abdomen. His legs extended forward and struck the back of the driver's seat. His head pitched forward rapidly over the shoulder harness causing a fracture/transsection of the cervical spine and cord at C7. This occupant also sustained a laceration/transsection of the right subclavian vein and right internal jugular vein. This was due to movement of the head first forward and then sharply to the left as it pivoted on shoulder belt. After first pitching forward, this occupant rebounded rearward and struck the back of the seat with his head—causing both brain injuries.

Figure 21. Exemplar view of likely seat belt orientation for rear left occupant (feet/legs would most likely have been stretched out).

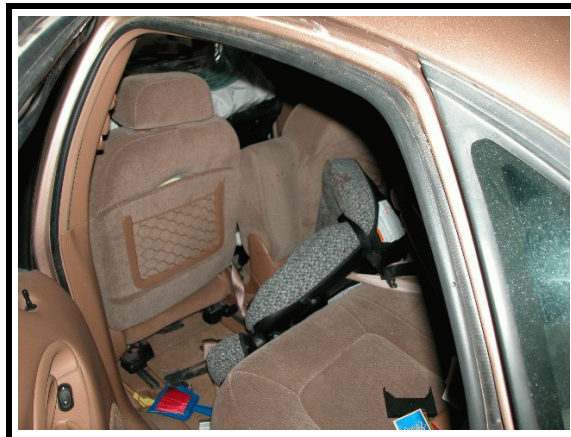
Figure 22. Left rear seating area

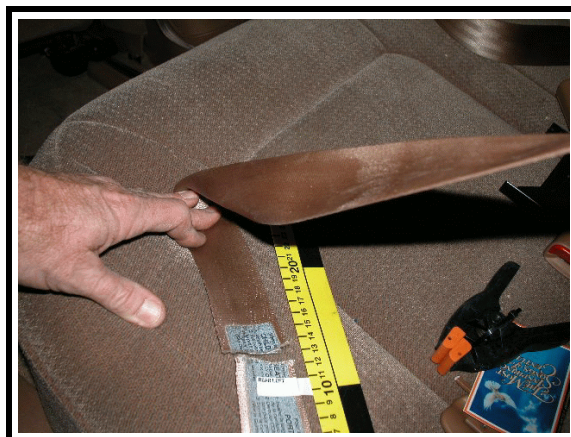
He came to rest in his seat belt slumped to the right. Civilian responders initially provided CPR on the child while he was in the vehicle in an upright position. They were in contact with emergency personnel via cell phone. They obtained permission to remove the child from the vehicle. They cut the seat belt off him and placed him flat on the roadway and continued CPR. He was declared dead after hospital arrival.

Figure 23. Rear left seat belt—shows loading and point where it was cut off

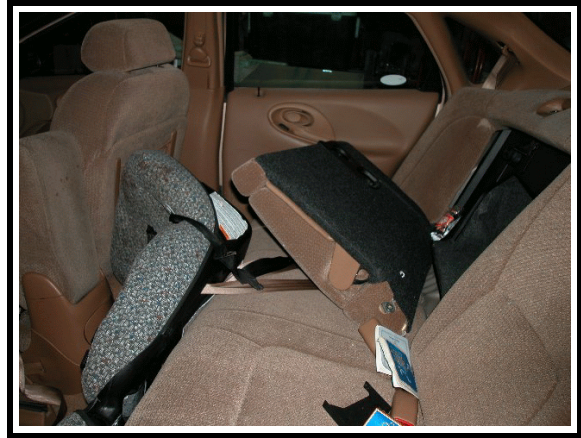
At impact 2, this occupant responded to the 12 o'clock direction of force by exhibiting a forward trajectory and loaded the child safety seat straps—causing the left shoulder abrasion. The child seat pitched forward, both due to the loose lap belt adjustment and the failed right rear seat back. The child sustained a forehead laceration but the injury source is not known. The responding EMT found the seat found tipped forward and leaning to the right with the base 15-20 cm (6-8 in) off the seat bottom.

Figure 24. Position of child seat at time of vehicle inspection

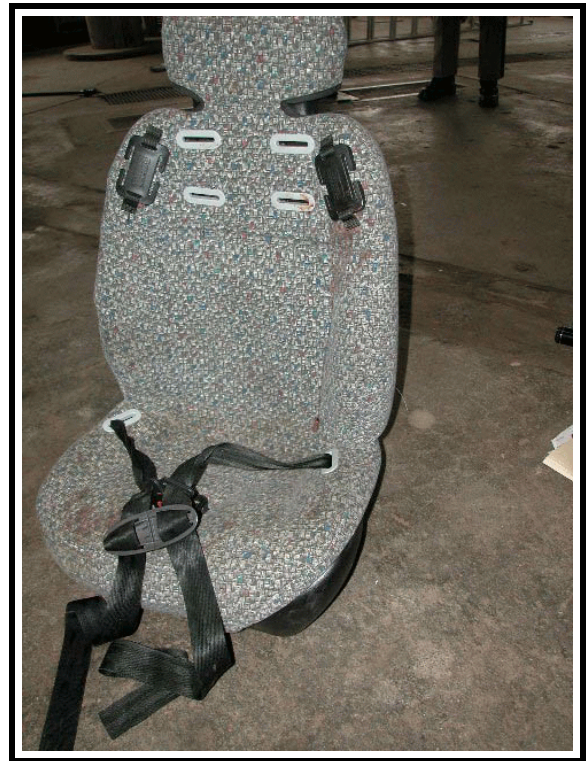
The 2-year-old rear middle female occupant was seated in a forward facing Century Breverra Classic child seat with a 5-point harness. The manufacturer recommends usage with children who weigh between 14-18 kg (30-40 lbs) and whose height is between 89-109 cm (35-43 in). The child seat was anchored to the vehicle using the available lap belt. The lap belt was routed through the correct slots. There were loading marks to the lap belt. It also appears that the child seat was not tightly anchored to the vehicle seat. The 5-point harness was in use during the crash. There are loading marks to both the seat and harness that indicate that the harness was being used. However, it does not appear that the shoulder straps were secured properly. In normal usage the straps are passed from the front to rear through either the upper or lower horizontal slots in the seat back—dependent on the height of child. The straps are then threaded through the metal adjuster bar above the slots on the back of seat. However, loading evidence found on the back of the child seat between the upper and lower slots would indicate that the straps had been routed from one slot to another in some fashion. The most likely configuration would have been the straps initially being routed through the bottom slot from the front, up to the top slot and back out to the front, and then back through the bottom slot before being secured by the metal locking mechanism.

Figure 25. Child safety seat

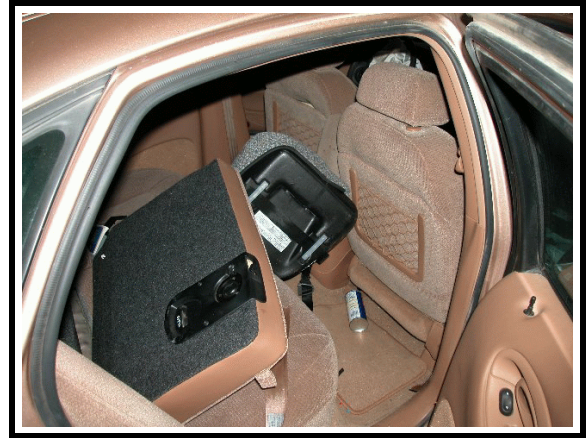
The 8-year-old rear right female occupant was seated in essentially an upright position on the fabric covered bench seat. The seat back was slightly reclined by design. She was wearing the available lap and shoulder belt. Per the responding EMT, this occupant had the shoulder belt behind her back. The belt was equipped with a switchable retractor that was in ELR mode at the time of the crash. At impact 2, this occupant responded to the 12 o'clock direction of force by exhibiting a forward trajectory and loaded the lap belt with her abdomen—causing the aortic tear and abdominal contusion. Her head pitched forward sharply and she sustained a L3 Chance fracture. This forward motion and the loading of the lap belt was likely exacerbated by the failed right rear seat back which would have pushed her torso further forward and down. After the impact, the case vehicle rotated sharply in a clockwise direction. This occupant would have been pushed to the left by the rotation forces and likely came into contact with the child seat in the rear middle seat position. This contact possibly caused the left ulna and radius fractures. Her seat belt was cut and she was removed by the responding EMTs.

Figure 26. Right rear seat position

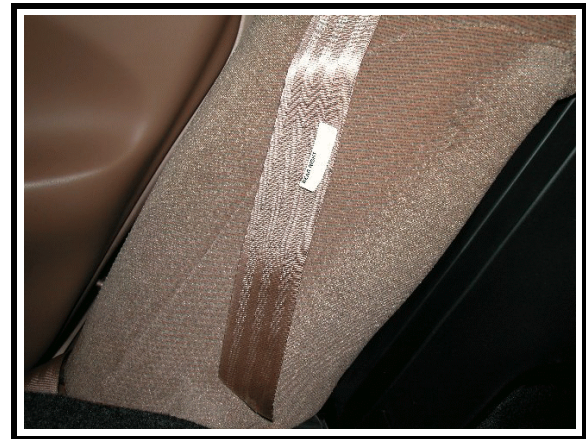
Figure 27. Loading to right rear lap and shoulder belt
