Potential Safety Defects Investigation / Vehicle to Vehicle
Dynamic Science, Inc. / Case Number: DS03013
2002 Mini Cooper
Maryland
March, 2003

1. Report No. DS03013		2. Government Accession No.		3. Recipient Catalog No.	
4. Title and Subtitle Potential safety defects Investigation				5. Report Date May 31, 2004

Description: This potential Safety Defects Case was identified by the National Highway Traffic Safety Administration (NHTSA). The side air curtain deployed and the driver's seat back mounted side air bag did not. DSI was assigned the case on April 25, 2003. The case was conducted as a remote investigation.

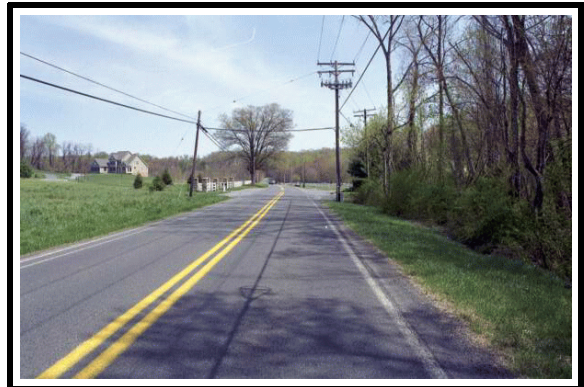
Figure 1. Approach to area of impact (east)

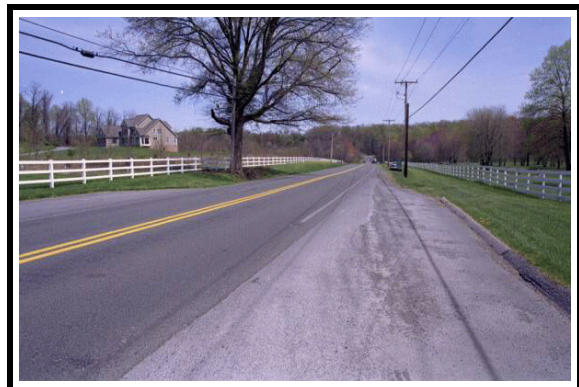
Figure 2. Area of impact/area of U turn by case vehicle (east)

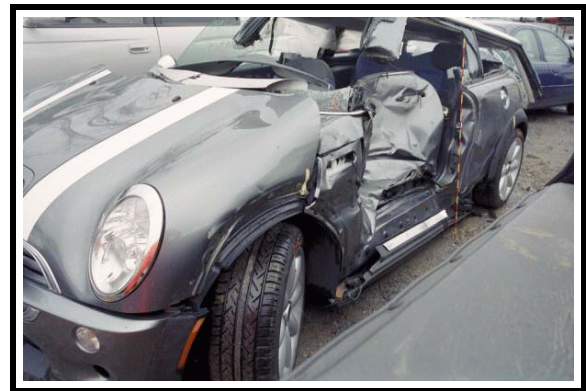
Figure 3. Left side, case vehicle

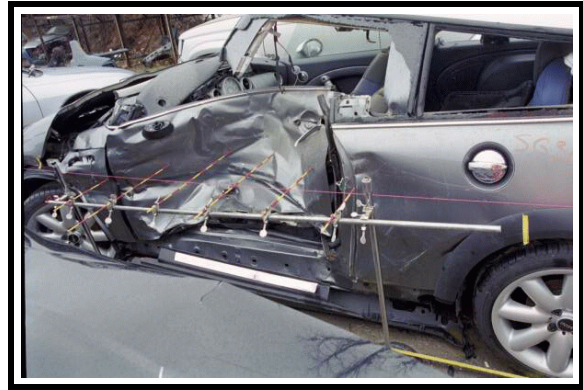
Figure 4. Left side, case vehicle

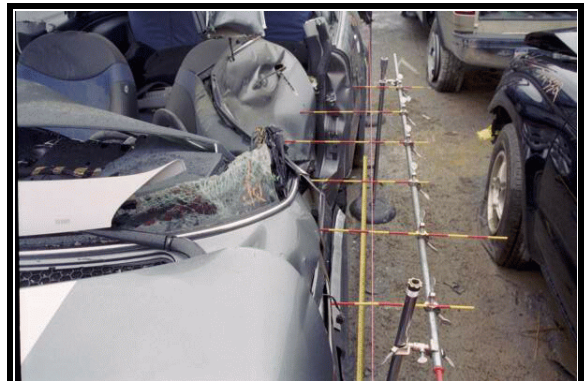
The maximum crush depth was 43 cm (17 in) located above the C3 position along the measurement field. The direct damage began 12 cm (4.7 in) forward of the left rear axle and extended 215 cm (84.6 in) up the right side. The direct damage to the area just behind the left side door (B-pillar and back) is mostly minor buckling/deformation and scratching.

Figure 5. Side view of left side crush

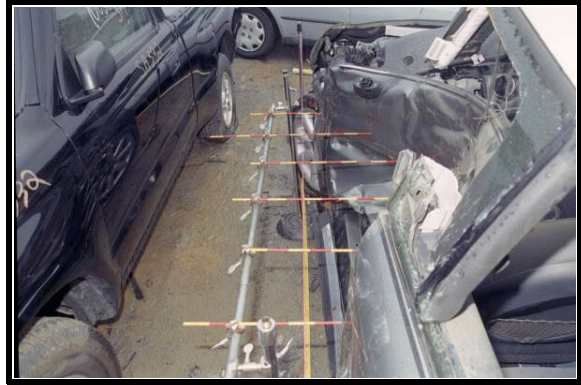
This is believed to be the result of inconsequential contact between the left and right sides of the vehicles or possibly emergency medical services extraction methods. Since this minor damage/scraping could not be accurately attributed to a post crash source, it was included in the direct damage width. The total damage width (field L) began 68.0 cm (26.8 in) forward of the left rear axle and extended 124.0 cm (48.8 in) up the left side. This crush profile included the driver's door and a portion of the left front fender area (based upon damage inflection points). The height of the crush, from the ground was around 60.0 cm (23.6 in). This height seems to match up with the overall bumper height of a Dodge Durango (2003 used for comparison) of 51 to 60 cm (20 to 24 in). The damage pattern to the case vehicle appears to be from the front right half of the other vehicle's bumper, including its front right corner.

Figure 6. Side view of crush as viewed from rear of vehicle

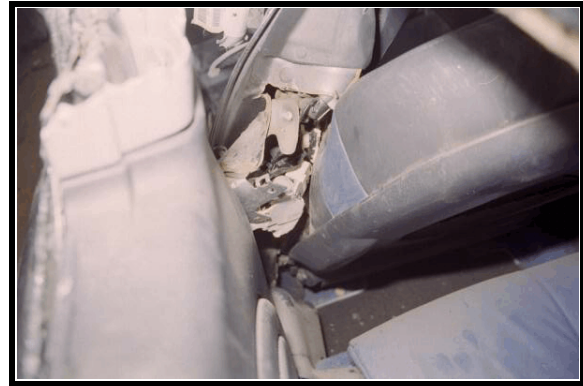
Interior damage to the 2002 Mini Cooper was moderate and attributed to occupant contact and passenger compartment intrusion. The windshield was cracked from impact forces and the front left glazing had disintegrated. There was intrusion to the left side from the door side panel, A pillar, B pillar, and the sill. The intrusion to the door was most significant and measured 32.0 cm (12.5 in) laterally. The left door was slightly opened with striker/latch failure. The upper portion of the steering wheel rim (left side more than right) was noticeably deformed (bent forward). The steering column was broken loose and was being supported by the seat cushion (likely damage by a combination of intrusion and EMS manipulation). The position of the tilt mechanism could not be determined. The door panel was intruded and was blocking the region where the seat back mounted side air bag would deploy.

Figure 7. Latch/striker failure

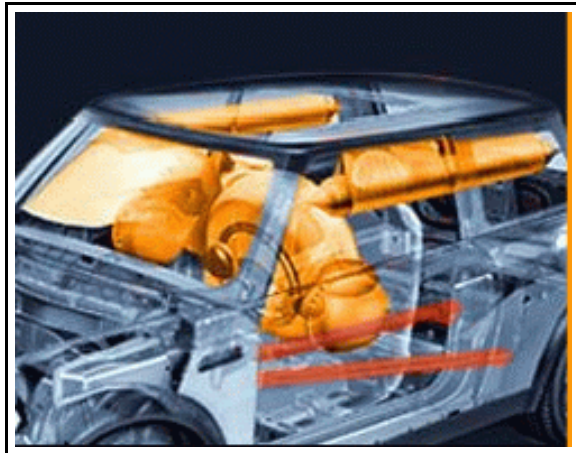
According to Mini Cooper, "... the two [side air bag and side air curtain] often deploy together because of the angle of impact needed to make them deploy, but they can deploy independently of each other." However, it appears that in this above threshold impact both air bags should have deployed. The reason for the non-deployment is not known. The most likely reason would seem to be the fact that this was a relatively long crash event due to the overriding nature of the impact. Because the time was so long, and the level of velocity change would not have been known early on, the system's logic may have determined that there was insufficient time to deploy the side air bag.

Figure 8. Overview of air bag systems

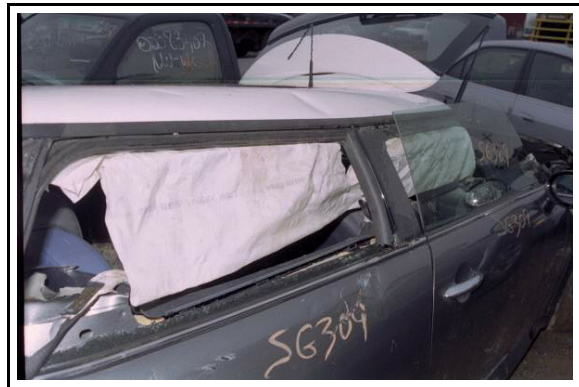
The left side air curtain measured 133.0 cm (52.3 in) long by 20.0 cm (7.9 in) high. The curtain was damaged somewhat during the extrication (roof removal) process. There were no occupant contacts visible.

Figure 9. Exterior view, left side air curtain (roof had been cut off and was put back onto vehicle backwards)

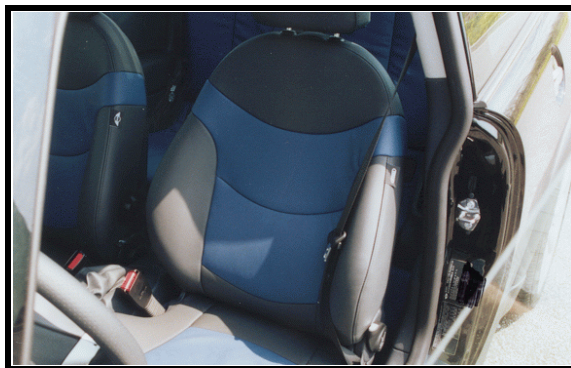
As a result of the left side impact with the front of the 2002 Dodge Durango SUV, the left side rail mounted air curtain in the case vehicle deployed. The driver's seat back mounted air bag did not deploy.

Figure 10. Driver's side air bag location

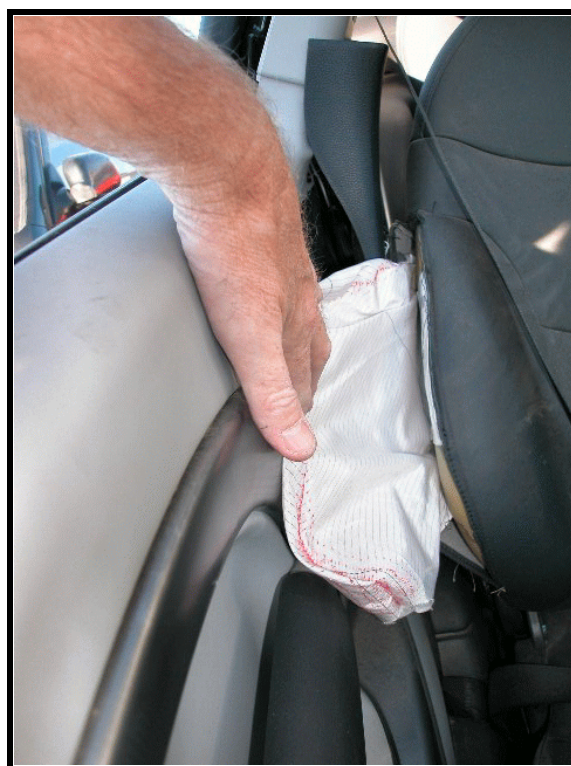
Figure 11. Exemplar view of deployed seat mounted air bag

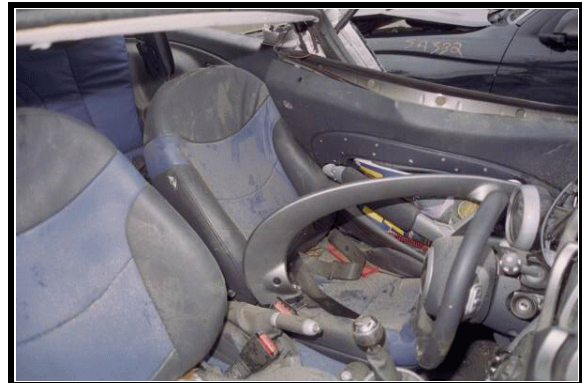
Figure 12. Left door side panel

At impact, the driver was projected left and slightly rearward. Her left shoulder, left upper arm and left flank engaged the intruding left side door panel. This contact caused the left rib fracture, left clavicle fracture, left elbow abrasion, and the left pulmonary contusion. The left side of the driver's jaw either engaged the door panel as it was pushed inward or her own left shoulder. This contact caused a contrecoup type skeletal fracture to the right mandible and occipital condyles as the jaw was pushed to the right. Her left hand was possibly "sandwiched" between the steering wheel rim and the door panel; however, the driver did mention that her left hand was caught between the two components, post crash, but was able to extricate her left hand from that area. Since the impact was relatively high on this vehicle, it should be noted that, the entrapment the EMS personnel noted was likely due to the occupant being somewhat pinned by the upper portions of the interior door panel riding atop her left thigh and blocking her chest. The first row width is approximately 132 cm (52 in) total with each individual seat width measuring approximately 55 cm (22 in), not including the center console. Based upon post crash inspection, the door panel intruded laterally 32 cm (12.6 in) reducing the driver's measured seating space (point specific) to 23 cm (9 in). The interior door intrusion is also believed to have deformed the upper left portions of the steering wheel rim.

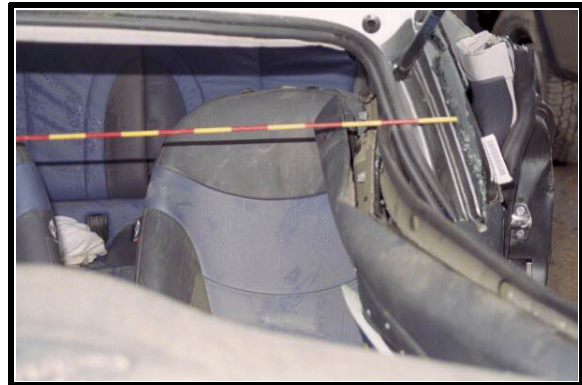
Figure 13. Left side intrusion
