On-site Air Bag Fatality Investigation / Vehicle to Object Dynamic Science, Inc. / Case Number: DS03018 1992 Ford Taurus L four-door sedan Colorado May, 2003 This document is disseminated under the sponsorship of the Department of Transportation in the interest of information exchange. The United States Government assumes no responsibility for the contents or use thereof.

Technical Report Documentation Page	
1. Report No.	2. Government Accession No.		3. Recipient Catalog No.	
DS03018				
4. Title and Subtitle			5. Report Date	
Adult Air Bag Fatality Investigation			September 4, 2003

This on-site investigation focused on the injury mechanisms that caused the death of a 16-year-old female driver of a 1992 Ford Taurus. The case vehicle was equipped with a frontal air bag for the driver position which deployed as a result of a frontal collision with a wooden pole. This driver air bag fatality case was identified by a local state patrol investigator. The National Highway Traffic Safety Administration (NHTSA) was notified on May 25, 2003. DSI was notified on May 28, 2003. This was an on-site investigation. The vehicle and scene inspections took place on May 30, 2003.

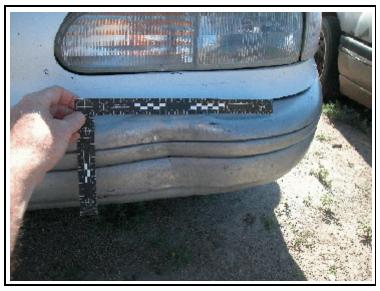
The case vehicle sustained direct contact damage that began 17.0 cm (6.7 in) right of the left bumper corner and measured 20.0 cm (7.9 in) wide. The residual crush as measured along the bumper was as follows: C1=1.0 cm (0.4 in), C2=7.0 cm (2.8 in), C3=3.0 cm (1.2 in), C4=3.0 cm (1.2 in), C5=1.0 cm (0.4 in), and C6=0 cm (0 in). The maximum crush was at C2. The principle direction of force was within the 12 o'clock sector.

Figure 7. Close up of minor damage to bumper

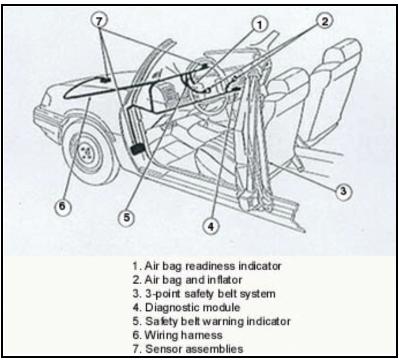
The driver's air bag module had an "H" configuration and was located in the center hub of the steering wheel rim. The single top flap measured 21.0 cm (8.3 in) wide and 13.0 cm (5.1 in) high. The bottom flap measured 21.0 cm (8.3 in) wide and 2 cm (0.8)in) high. There was no contact evidence on the cover flaps. The diameter of the air bag measured 72.0 cm (28.3 in) in its deflated state. There was a single tether and two vent ports. The ports were at the 11 and 1 o'clock positions. The air bag had a maximum excursion of 26.0 cm (10.2 in).

Figure 8. Air bag systems component locations

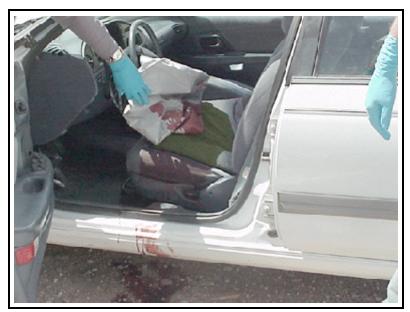
Figure 11. Cloth pillow on seat-color of pillow has been enhanced

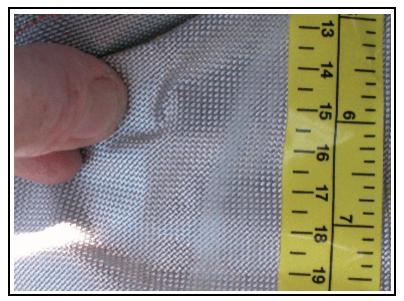
bottom and bottom right of the air bag face. There was a single 15.0 cm (5.9 in) high by 1-2 cm (0.4-0.8 in) wide vertical scuff on the upper left of the air bag face.

Figure 12. Skin transfer, upper left quadrant of driver's air bag

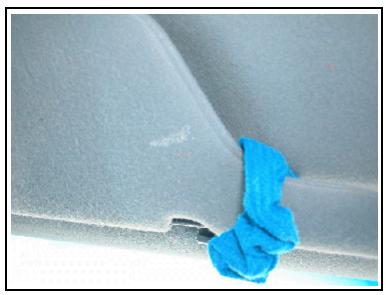
Figure 13. Close up of contact to left side visor

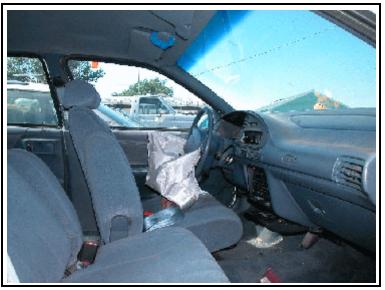
Figure 14. Side view of driver's seated position
