**TRANSPORTATION SCIENCES
CRASH DATA RESEARCH CENTER**

INVESTIGATION

CASE NO: CA03-048

VEHICLE: 2003 CHEVROLET SILVERADO

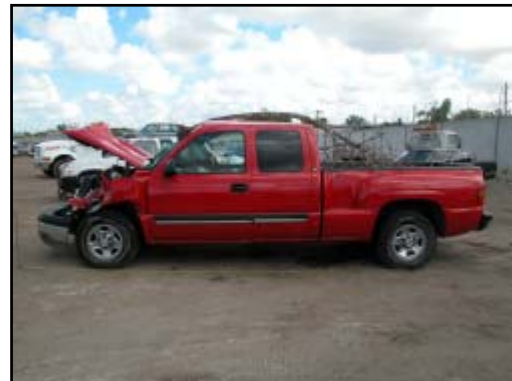
This on-site investigative effort focused on the crash severity, the performance of the Certified Advanced 208-Compliant (CAC) Safety System, and the resulting injury mechanisms for a 30-year-old female driver of a 2003 Chevrolet Silverado pickup truck (**Figure 1**). A CAC vehicle is certified by the manufacturer to be compliant to the Advanced Air Bag portion of Federal Motor Vehicle Safety Standard (FMVSS) No. 208. The CAC safety system consisted of dual-stage frontal air bags, an occupant sensing system for the front right seating position, and an Event Data Recorder (EDR). The Silverado was involved in a run-off-road crash with a tree that resulted in moderate damage to the vehicle, and a subsequent minor right side sideswipe impact

Figure 1. Damaged 2003 Chevrolet Silverado

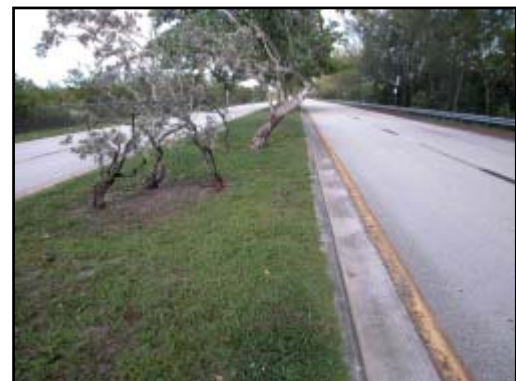
Although not reported by police, rescue personnel reported that the 30-year-old female driver exhibited a strong odor of alcohol. She was operating the vehicle eastbound on the inboard lane of the four-lane divided roadway. The output from the EDR indicated that the vehicle speed five seconds prior to the impact was 126 km/h (78 mph). The driver relinquished control of the vehicle and the Silverado veered slightly to the left against the inboard curb in a tracking mode. The Silverado overrode the curb edge and continued eastbound toward a tree on the median (**Figure 2**).

Figure 2. Eastbound approach showing struck tree

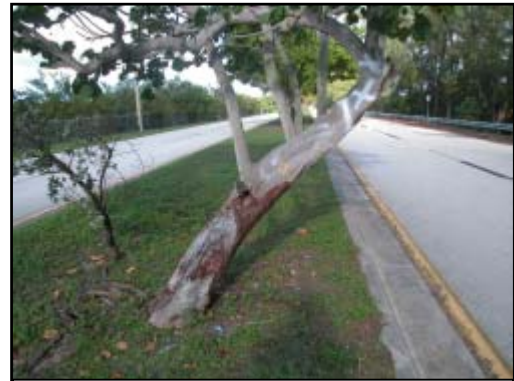
The tree trunk was leaning toward the eastbound lanes of the roadway and also had limbs overhanging the median curb edge (**Figure 3**). A V-shaped limb that encompassed two smaller limbs which measured 12.7 cm (5.0”) and 10.2 cm (4.0”) in diameter, radiated off the top of the trunk and was directly in the path of the Silverado. The driver applied the brakes, evidenced by the brake switch circuit status shown as “on” on the EDR output, and the vehicle speed one second prior to Algorithm Enable (AE) was 84 km/h (52 mph).

Figure 3. Close-up of the tree

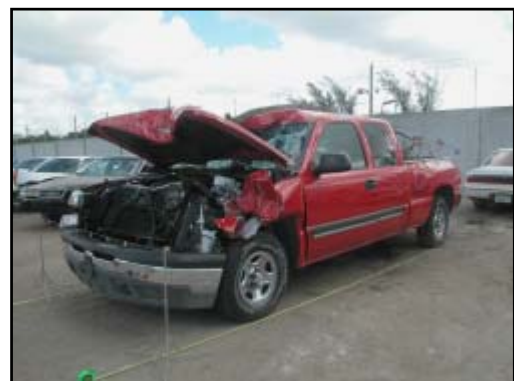
The 2003 Chevrolet Silverado sustained moderate frontal damage (**Figure 4**) as a result of the tree impact. The direct damage on the hood began 26.7 cm (10.5”) left of the centerline and extended laterally to the right 35.6 cm (14.0”). The direct contact with the tree produced abrasions and concave deformation to the leading edge of the hood. The corresponding direct damage on the frontal plane began at the front left corner above the bumper and extended laterally 71.1 cm (28.0”) to the centerline of the upper radiator

Figure 4. Frontal damage to the Silverado

support. The left side of the radiator and upper radiator support were abraded and crushed rearward. The left headlamp and grille were separated. The left front fender was crushed rearward to the left front axle. The combined direct and induced damage measured 137.2 cm (54.0") across the upper radiator support (**Figure 5**). The entire radiator was displaced rearward, and the upper and lower radiator supports were deformed. The hood was buckled rearward the rear aspect of the left front fender was deformed as a result of induced buckling. Six crush measurements were documented along the upper radiator support and were as follows: C1 = 48.9 cm (19.3"), C2 = 40.0 cm (15.8"), C3 = 35.6 cm (14.0"), C4 = 21.0 cm (8.3"), C5 = 5.7 cm (2.3"), C6 = 0.0 cm. The Collision Deformation Classification (CDC) for the initial tree impact was 12-FYMW-2.

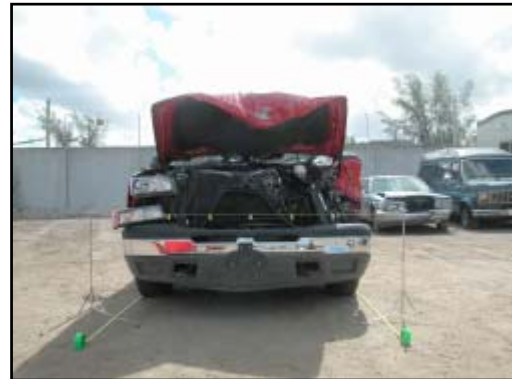
Figure 5. Frontal view of the damaged Silverado

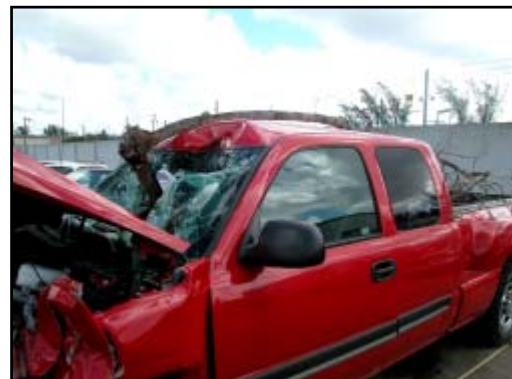
The secondary impact with the tree limb resulted in moderate damage to the windshield and windshield header of the Silverado (**Figure 6**). The direct damage on the windshield header began 36.8 cm (14.5") inboard of the top of the left A-pillar and extended 34.3 cm (13.5") laterally to the right. The windshield header sustained longitudinal and vertical crush as a result of the limb impact. The combined direct and induced damage involved the entire width of the windshield and windshield header and measured 124.5 cm (49.0"). The maximum crush was located at the center of the windshield header and measured 11.4 cm (4.5"). The windshield was holed as a result of the tree limb penetration and the windshield header was buckled laterally and rearward at the center aspect. The CDC for the secondary impact with the tree limb was 12-FYGN-7.

Figure 6. View of windshield header damage and tree limb

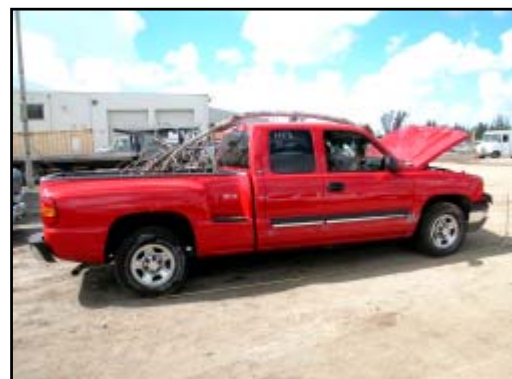
The Silverado sustained minor right side damage as a result of the guardrail sideswipe. The direct contact damage began on the right front corner of the front bumper, continued 485.0 cm (190.9") rearward along the lower door area, and terminated 25 cm (9.8") aft of the right rear axle (**Figure 7**). The direct contact resulted in abrasions that measured 12.7 cm (5.0") in height and were located on the lower aspect of the side trim. The CDC for the sideswipe event was 12-FRLS-9.

Figure 7. Damage to the right side of the Silverado

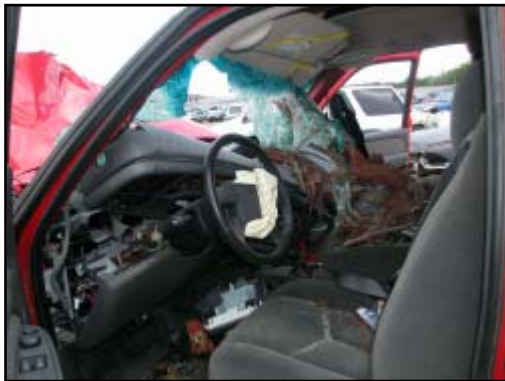
The Silverado sustained severe interior damage as a result of passenger compartment intrusion (Figures 8 and 9). The instrument panel was displaced and intruded into the passenger compartment. The knee bolster was partially separated and the right instrument panel was displaced against the front right seat cushion. The plastic dome/map light console was separated from the headliner and the rear view mirror was separated from direct contact with the intruding tree limb. The tree limb intruded 116.8 cm (46.0”) into the front right position from the base of the windshield. Minor body fluid (blood) transfers were present on the left aspect of the headliner and on the inboard aspect of the driver’s sun visor. Scuff marks that measured 7.6 cm (3.0”) in length were present on the center of the windshield header and headliner from direct contact with the tree limb. They began 14.0 cm (5.5”) left of the centerline and extended 17.8 cm (7.0”) to the right. The headliner was separated 7.6 cm (3.0”) vertically from the windshield header at the centerline.

Figure 8. Interior view from left side

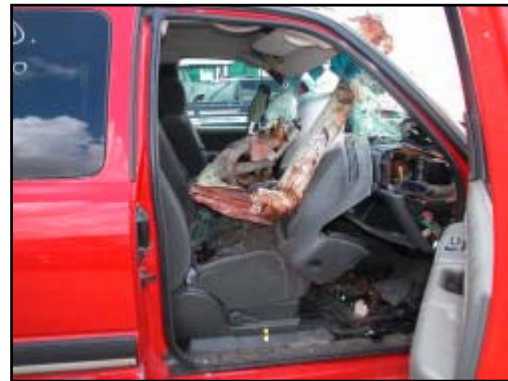
Figure 9. Interior view from right side

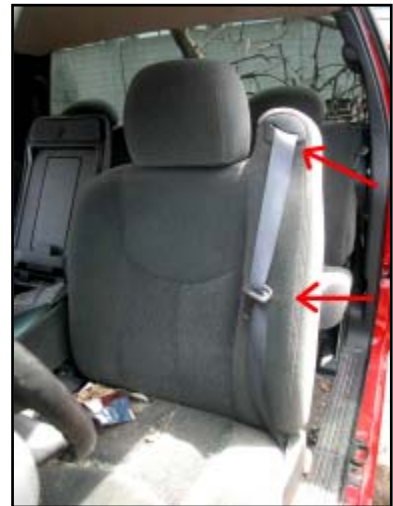
The driver was not utilizing the manual restraint in this crash. Belt non-use was supported by a pronounced crease in the webbing at the plastic retractor cover (in the stowed position) and lack of loading evidence on the safety belt webbing. In addition, a scuff mark was present on the outboard aspect of the driver's seat back from engagement of the safety belt stop button against the seat back fabric while in the stowed position (**Figure 9**). The EDR summary indicated that the driver's belt switch circuit status was "unbuckled."

Figure 9. View of driver's safety belt highlighting webbing crease and scuff mark

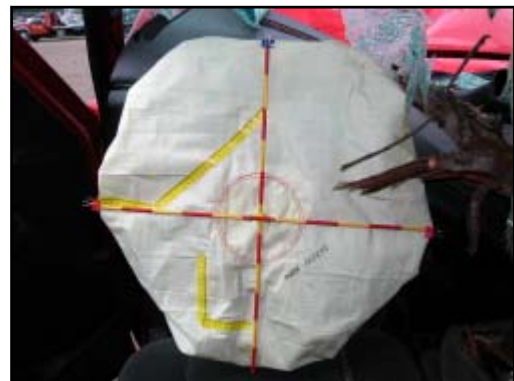
The 2003 Chevrolet Silverado was equipped with a Certified Advanced Complaint Safety System that included dual-stage frontal air bags, an occupant sensing system for the front right seating position, and an EDR. The initial tree impact was sufficient to warrant a first stage deployment of the driver's air bag. The driver's air bag (**Figure 10**) deployed from the steering wheel hub through symmetrical I-configuration cover flaps. Each cover flap measured 7.0 cm (2.8") in width and 11.7 cm (4.6") in height. The deployed air bag measured 66.0 cm (26.0") in diameter. The air bag was vented by two circular ports located at the 11 and 1 o'clock positions on the rear aspect of the air bag. The vent ports measured 2.5 cm (1.0") in diameter and were located 8.9 cm (3.5") inboard of the peripheral seam. The air bag was tethered by two internal straps located at the 3 and 9 o'clock positions that measured 12.7 cm (5.0") in width. An area of faint body fluid transfer (blood) was present on the upper left quadrant of the face of the air bag. The faint transfer extended to the rear aspect of the air bag, from probable post-crash handling by the driver. An area of abrasion was located on the bottom left quadrant of the air bag and measured

Figure 10. Deployed driver's air bag

8.3 cm (3.3”) in width and 10.2 cm (4.0”) in height from contact with the fractured windshield. Dark vinyl transfers were present on the bottom aspect adjacent to the peripheral seam from engagement against the cover flaps during the expansion of the air bag.

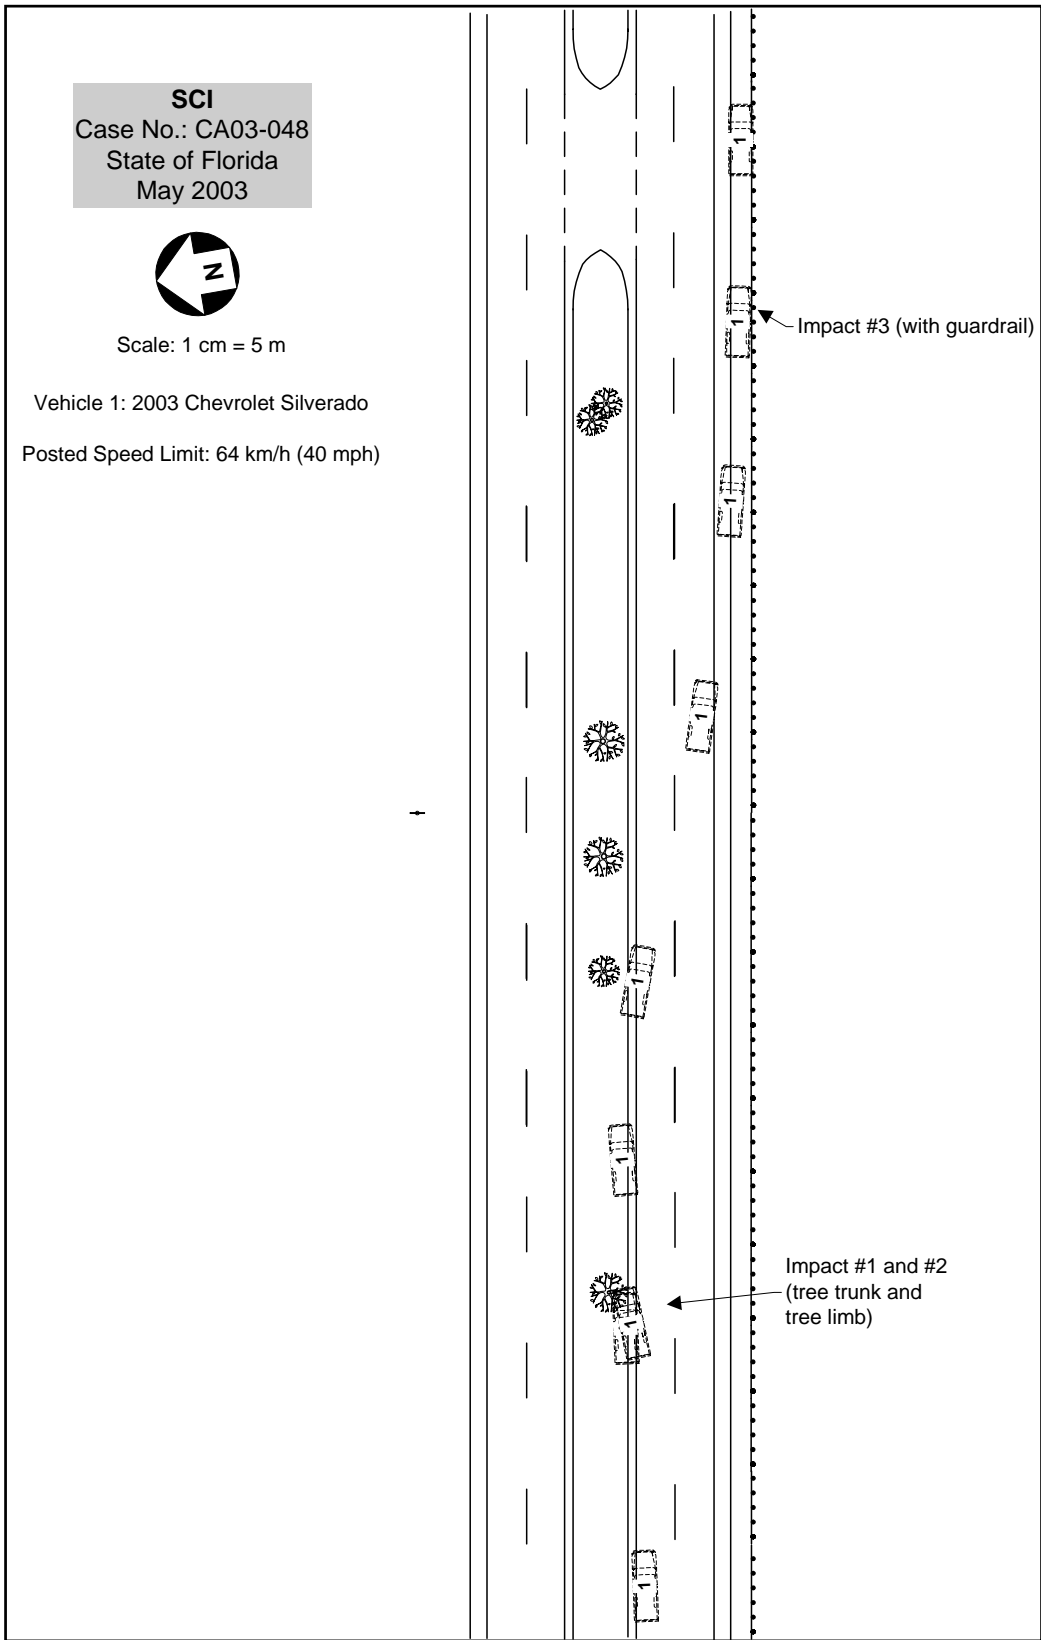
Figure 11. Scene schematic

This single-vehicle crash occurred during the nighttime hours of May 2003 in the state of Florida. At the time of the crash, the weather was clear and the asphalt roadway surface was dry. The crash occurred on the eastbound lanes of a four-lane divided roadway. The east/west roadway was configured with two travel lanes in each direction that were separated by a curbed median and bordered by asphalt shoulders. Grassy areas bordered each shoulder and the eastbound shoulder was bordered by a W-beam guardrail. The curbed median consisted of grass and several trees, and was configured with left turn channels. Some of the tree branches partially extended horizontally over the inboard travel lanes. The roadside environment consisted of trees, grass, and wooded areas. The posted speed limit was 64 km/h (40 mph). The scene schematic is included as **Figure 11** of this narrative report.
