### SCI/NASS COMBINATION ADULT AIR BAG-RELATED FATALITY INVESTIGATION

CASE NUMBER - NASS-2004-49-168A  
LOCATION - Texas  
VEHICLE - 2004 Mercedes Benz S430  
CRASH DATE - June 2004

Submitted:  
April 22, 2005  
Revised:  
December 27, 2005

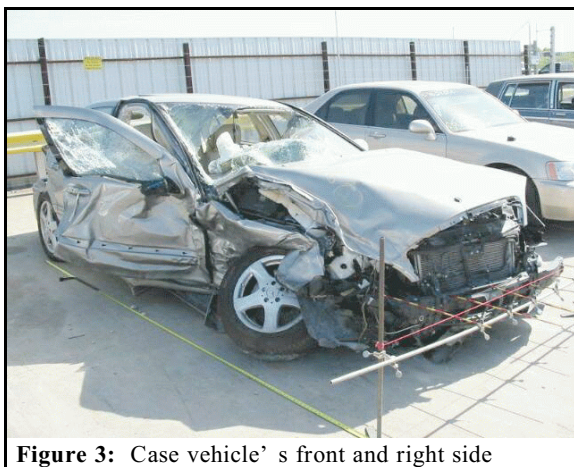
**Figure 3:** Case vehicle's front and right side

The case vehicle sustained heavy direct contact damage from the first impact at the front right corner. As the two vehicles rotated into each other, the right front wheel/axle/suspension, fender, hood, A-pillar and the right front door also sustained heavy direct contact damage (**Figure**

3). The bumper cover was torn away, the grill was shattered, both headlamp/turn signal assemblies were broken away and the left front wheel and fender sustained substantial induced damage (**Figure 4**). Maximum longitudinal crush for the frontal impact was measured as 43 centimeters [16.9 inches] at the front right corner. The right front corner structures were crushed 27 centimeters [10.6 inches] laterally. The right wheelbase was reduced by 33 centimeters [13.0 inches] and left wheelbase was stretched by 6 centimeters [2.4 inches]. The right front axle/suspension was broken and the right front tire was restricted by deformed body panels.

The CDC for the case vehicle' s first impact was determined to be **01-FREW-2 (40)**. The WinSMASH reconstruction program, damage algorithm based on the measured crush profile of both vehicles, was used. For the most severe (first) impact, the case vehicle' s total, longitudinal and lateral delta-Vs are, respectively: 30 km.p.h. [19 m.p.h.], -23 km.p.h. [-14 m.p.h.] and -19 km.p.h. [-12 m.p.h.]. The NASS researcher judged that these results are reasonable but probably somewhat low due to the stiffness of the structures at the right front wheel and right A-pillar.

The case vehicle' s windshield was heavily cracked across its entire width, with complete separation along the left two-thirds of the windshield header, tearing of the laminate along an oblique crack and further separation along the right A-pillar (**Figures 3 and 4**). The case vehicle' s side glazing was laminated and the right front door window glazing was entirely

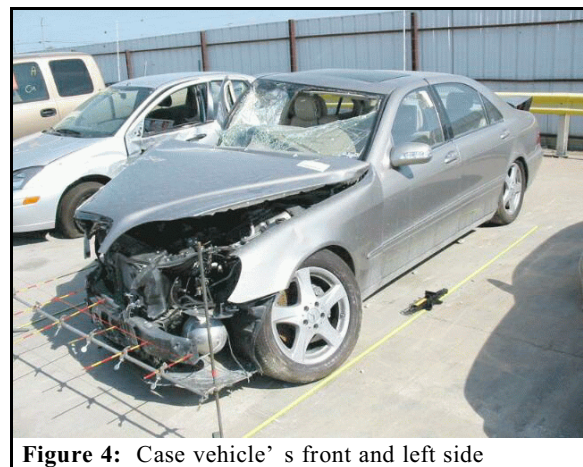
**Figure 4:** Case vehicle's front and left side

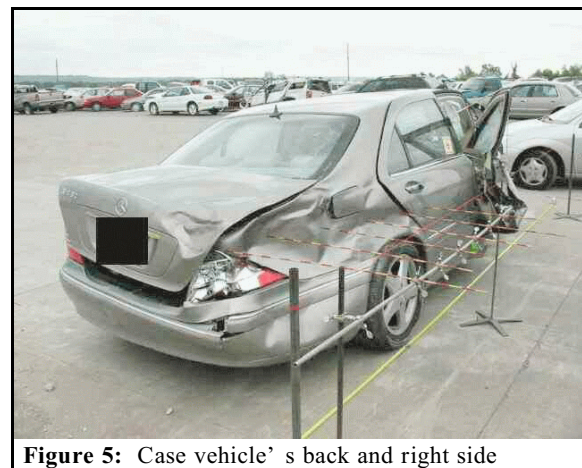
The case vehicle also sustained moderate direct contact damage from the second (side slap) impact at its right rear corner (**Figure 5**). As the two vehicles rotated and separated from the first impact, the case vehicle sustained direct contact beginning at the right rear corner and continuing forward to the C-pillar and the trailing edge of the right rear door. The right rear turn signal/tail lamp assembly was shattered, the quarter panel was crushed inward, the trunk lid was deformed and displaced, the area above the wheel well including the fuel port was dented and crushed slightly, and there was abrading on the lower C-pillar and on the right rear door near. The right rear tire was restricted by deformed body panels.

**Figure 5:** Case vehicle' s back and right side

Maximum crush was measured as 30 centimeters [11.8 inches] slightly forward of the apex of the right rear corner.

The CDC for the second impact was determined to be **03-RZEW-2 (90)**. The WinSMASH reconstruction program, damage algorithm based on the measured profile of both vehicles, was used. For the second (side slap) impact, the case vehicle' s total, longitudinal and lateral delta-Vs are, respectively: 9 km.p.h. [6 m.p.h.], 0 km.p.h. [0 m.p.h.] and -9 km.p.h. [-6 m.p.h.]. These results seem reasonable. The second impact was of minor severity (1-13 km.p.h. [1-8 m.p.h.]) for the case vehicle.

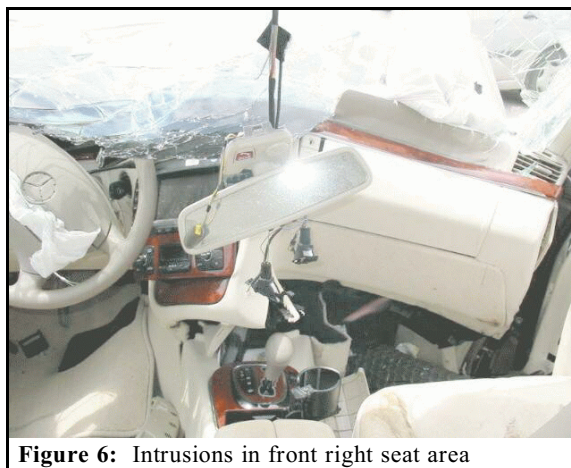
The case vehicle sustained several moderate intrusions primarily at the front right seat area (**Figure 6**), including: the lower right A-pillar (17 cm. [6.7 inches] longitudinal); the right side panel forward of the A-pillar (11 cm. [4.3 inches] lateral); the right front door sill (approximately 10 cm. [3.9 inches] lateral); the right front toe pan (approximately 10 cm. [3.9 inches] longitudinal); the right instrument panel (approximately 10 cm. [3.9 inches] longitudinal); the right roof rail in the right front seat area (4 cm. [1.6 inches] lateral); and other intrusions, of lesser magnitude, across the entire width of the front seat row. The right front door was jammed shut and there are pry marks where rescue personnel forced the door open.

**Figure 6:** Intrusions in front right seat area

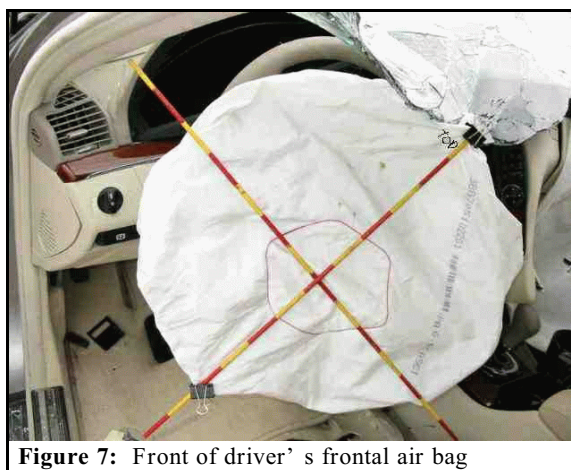
The driver's frontal air bag (**Figure 7**) was mounted in the steering wheel hub with the module cover flaps in the H-configuration. The

**Figure 7:** Front of driver's frontal air bag

cover flaps measured 16 centimeters [6.3 inches] horizontally, with the upper flap 6 centimeters [2.4 inches] vertically and the lower flap 9 centimeters [3.5 inches]. The cover flaps opened at the tear points and there was no evidence of damage to the cover flaps or the adjacent structures. The driver's frontal air bag was round with a diameter of 60 centimeters [23.6 inches]. There was one circular vent port of unknown diameter, located near the center on the back. There were areas of blood droplets and scuffing on the front of the air bag, with no evidence of contact on the back. There was no evidence of damage to the driver's frontal air bag.

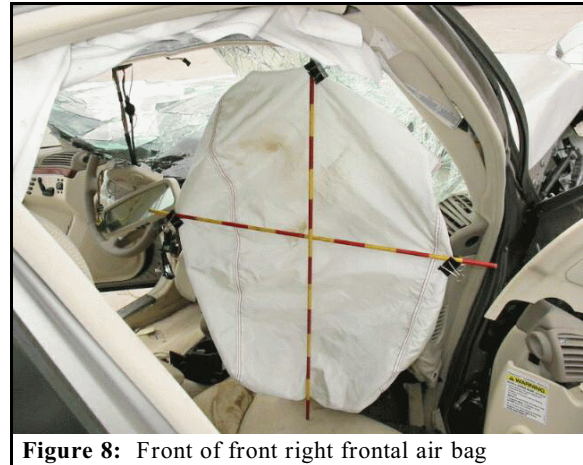
The front right passenger's frontal air bag (**Figure 8**) was located in the top of the instrument panel on the right, with cover flaps in the H-configuration. The cover flaps measured 30 centimeters [11.8 inches] horizontally, with the upper flap 10 centimeters [3.9 inches] vertically and the lower flap 6 centimeters [2.4 inches]. The cover flaps opened at the tear points, except the pre-stressed seam on the right side of the lower flap did not tear open along its entire length, and there was no evidence of damage to the cover flaps or the adjacent structures. The front right passenger's frontal air bag was rectangular, measuring 60 centimeters [23.6 inches] horizontally and 50 centimeters [19.7 inches] vertically. There was one vent port, of unknown diameter, on the right side of the air bag. There were areas of blood staining, makeup transfers and scuffing on the front of the air bag, with no evidence of contact on the top, bottom or sides. There was no evidence of damage to the front right passenger's frontal air bag.

Figure 8: Front of front right frontal air bag

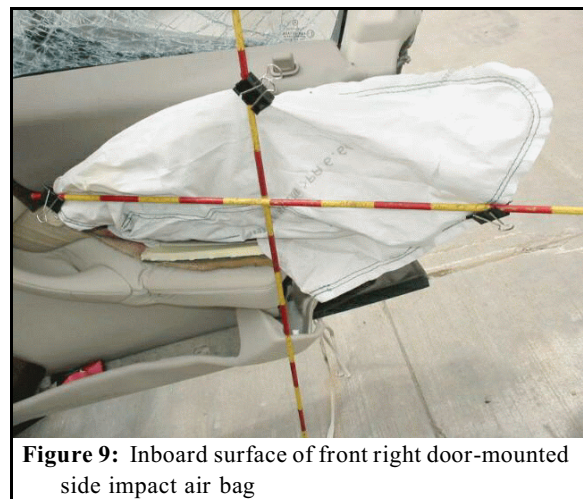
The front right door-mounted side impact air bag (**Figure 9**) was located above the arm rest, with a single cover flap behind a fabric panel. The fabric panel separated along a pre-stressed seam and the module cover flap opened downward through the opening in the fabric panel. There was tearing of the upper fabric panel on the rearward edge. The cover flap measured 20 centimeters [7.7 inches] horizontally and 6 centimeters [2.7 inches] vertically. There was no evidence of damage to the cover flap. The air bag was approximately trapezoidal in shape, measuring 52 centimeters [20.5 inches] horizontally and 30 centimeters [11.8 inches] vertically. There was no vent port. There was an area of unidentified staining on the inboard surface of the air bag, near the forward edge, and no other evidence of occupant contact. There was no evidence of damage to the front right door-mounted side impact air bag.

Figure 9: Inboard surface of front right door-mounted side impact air bag

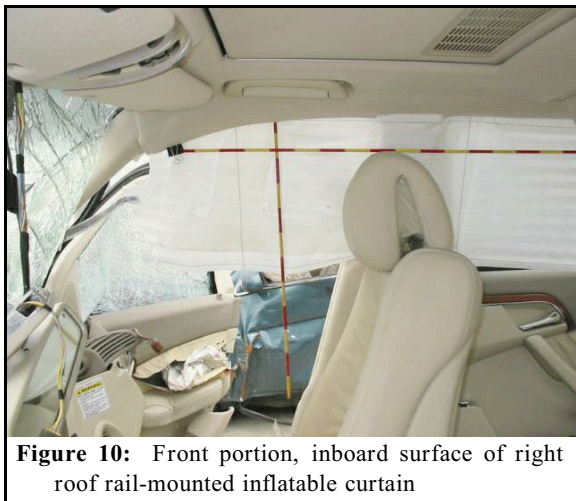
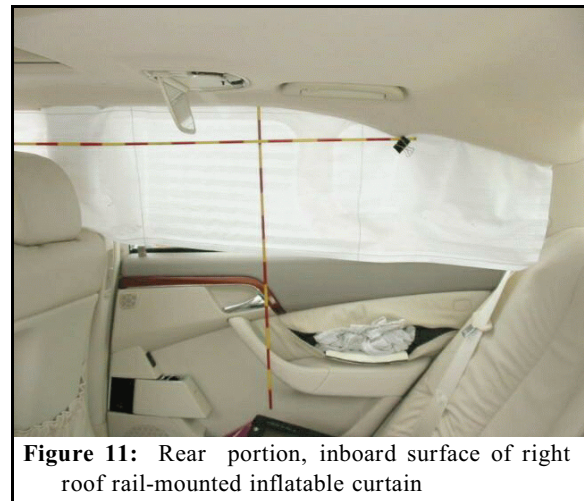
The right side roof rail-mounted inflatable curtain (**Figures 10 and 11**) was installed behind a trim panel where the roof joins the side of the passenger compartment interior. There is no module cover flap as such for the inflatable curtain. Rather, the expanding inflatable curtain causes the trim panel to separate from the side structures and the inflatable curtain emerges through this opening. There was no evidence of damage along the length of the trim panel. The single inflatable curtain provides protection for both the front and back seat areas. The curtain wall was rectangular, measuring 162 centimeters [63.8 inches] horizontally and 31 centimeters [12.2 inches] vertically. There was no vent port. There was an area of scuffing from an undetermined source near the front edge and no other evidence of contact. There was no evidence of damage to the right roof rail-mounted inflatable curtain.

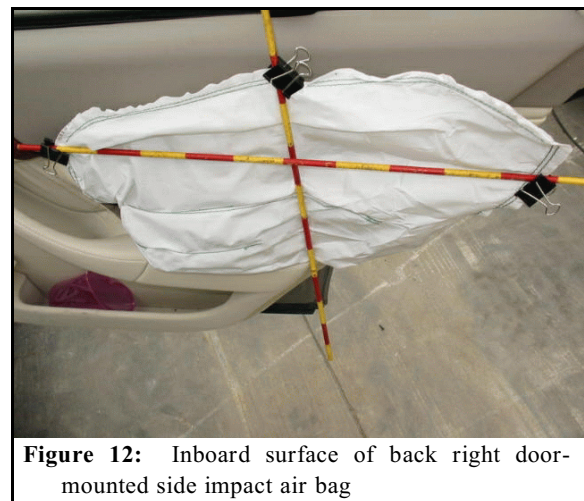
The back right door-mounted side impact air bag (**Figure 12**) was located immediately above the arm rest, with a single cover flap behind a fabric panel. The fabric panel separated along a pre-stressed seam across the middle, with the module cover flap opening downward through the opening in the fabric panel. There was no evidence of damage to the fabric panels. The cover flap measured 20 centimeters [7.7 inches] horizontally and 6 centimeters [2.7 inches] vertically. There was no evidence of damage to the cover flap. The back right door-mounted side impact air bag was approximately oval in shape, measuring 52 centimeters [20.5 inches] horizontally and 30 centimeters [11.8 inches] vertically. There was no vent port. There was no evidence of occupant contact and no evidence of damage to the back right door-mounted side impact air bag.

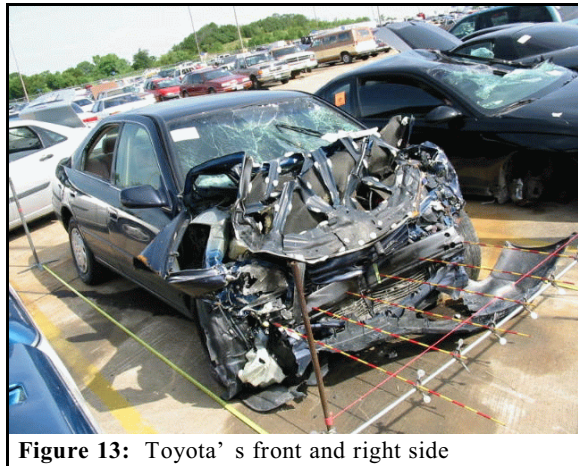
**Figure 13:** Toyota' s front and right side

The Toyota sustained direct contact damage across its entire front from the first impact (**Figures 13 and 14**). The grille and both headlamp/turn signal assemblies were shattered and broken away, the bumper cover was torn off, and all the structures in the front overhang were shifted to the right. The steel bumper was crushed rearward, more so on the right, and the radiator was crushed against the engine block. The surface panel of the hood was torn off of its frame and the frame was crushed rearward and folded. The right fender was crushed rearward and folded outward. The left fender had extensive direct crush resulting from the sustained contact as the Toyota rotated clockwise into the right side of the case vehicle. Maximum longitudinal crush from the first impact was measured as 71 centimeters [27.9 inches] near the center of the front plane. Both front tires were deflated and their rotation was restricted by deformed body panels. The wheelbase was shortened by 20 centimeters [7.9 inches] on the right and 8

centimeters [3.1 inches] on the left. The windshield was heavily cracked, the left front and right rear window glazing was shattered and there was no other glazing damage.

The CDC for the Toyota's first impact was determined to be **71-FDEW-3 (340)** (i.e., the force was in the 11:00 o' clock sector with the + 60 right end shift increment). The WinSMASH reconstruction program, damage algorithm based on the measured crush profile of both vehicles, was used. For the most severe (first) impact, the Toyota's total, longitudinal and lateral delta-Vs are, respectively: 44 km.p.h. [27 m.p.h.], -41 km.p.h. [-26 m.p.h.] and + 15 km.p.h. [+ 9 m.p.h.]. The NASS researcher judged that these results are reasonable but probably somewhat low.

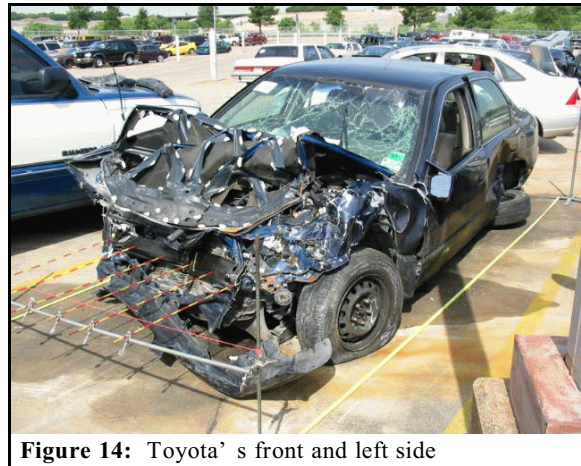
**Figure 14:** Toyota' s front and left side

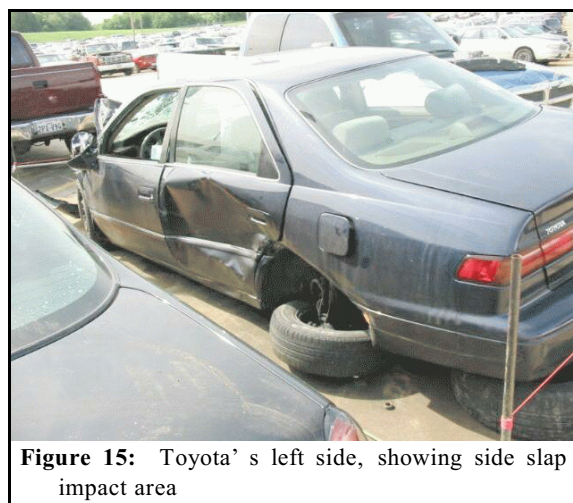
The Toyota also sustained direct contact damage in the area of the left rear door, wheel well and wheel from the second (side slap) impact (**Figure 15**). As the Toyota rotated clockwise in response to the 11:00 o' clock force of the first impact, its front pitched downward and its rear wheels were probably off the ground. The left rear door panel and the leading edge of the left rear wheel well contacted the case vehicle's right rear corner and quarter panel (see **Figure 5**). The Toyota sustained moderate crush and the left rear wheel was broken off the axle. Maximum crush was measured as 13 centimeters [5.1 inches], at the trailing edge of the left rear door.

**Figure 15:** Toyota's left side, showing side slap impact area

The CDC for the Toyota's second impact was determined to be **09-LZEW-2 (270)**. The WinSMASH reconstruction program, damage algorithm based on the measured profile of both vehicles, was used. For the second (side slap) impact, the Toyota's total, longitudinal and lateral delta-Vs are, respectively: 13 km.p.h. [8 m.p.h.], 0 km.p.h. [0 m.p.h.] and + 13 km.p.h. [+ 8 m.p.h.]. These results seem reasonable. The second impact was of minor severity (1-13 km.p.h. [1-8 m.p.h.]) for the Toyota.
