**ON-SITE CERTIFIED ADVANCED 208-COMPLIANT VEHICLE CRASH
INVESTIGATION
CALSPAN CASE NO: CA04-001**

VEHICLE: 2003 CHEVROLET C1500 SILVERADO PICK-UP TRUCK

**LOCATION: MARYLAND
CRASH DATE: DECEMBER, 2003**

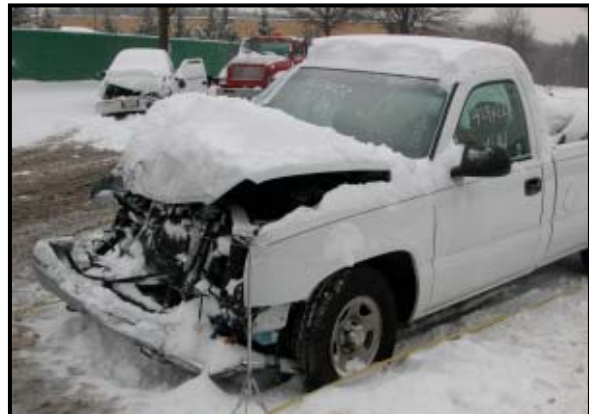
Figure 1: Front left view of the damaged Chevrolet.

The Chevrolet was involved in a minor front-to-rear under-ride collision with a 1999 Mack tractor/semi-trailer. The front of the Chevrolet struck the back plane of the semi-trailer during a back-up in traffic on the interstate highway. The frontal air bags in the Chevrolet did not deploy as a result of the crash. The 50-year old unrestrained male driver of the Chevrolet was uninjured and was not transported. The 60-year old unrestrained front right passenger in the Chevrolet sustained a police reported incapacitating injury and was transported to a local hospital. However, the hospital did not have a record of treating this patient and she declined an interview. The exact nature and/or extent of her injury was not known. The 37-year old driver of the tractor trailer was not injured in the event. The tractor trailer was driven from the crash scene at the conclusion of the police investigation and was not inspected.

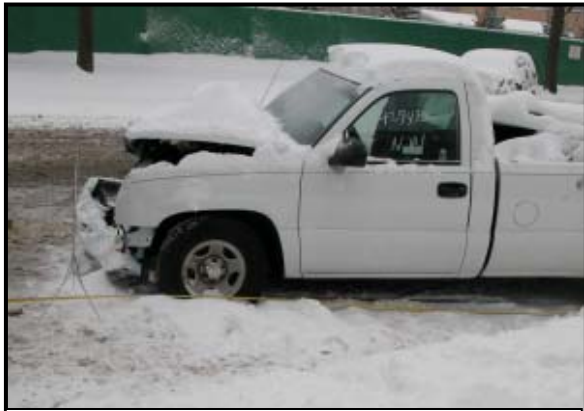
Figures 3 through 5 are the left lateral, right lateral and frontal views of the Chevrolet. The direct damage measured 140 cm (55.1 in). This direct damage extended from the left bumper corner to the right bumper corner. The damage pattern was indicative of an under-ride impact into the back plane of the semi-trailer with the maximum deformation occurring at the elevation of the upper radiator support. The damaged components included the front bumper, center grille, headlamp assemblies, hood and right front fender. The front bumper was deflected downward with the maximum deformation located at its left corner. The left end of the bumper deflected

inboard and rearward puncturing the left front tire. The residual crush measured along the front bumper was as follows: C1 = 13 cm (5.1 in), C2 = 1 cm (0.4 in), C3 = 0, C4 = 0, C5 = 0, C6 = 0.

The residual above-bumper crush from contact with the back plane of the trailer began at an elevation 51 cm (20 in) above the ground and extended vertically to 109 cm (43 in) above the ground reference. The maximum crush at this location measured 26 cm (10.2 in). The residual profile along the upper radiator support was as follows: C1 = 0, C2 = 5 cm (2.0 in), C3 = 12 cm (4.7 in), C4 = 14 cm (5.5 in), C5 = 26 cm (10.2 in), C6 = 24 cm (9.4 in). The hood buckled and folded in a V-shape pattern. The longitudinal contact length to the surface of the deformed hood measured 28 cm (11.0 in) at its right aspect. The length of the deformed right fender measured 79 cm (31 in). For reference, the length of the un-deformed left fender measured 119 cm (47 in). The right wheelbase was reduced 10 cm (4.0 in) and the right front tire was debanded. The left wheelbase measurement was unchanged. The principle direction of the impact force was in the 11 o'clock sector (an estimated 340 degrees). There was no evidence of cab-to-bed contact. The windshield was not damaged and there was no damage to the side glazings. The left door remained closed during the impact and was operational post-crash. The right door was removed post-crash and was located in the pick-up bed; it was not damaged.

Figure 3: Left lateral view of the Chevrolet.

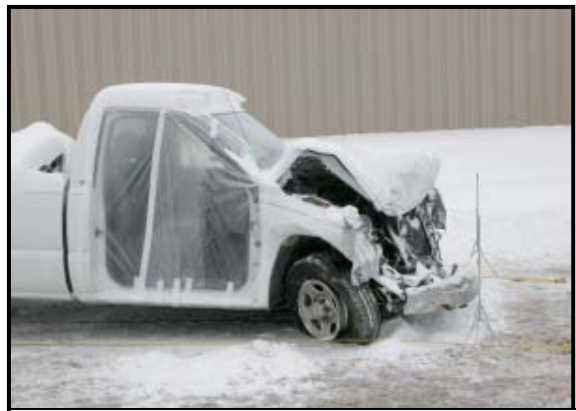
Figure 4: Right lateral view.

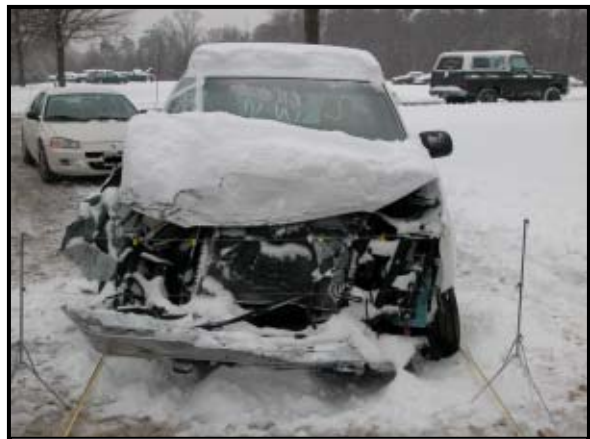
The Collision Deformation Classification was 11-FDEW-1. The Barrier Algorithm of the WINSMASH model was used to assess the crash severity (delta V) based on an average of the above referenced profiles. The crush profile used in that analysis was: C1 = 13 cm (5.1 in), C2 = 1 cm (0.4 in), C3 = 0, C4 = 7 cm (2.8 in), C5 = 13 cm (5.1 in), C6 = 12 cm (4.7 in). The calculated BES for the Chevrolet was 14 km/h (8.9 mph). The computed BES was in general agreement with the delta V recorded by the Event Data Recorder. The maximum recorded delta V was -

Figure 5: Front view.

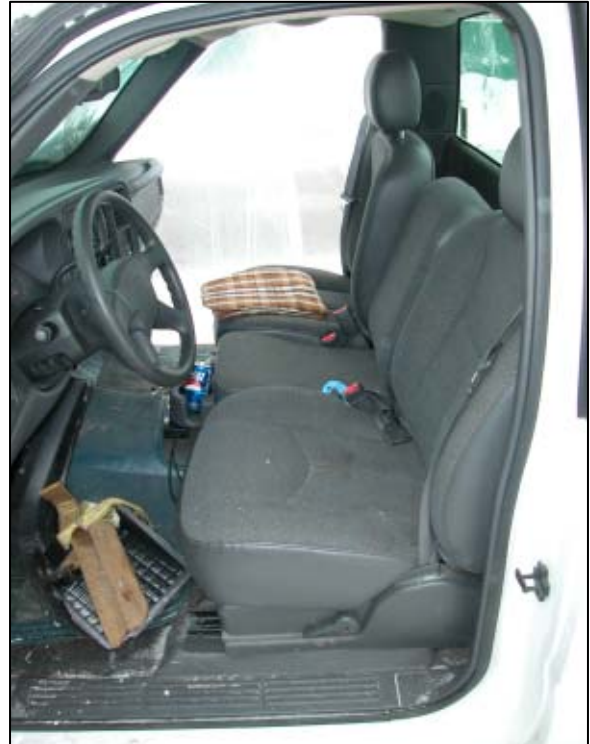
Figure 6 is an interior view of the Chevrolet. There was no intrusion or interior damage related to the exterior crash forces.

Figure 6: Left interior view.

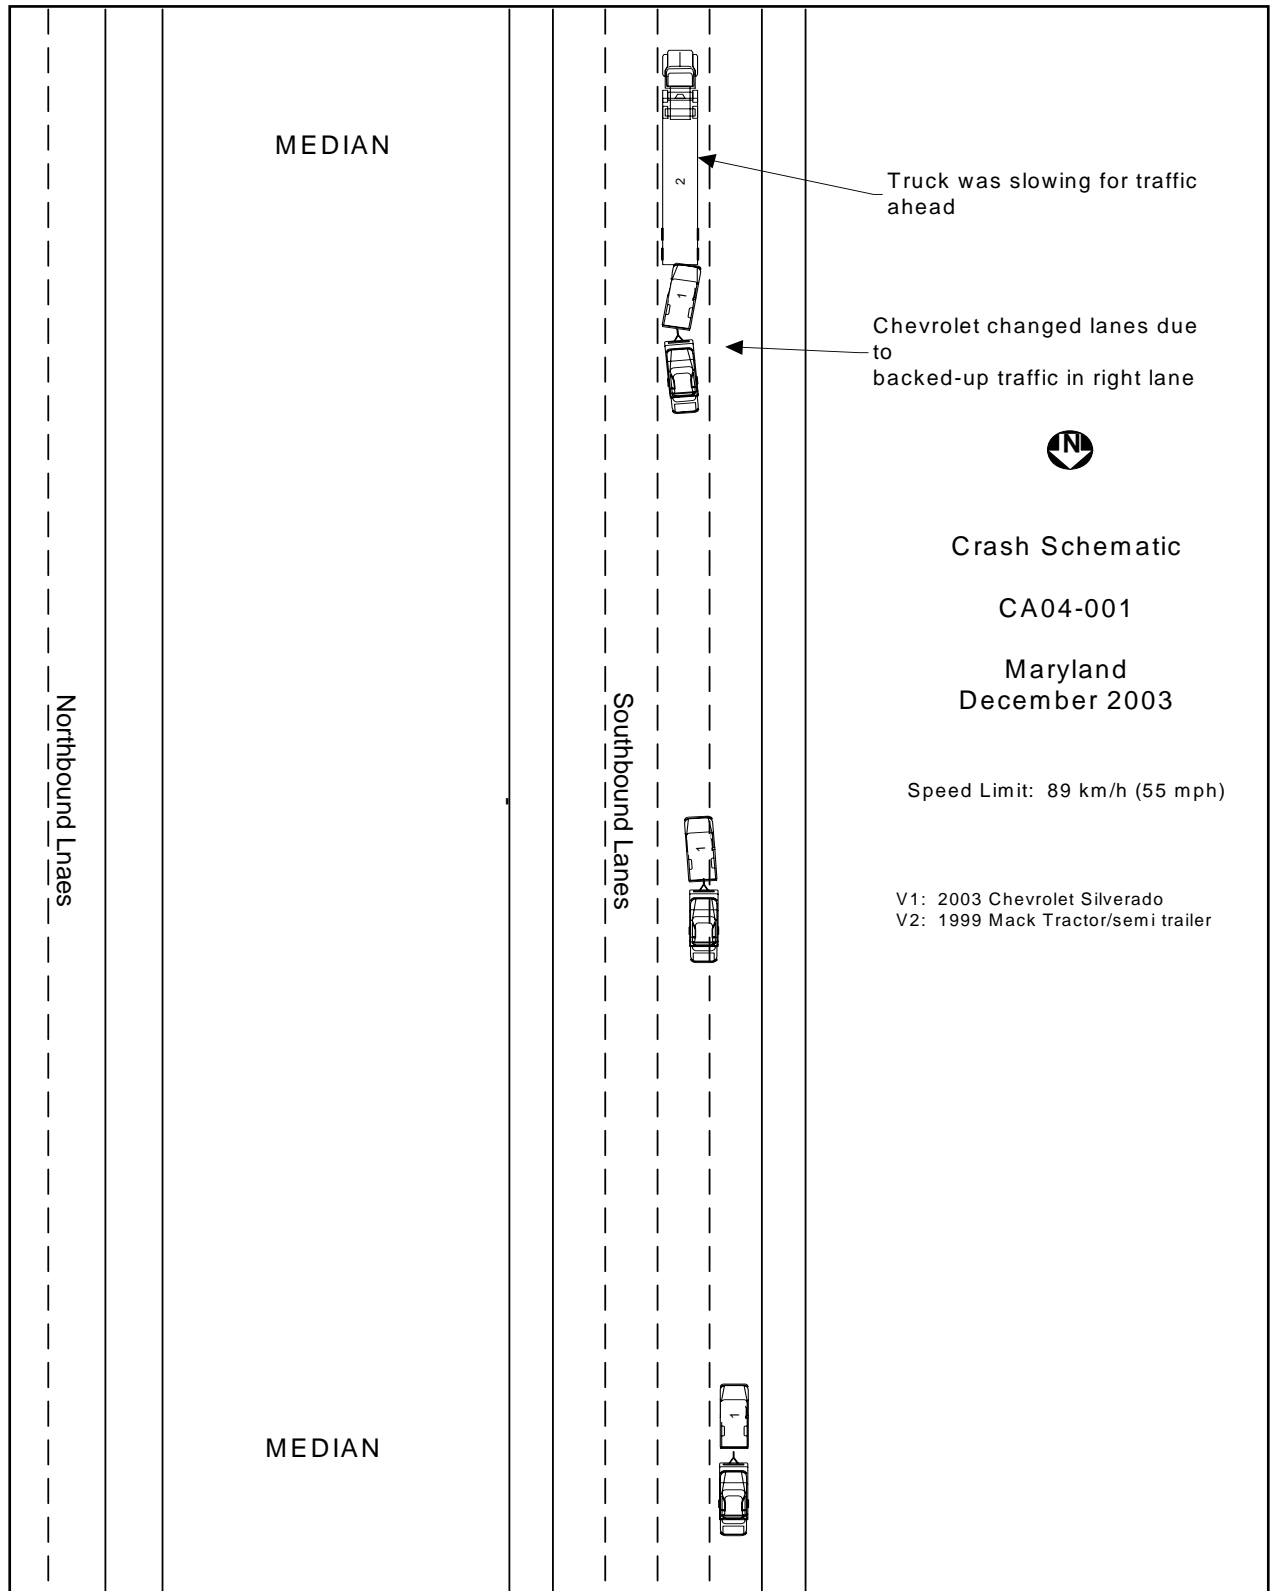
Figure 7: Crash Schematic.

The front plane of the Chevrolet impacted the back plane of the semi-trailer in a front-to-rear configuration. The nature of the damage suggested the Chevrolet was rotated slightly clockwise at impact. This orientation may have resulted from a loss of control of the towed vehicle. The Chevrolet underrode the back of the trailer due to the mismatch of the profiles of the respective vehicle. As a result of the under-ride, the primary damage sustained by the Chevrolet was above the elevation of the front bumper. The force of the impact was not sufficient to warrant the deployment of the Chevrolet's advanced frontal air bags. The WINSMASH program's barrier equivalent algorithm was used to calculate a Barrier Equivalent Speed (BES) for the Chevrolet. The calculated BES for the Chevrolet was 14 km/h (8.9 mph). The maximum longitudinal delta V recorded by the Chevrolet's EDR was 13 km/h (8.01 mph). **Figure 7**, at the end of this narrative report, is a schematic of the crash.
