Vehicle Defect - Tour Bus Investigation / Vehicle to Object
Dynamic Science, Inc. / Case Number: DS04014
1997 Van Hool tour bus
Arizona
June 2004

1. Report No. DS04014	2. Government Accession No.		3. Recipient Catalog No.	
4. Title and Subtitle Vehicle Defect - Tour Bus Investigation			5. Report Date August 3, 2006

The focus of this on site investigation was the performance of the brake system on a 1997 Van Hool tour bus.

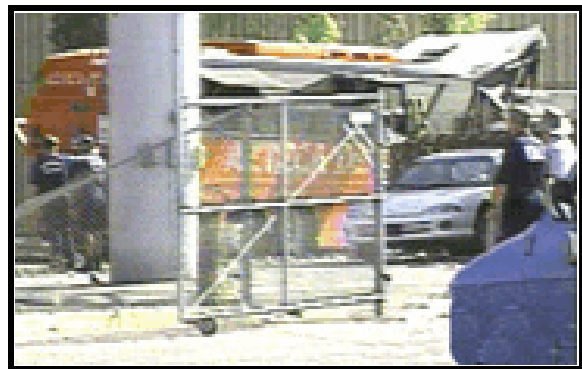
Figure 3. Final rest

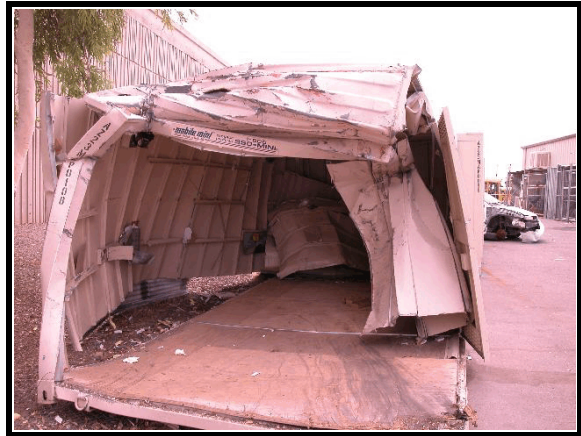
There were multiple tire/curb impacts. The vehicle continued forward striking the following objects: a wooden railroad tie fence, the first chain link fence, the second chain link fence, and finally the first metal storage structure. The storage structure was penetrated and then pushed rearward approximately 3.0 m (10 ft) and rotated clockwise. A third chain link fence which ran in an east/west direction was torn down due to the impact with structure. As the structure went rearward it struck a second structure and pushed it rearward. This second structure struck the right side of the parked van and then pushed that vehicle into a second parked vehicle.

Figure 4. First metal storage structure

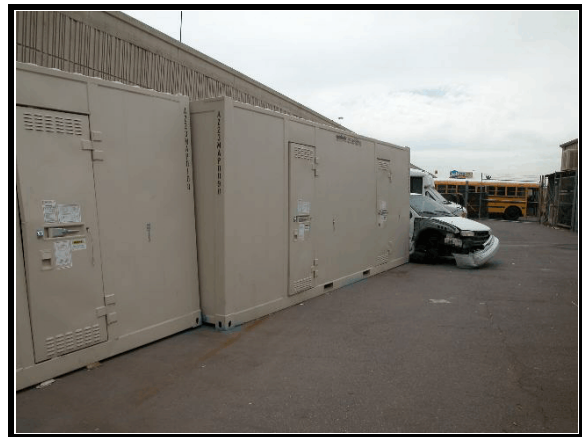
Figure 5. First storage unit, second storage unit, parked van

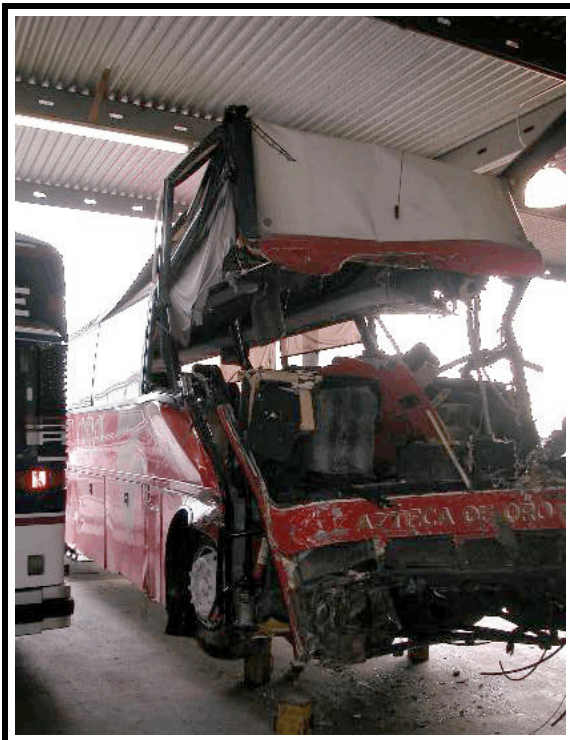
Damage Description: The Van Hool bus sustained major external damage. The front end was entirely caved in. There was 78 cm (31 in) of crush at the front right corner. Both A pillars and the windshield header were forced rearward causing the roof to buckle upwards. The front right entry way was crushed rearward, with a maximum opening width of 56 cm (22 in) at the bottom and a minimum opening width of 12 cm (5 in) at the belt line. Both front seats were crushed by instrument panel/dash intrusion. The front right tire was flattened and restricted. The left front tire was flattened. There was side swiping type contact damage down the entire right side extending vertically from the frame level to 59 cm (23 in) at the highest point. There was also scraping contacts along the right side undercarriage.

Figure 6. Front right, 1997 Van Hool tour bus

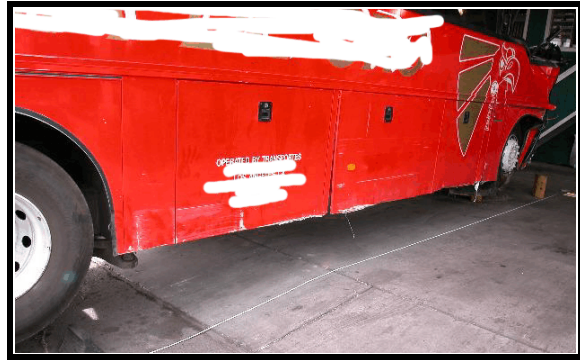
Figure 9. Right side contact damage

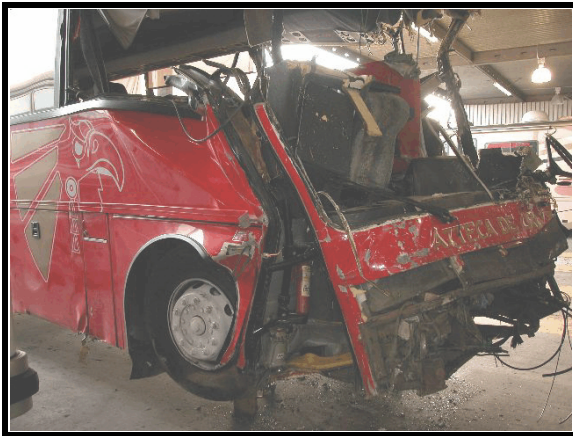
Figure 10. Front right, shows crushed entry way

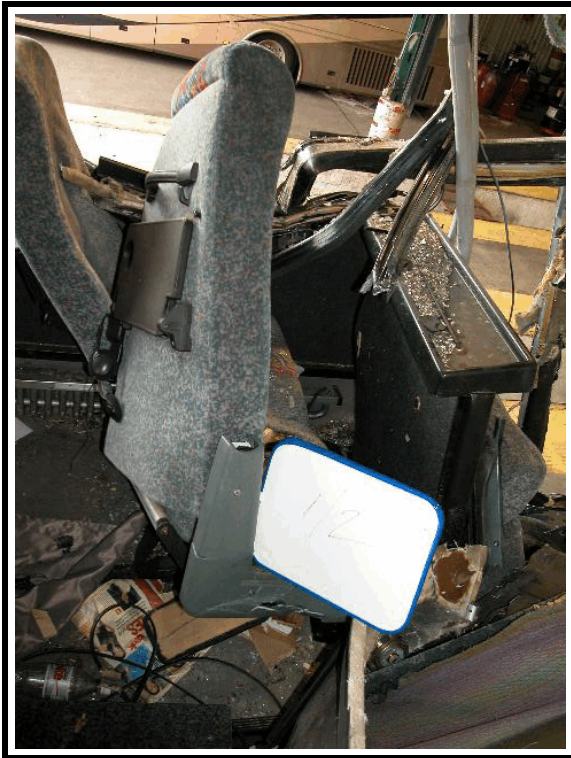
Figure 11. Bus row 1, left aisle seat

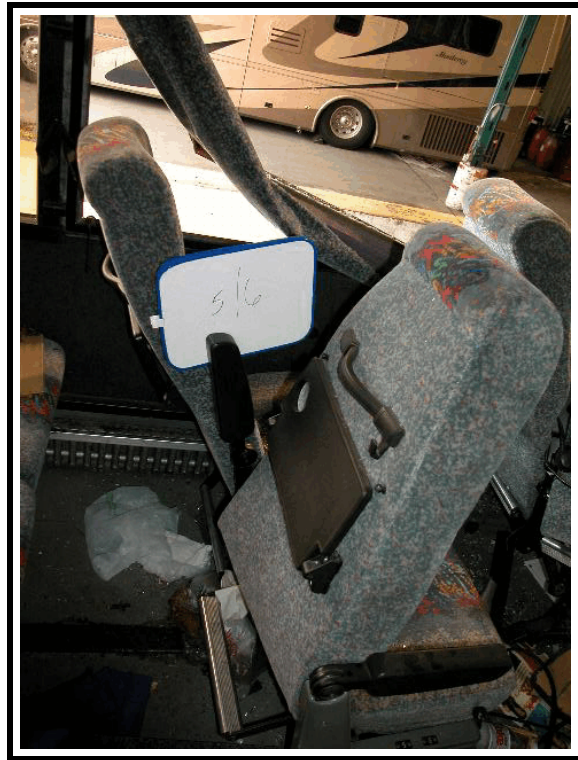
Figure 12. Example of seat back deformation. Bus row 2, aisle seat
