ON-SITE CERTIFIED ADVANCED 208- COMPLIANT VEHICLE INVESTIGATION

CASE NUMBER - IN-04-024

VEHICLE - 2003 CHEVROLET C1500 SILVERADO, EXTENDED CAB

CRASH DATE - June 2004

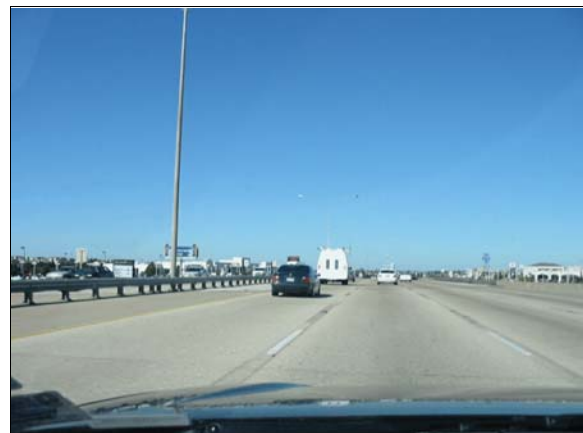
Pre-Crash: The case vehicle was traveling northwest in the inside center through-lane, and the driver was intending to continue straight ahead (**Figure 1**). The police crash report indicated that, based on a witness statement, the driver lost control of the vehicle as a vehicle in front of it slowed for traffic. The police crash schematic shows the case vehicle rotating counterclockwise to the left prior to the impact. The driver stated she hydroplaned due to the wet pavement and went to the left. She also stated she steered left and braked, but she was not clear as to when the

Figure 1: Approach of case vehicle in inside center through-lane

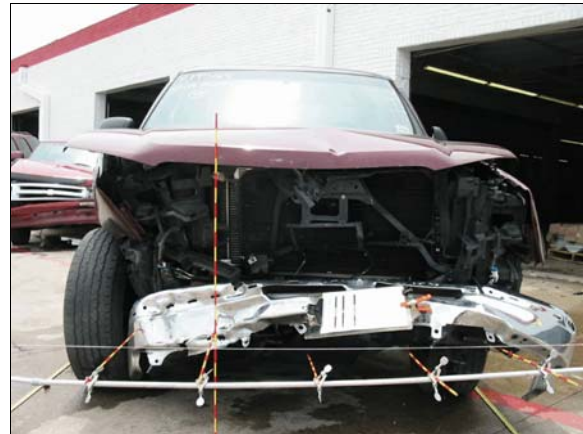
Crash: The front right of the case vehicle (**Figure 2**) impacted the steel, blocked-out, W-beam median guardrail (**Figure 3**) causing the case vehicle's driver air bag to deploy. Based on the EDR data, the deployment command criteria was met for only the first stage of the two stage driver air bag system. The case vehicle was equipped with a front right passenger air bag equipped with an air bag suppression switch that was set to the "auto" position and an occupant detection sensor in the front right seat. Deployment of this air bag was properly suppressed during the crash sequence because there was no front right passenger in the vehicle. Following the median guardrail impact, the case vehicle deflected to the right, continued to rotate counterclockwise and traveled diagonally across all four lanes of the roadway and the outside shoulder. The front right of the case vehicle then sustained a minor impact with the steel guardrail on the right side of the roadway (**Figure 4**).

Figure 2: Front damage to case vehicle from impact with the median guardrail, each stripe on rod is 5 cm (2 in)

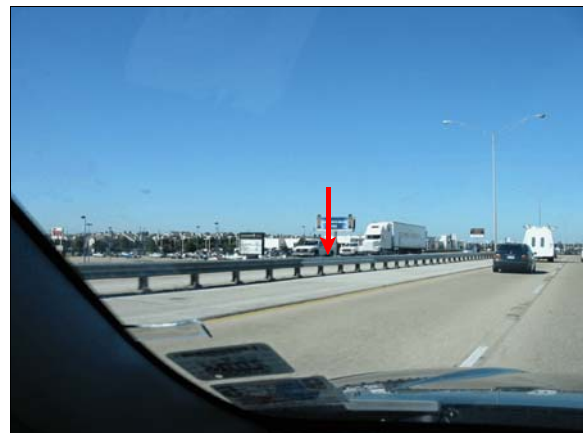
Figure 3: Overview of median guardrail impacted by case vehicle, arrow shows new section of guardrail indicating likely area of impact

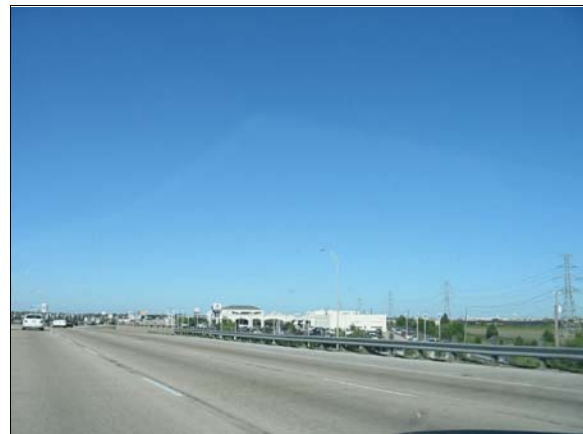
Post-Crash: The case vehicle came to rest on the outside shoulder of the roadway facing north with the front right of the vehicle against the guardrail (**Figure 4**).

Figure 4: View northwest to area of second guardrail impact and final rest of case vehicle

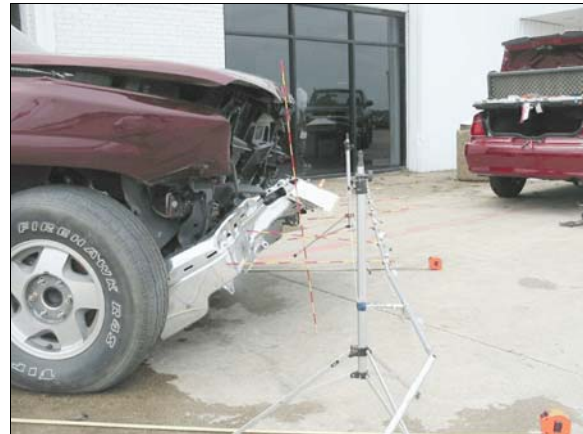
Exterior Damage:: The case vehicle’s impact with the median guardrail involved the front plane of the vehicle. Direct damage began at the right bumper corner and extended 151 centimeters (59.4 inches), along the front bumper. Residual maximum crush was measured as 25 centimeters (9.8 inches) at C₅ (**Figure 5** below). The case vehicle’s front bumper, bumper fascia, grille, radiator, right fender, and front edge of the hood were directly damaged and crushed rearward as well as to the left. The table below shows the case vehicle’s crush profile.

Figure 5: Right side view of crush to case vehicle's front bumper, each stripe on rods is 5 cm (2 in), the front baseline is set 17 cm (6.7 in) beyond the undeformed front bumper position

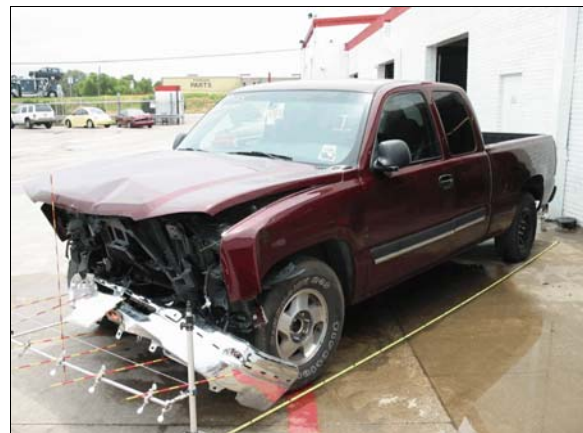
The case vehicle's wheelbase was unaltered by the crash. Induced damage involved the hood and both the right and left fenders (**Figures 6 and 7**). The front grille and headlamp/ turn lamp assemblies had been removed from the vehicle and were not available at the time of the inspection.

Figure 6: Overview of front and left side of case vehicle, each black mark on tape measure is 0.31 meter (1 foot)

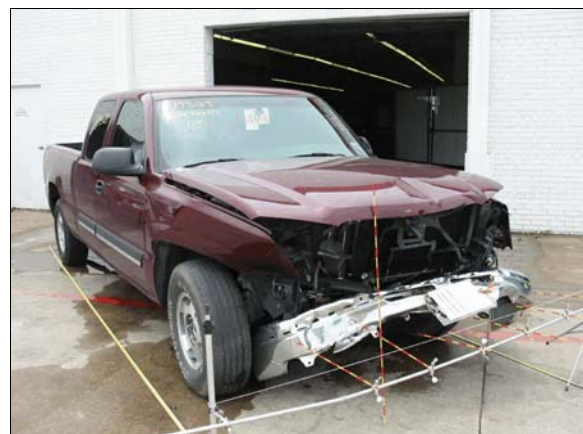
Figure 7: Overview of front and right side of case vehicle

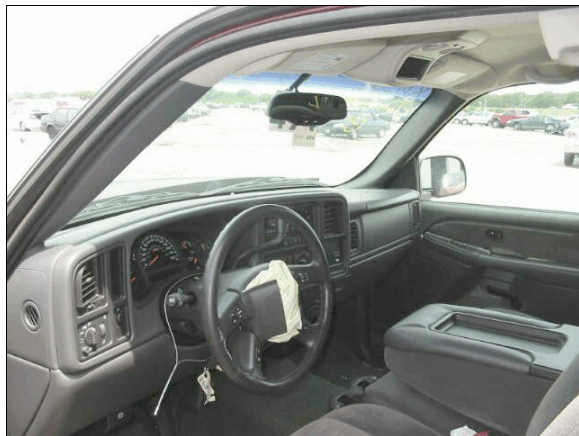
Vehicle Interior: Inspection of the case vehicle's interior (**Figure 8** below) revealed no obvious occupant contacts on the interior surfaces of the vehicle. However, what appeared to be makeup transfers were observed on the right upper quadrant of the driver's air bag, indicating the driver's face contacted the air bag during the crash. In addition, the driver's safety belt appeared to be stretched due to the driver loading it during the crash. No deformation of the steering wheel rim or compression of the energy absorbing steering column was observed (**Figure 9** below). Lastly, the case vehicle sustained no occupant compartment intrusions.

Figure 8: Overview of case vehicle's windshield, steering wheel and instrument panel

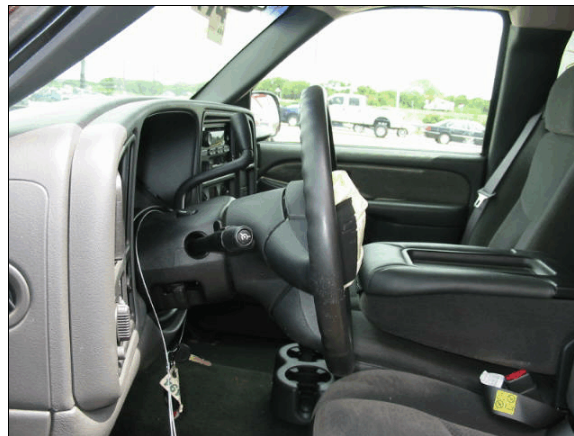
Figure 9: Case vehicle's steering column and steering wheel

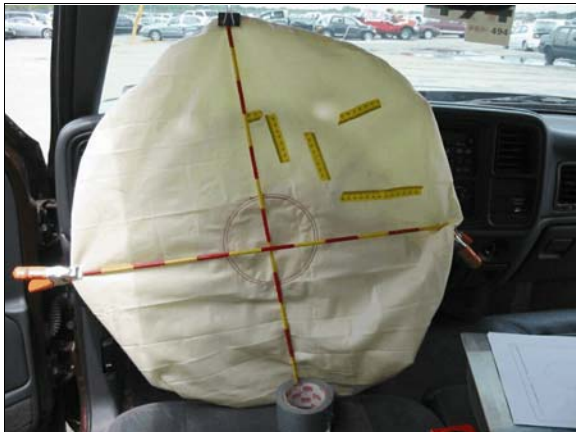
The case vehicle's driver air bag (**Figure 10** below) was located in the steering wheel hub. An inspection of the air bag module cover flaps and the air bag's fabric revealed that the cover flaps opened at the designated tear points (**Figure 11** below), and there was no evidence of damage during the deployment to the air bag or the cover flaps. The module cover consisted of "I" configuration cover flaps made of pliable vinyl each 7.5 centimeters (3.0 inches) in width at the top, 5.0 centimeters (2.0 inches) in width at the bottom and 13 centimeters (5.1 inches) in height at the center tear seam. The driver's air bag was designed with two tethers, each approximately 13.5 centimeters (5.3 inches) in width. The driver's air bag had two vent ports, (**Figure 12** below) approximately 3.0 centimeters (1.2 inches) in diameter, located at the 10:00 and 2:00 clock positions. The deployed driver's air bag was round with a diameter of approximately 65 centimeters (25.6 inches). The distance between the mid-center of the driver's seat back, as

Figure 10: Overview of driver air bag, yellow tape shows probable make-up transfer on air bag

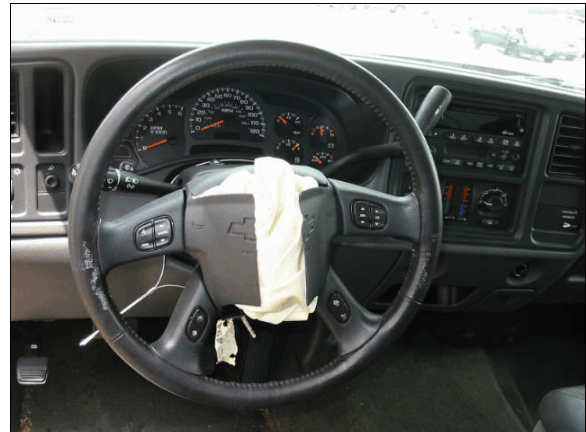
Figure 11: Driver air bag module cover flaps and the steering wheel

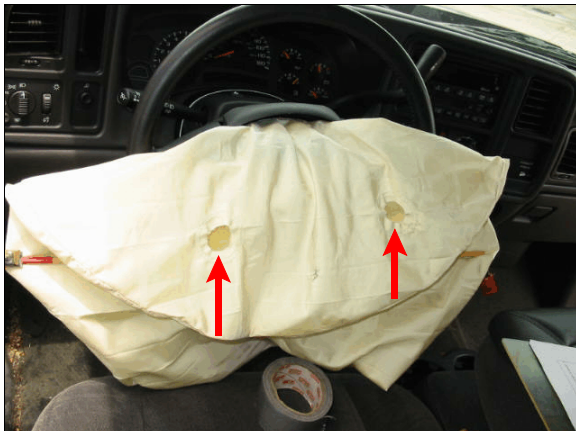
Figure 12: Driver's air bag vent ports

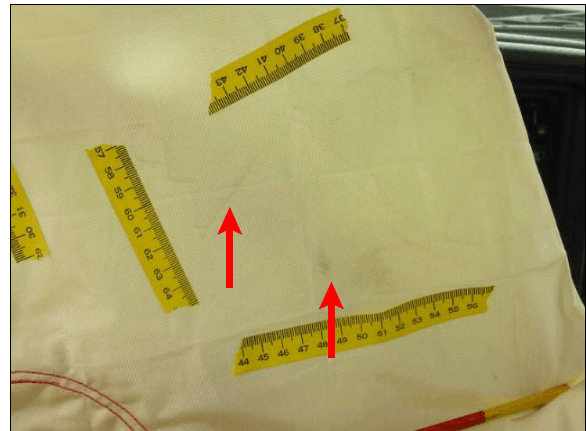
positioned at the time of the vehicle inspection, and the front surface of the air bag at full excursion was 39 centimeters (15.4 inches). An inspection of the driver's air bag fabric revealed probable makeup transfers on the right upper quadrant of the air bag (**Figure 13**), and a few light scuffs were noted on the back of the air bag, which appeared to be due to deployment.

Figure 13: Probable make up transfers on upper right quadrant of air bag

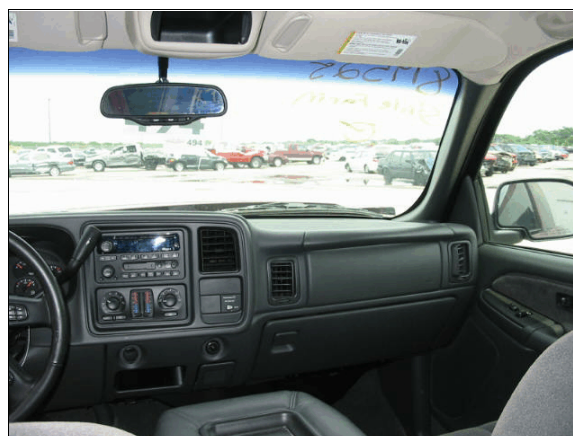
The front right passenger's air bag was located in the middle of the instrument panel (**Figure 14** below) and properly did not deploy. The case vehicle's front right seat occupant sensing system correctly determined the absence of a front right occupant and suppressed deployment of the front right air bag. The case vehicle was also equipped with a suppression switch for this air bag, which was set to the "Auto" position (**Figure 15** below).

Figure 14: Overview of location of front right air bag in middle of instrument panel above glove box door

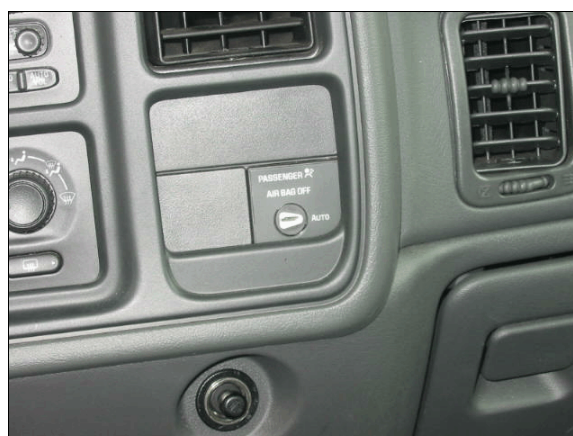
Figure 15: Front right passenger air bag suppression switch set to "AUTO" position

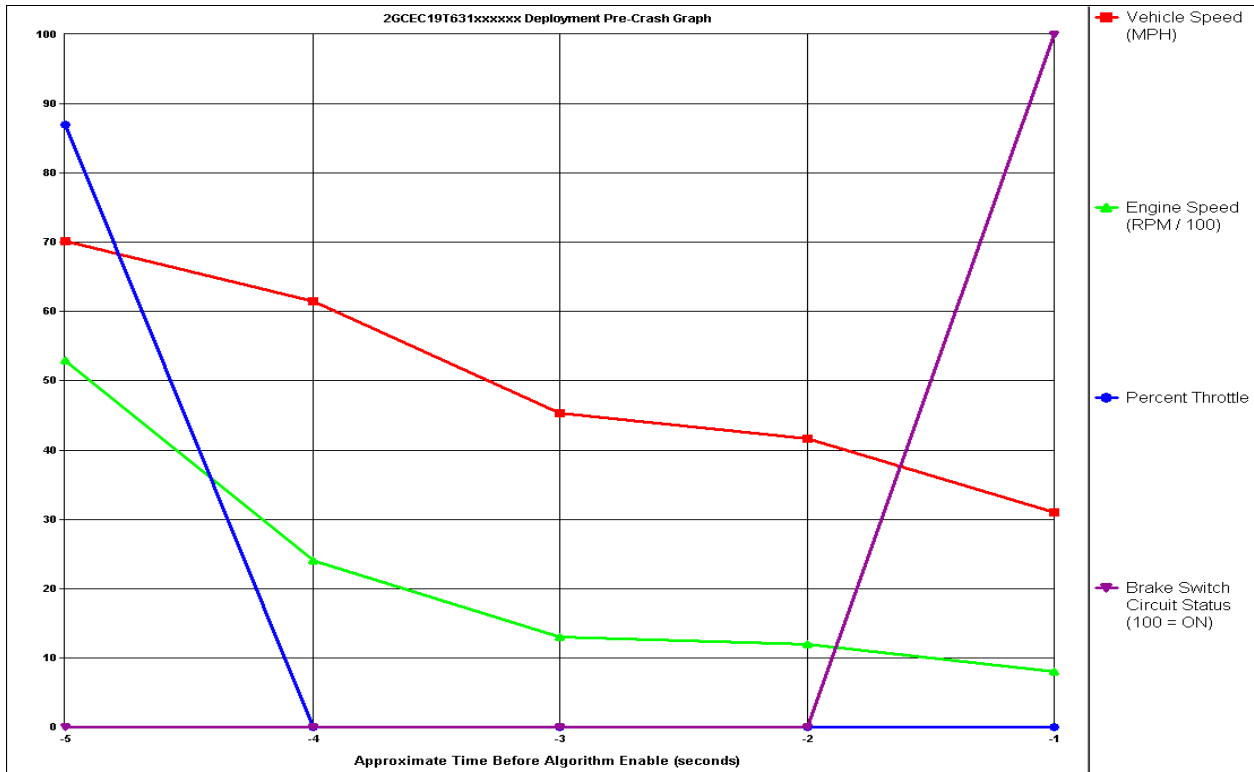
The pre-crash data for the deployment event recorded the case vehicle traveling 113 km.p.h. (70 mph) at 87% throttle five seconds prior to the crash (i.e., AE). At four seconds prior to the crash, the percent throttle drops to zero and speed drops to 100 km.p.h. (62 m.p.h.). The speed continues to drop and the throttle remains at zero percent for the remaining three sample periods. The brake switch circuit status is then recorded as on at the last sample period (i.e., one second prior to the crash) indicating the driver applied the brakes prior to impacting the median guardrail.

Figure 17: Case vehicle's Deployment Pre-Crash Graph

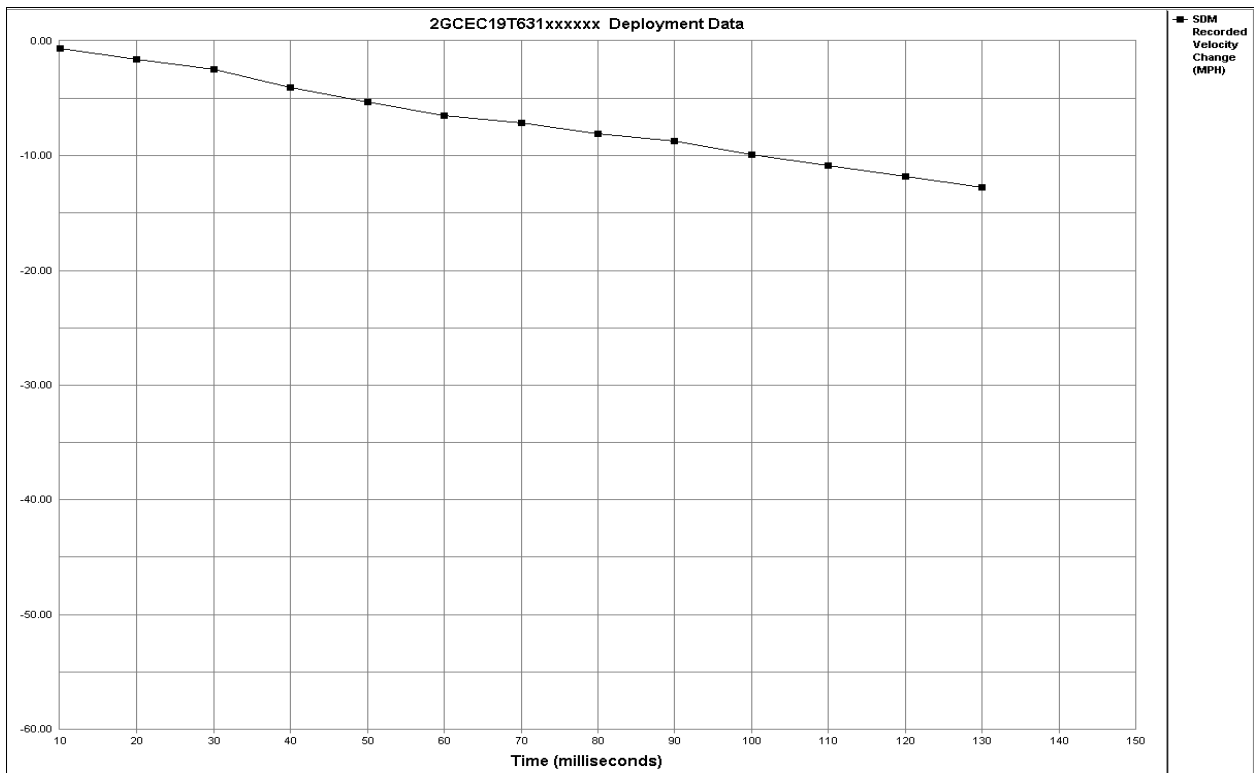
The download of the case vehicle's EDR was done during the vehicle inspection through the diagnostic link connector. The EDR recorded a deployment event and a non-deployment event. The EDR reports for both events are presented at the end of this report (Figures 16-21). The EDR recorded the SIR warning lamp as "off" and the driver's safety belt switch circuit as "buckled". The system status report for the deployment event indicates the driver's air bag, first stage deployment criteria was met at 32.5 milliseconds after algorithm enable (AE), and the maximum SDM recorded velocity change was -22.63 km.p.h. (-14.07 m.p.h.) occurring 174 milliseconds after AE.

Figure 18: Case vehicle's deployment SDM Recorded Velocity Change graph

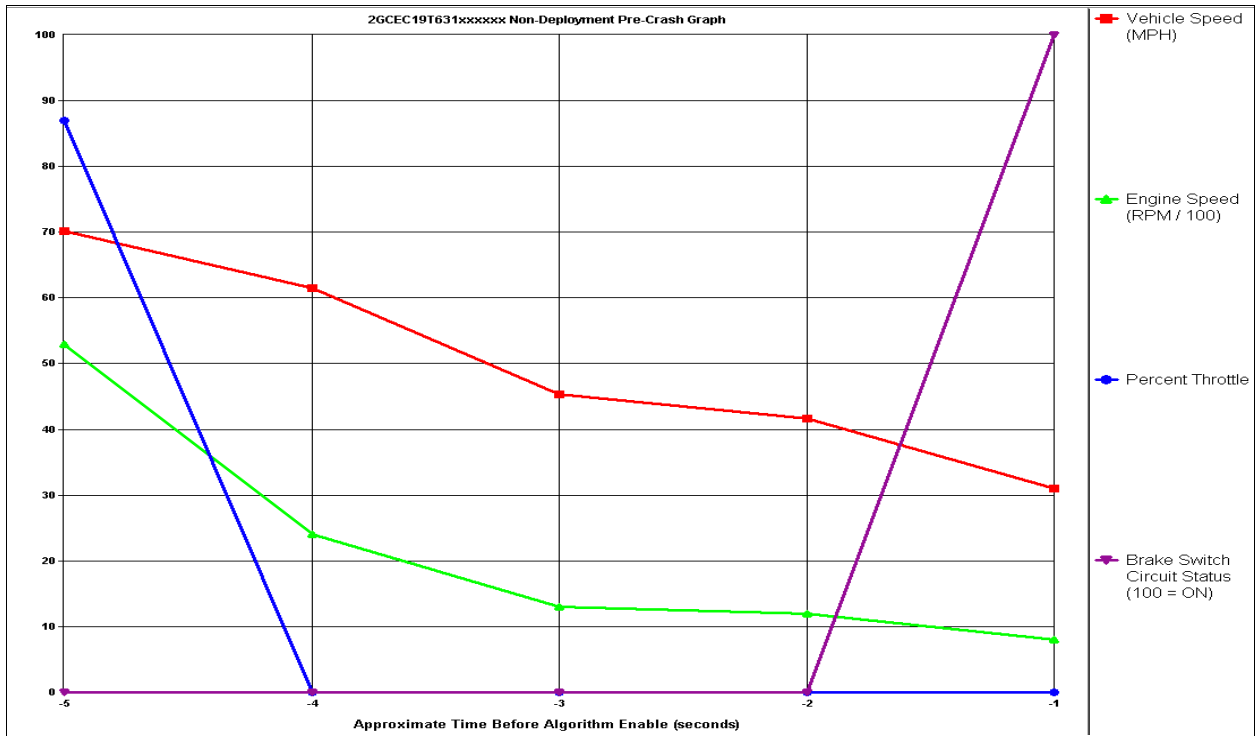
Figure 20: Case vehicle's Non-deployment Pre-Crash Graph

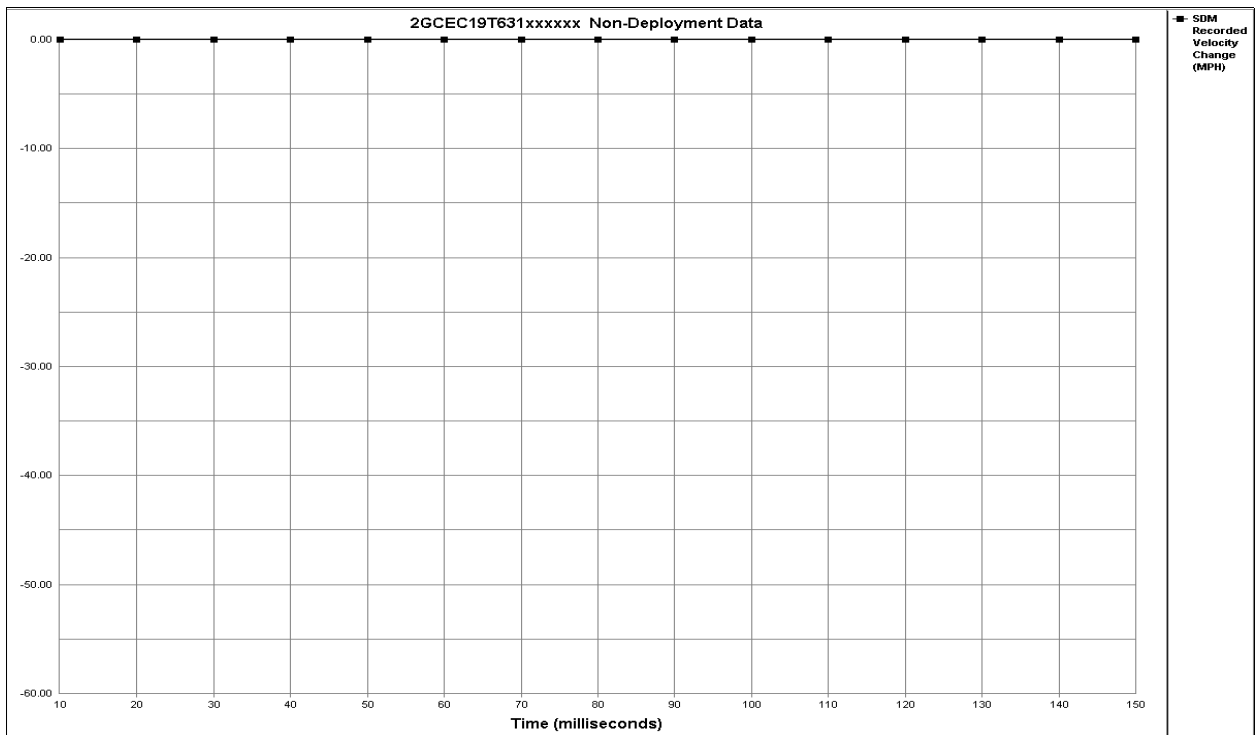
The non-deployment event was very minor. The EDR recorded the maximum SDM recorded velocity change as 0.00 km.p.h. (0.00 m.ph.) occurring at 207.5 milliseconds after algorithm enable, indicating the event was just sufficient to wake up the crash sensing algorithm. It is this contractor's opinion that the non-deployment event was the result of a minor second contact with the median guardrail.

Figure 21: Case vehicle's Non-Deployment SDM Recorded Velocity Change graph
