INDIANA UNIVERSITY

TRANSPORTATION RESEARCH CENTER

ON-SITE CERTIFIED ADVANCED 208- COMPLIANT VEHICLE INVESTIGATION

CASE NUMBER - IN-04-032
LOCATION - Texas
VEHICLE - 2004 FORD TAURUS
CRASH DATE - August 2004

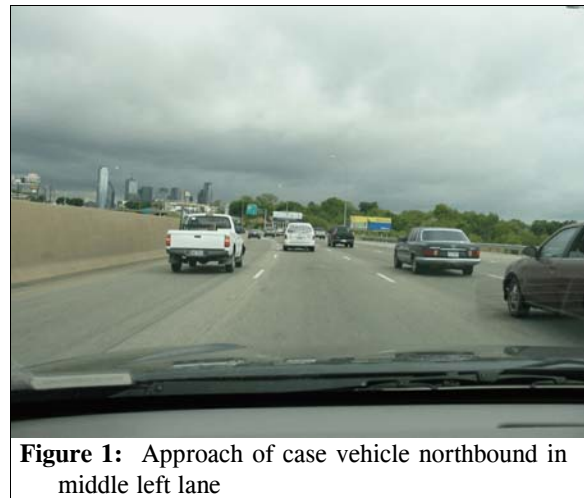
Pre-Crash: The case vehicle was northbound in the middle left lane, and the driver was intending to continue northbound (**Figure 1**). The Chrysler was in the same lane and was stopped facing northbound due to its involvement in a prior crash. The case vehicle's driver braked to avoid the crash. The crash occurred in the middle left lane.

Figure 1: Approach of case vehicle northbound in middle left lane

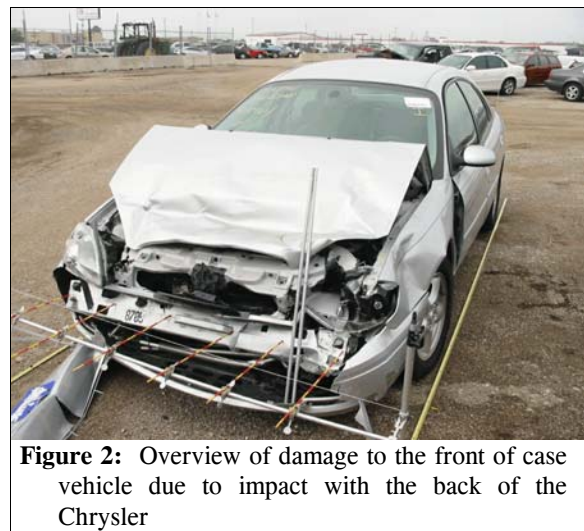
Crash: The front of the case vehicle (**Figure 2** below) impacted the back of the Chrysler causing a stage 1 deployment of the case vehicle's driver air bag and activation of the driver's and front right passenger's safety belt buckle-mounted pretensioners. The case vehicle's front right air bag did not deploy. The case vehicle driver's pre-crash braking caused the case vehicle's front suspension to load, and the front of the case vehicle dipped down and underrode the back of the Chrysler.

Figure 2: Overview of damage to the front of case vehicle due to impact with the back of the Chrysler

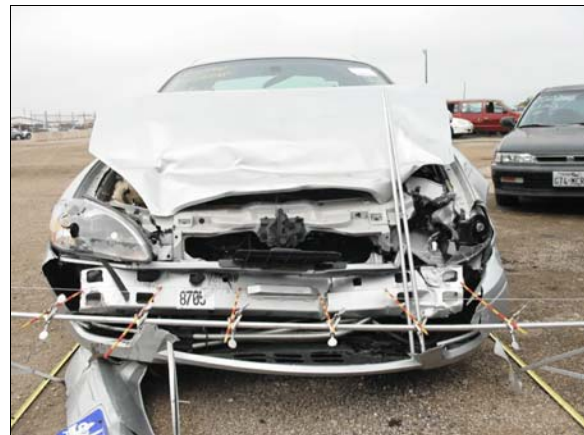
Figure 3: Damage to front of case vehicle due to impact with back of Chrysler, each stripe on rods is 5 cm (2 in)

Exterior Damage: The case vehicle's impact with the Chrysler involved the front bumper, both headlamp/turn lamp assemblies, grille, and the hood (**Figure 3**). The direct damage began at the left corner of the front bumper and extended 146 centimeters (57.5 inches) across the bumper. The direct damage also involved the front portion of the hood. The hood damage indicates the case vehicle underrode the back of the Chrysler (**Figure 4**). Crush measurements were taken at the bumper level, on the bumper bar (i.e., the bumper cover was torn off), and maximum crush

was measured as 23.0 centimeters (9.1 inches) occurring at C₂ and C₃. The table below shows the case vehicle’s crush profile.

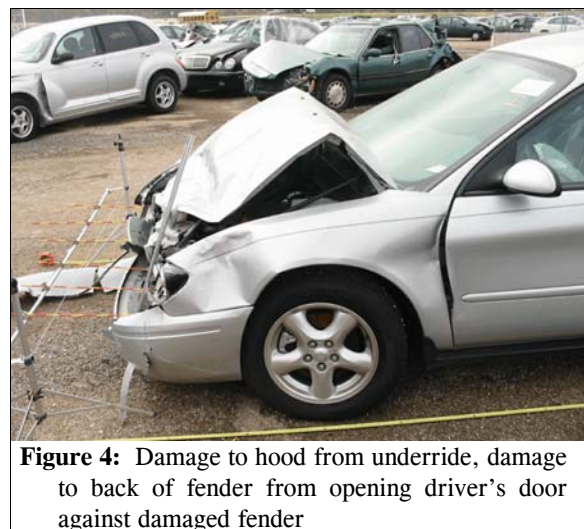
Figure 4: Damage to hood from underride, damage to back of fender from opening driver's door against damaged fender

The case vehicle’s wheelbase was unchanged by the damage. Induced damage involved the hood and both fenders. In addition, the front of the driver’s door was damaged due to being opened against the displaced left fender (**Figure 4** above).

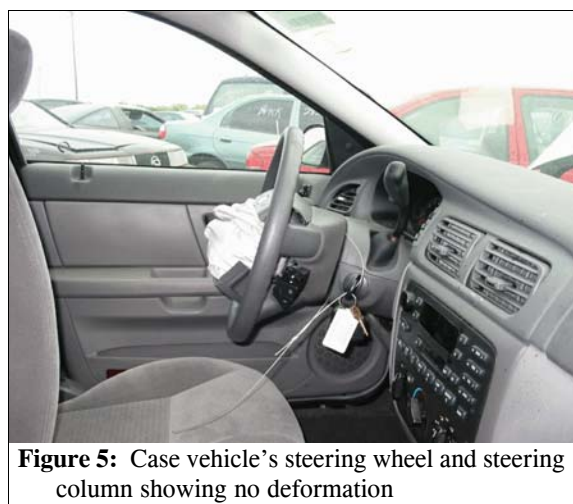
Figure 5: Case vehicle’s steering wheel and steering column showing no deformation

about 23 centimeters (9.1 inches), and the back of the front right passenger seat intruded forward into the front right passenger's occupant space about 14 centimeters (5.5 inches). No other occupant contact evidence was found, and there was no evidence of compression of the energy absorbing steering column or deformation of the steering wheel rim (**Figure 5** above).

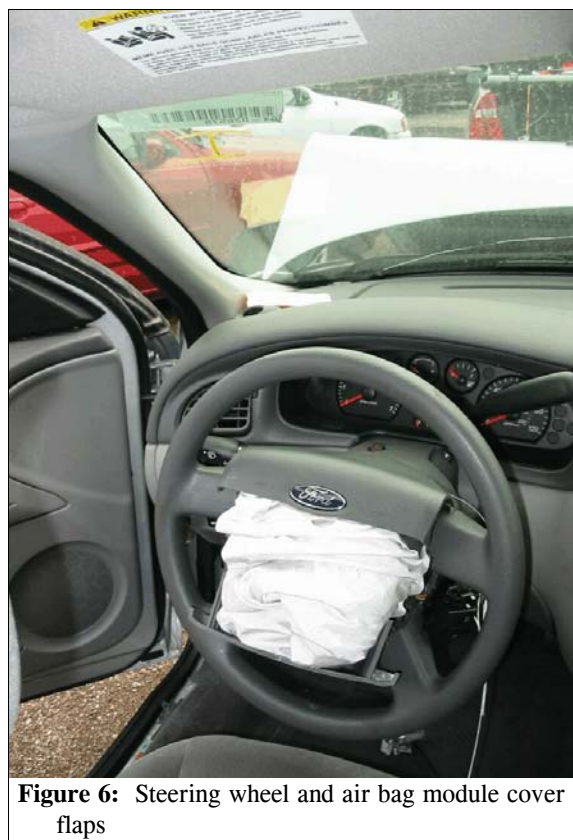
The case vehicle's driver air bag was located in the steering wheel hub. An inspection of the air bag module cover flaps and the air bag fabric revealed that the cover flaps opened at the designated tear points (**Figure 6**). There was no evidence of damage during the deployment to the air bag module cover flaps or the air bag fabric. One small stain of unknown origin was found at the bottom of the left quadrant of the air bag; however, no clear occupant contact marks were observed on the air bag (**Figure 7** below). The deployed driver's air bag was round with a diameter of approximately 59 centimeters (23.2 inches). The air bag was designed with one cone-shaped tether sewn to the circumference of the center portion of the air bag. The air bag had two vent ports (**Figure 8** below), each approximately 2.0 centimeters (0.8 inches) in diameter, located at the 11 and 1 o'clock positions. The air bag module cover flaps (**Figure 6**) were constructed of vinyl and plastic, and the tear seam was configured across the middle of the air bag module. The top module cover flap was 22 centimeters (8.7 inches) in width and 6.0 centimeters (2.4 inches) in height. The bottom module

Figure 6: Steering wheel and air bag module cover flaps

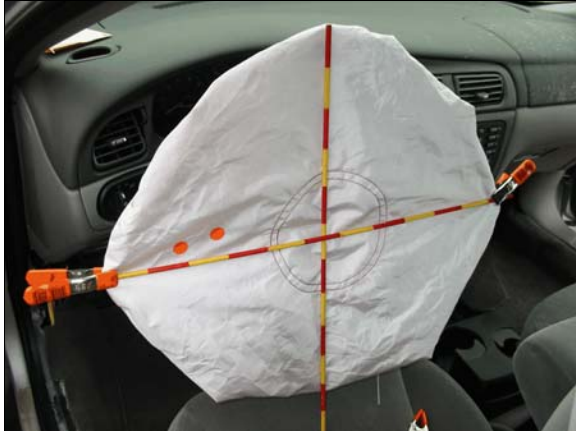
Figure 7: Case vehicle’s driver air bag, orange dots show small stain of unknown origin

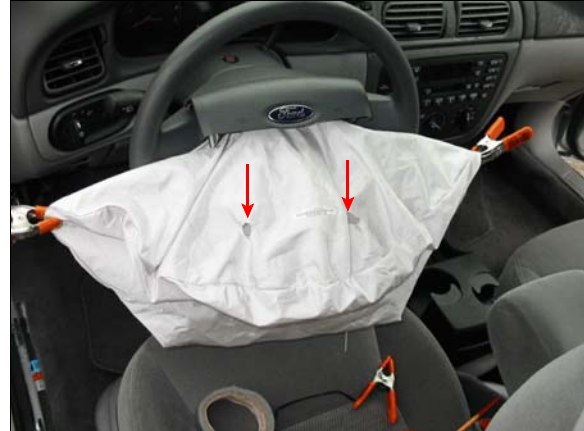
Figure 8: Back of top portion of case vehicle’s air bag, arrows show vent ports

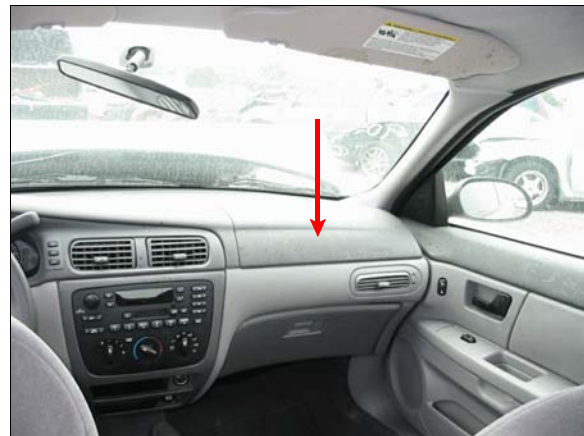
The front right passenger air bag was located in the middle of the instrument panel (Figure 9). The front right passenger air bag did not deploy in the crash. The EDR analysis provided by Ford indicated that the front right passenger seat weight sensor evaluated the passenger as “small”. This indicates that the weight on the seat was below the threshold value for air bag system activation and the deployment of the air bag was suppressed.

Figure 9: Case vehicle’s front right air bag located in middle of instrument panel above glove box door

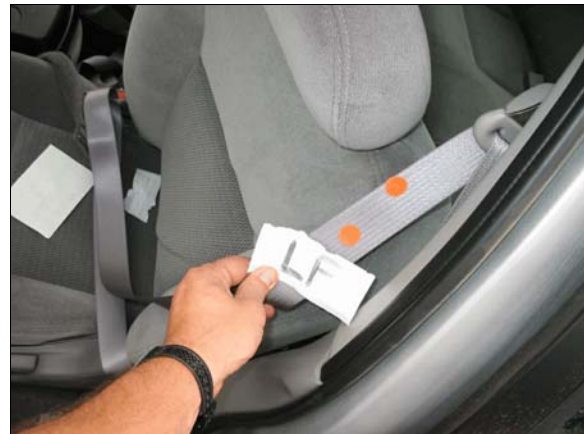
The evidence indicates the case vehicle's driver was restrained by his manual, three-point, lap-and-shoulder safety belt system. The shoulder belt was observed to be slightly scuffed in an area that corresponded to the D-ring when the belt was placed in the approximate in-use position (**Figure 10**). In addition, the EDR data indicated the driver's safety belt was buckled, and the safety belt buckle-mounted pretensioner activated during the crash (**Figure 11**) indicating the safety belt was buckled. The pretensioner piston movement was approximately 2.5 centimeters (1.0 inch).

Figure 10: Case vehicle driver's seat belt, orange dots show small area of scuffing

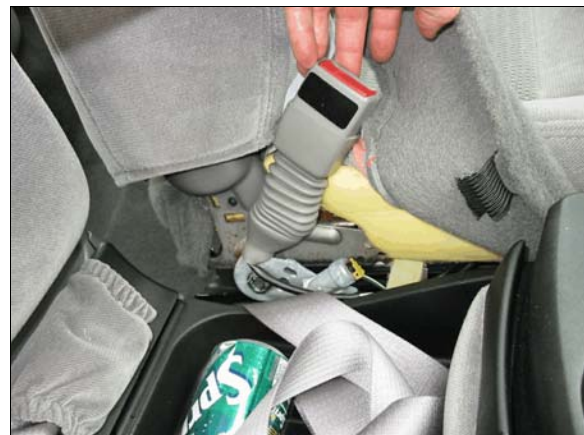
Figure 11: Driver's seat belt buckle stalk is compressed indicating pretensioner activated

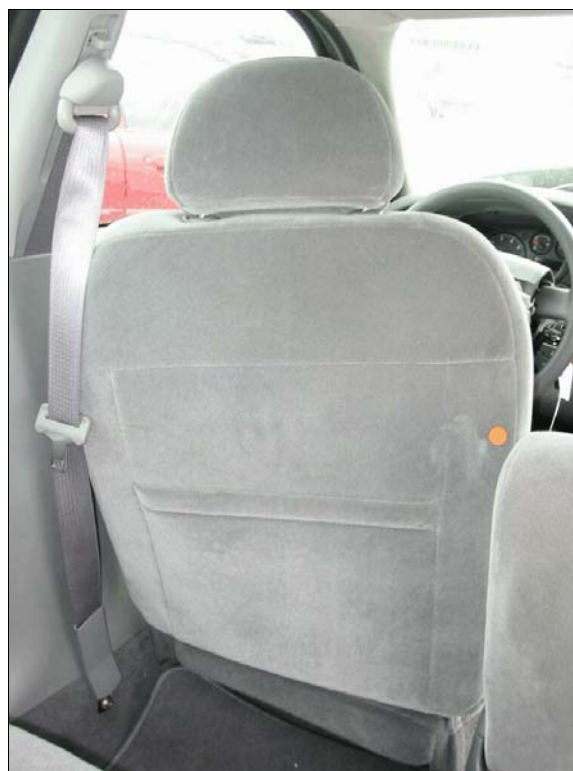
Figure 12: Back of driver's seat, orange dot shows occupant contact, seat back bent forward on right

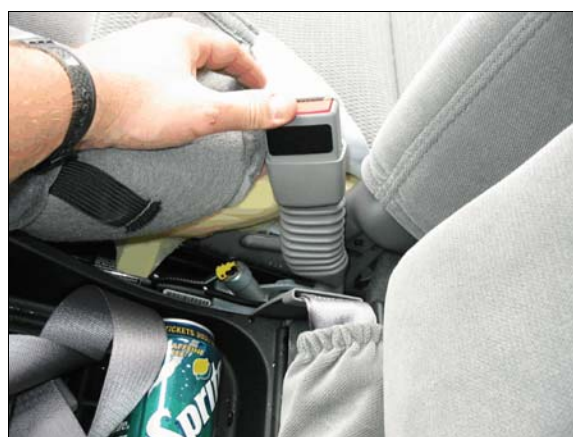
The evidence indicates the front right passenger was restrained by his manual, three-point, lap-and-shoulder safety belt system. The EDR data indicated the passenger's safety belt was buckled, and the safety belt buckle-mounted pretensioner activated (**Figure 13**) indicating the safety belt was buckled. The pretensioner piston movement was approximately 3.0 centimeters (1.2 inches).

Figure 13: Front right seat belt buckle stalk is compressed indicating pretensioner activated

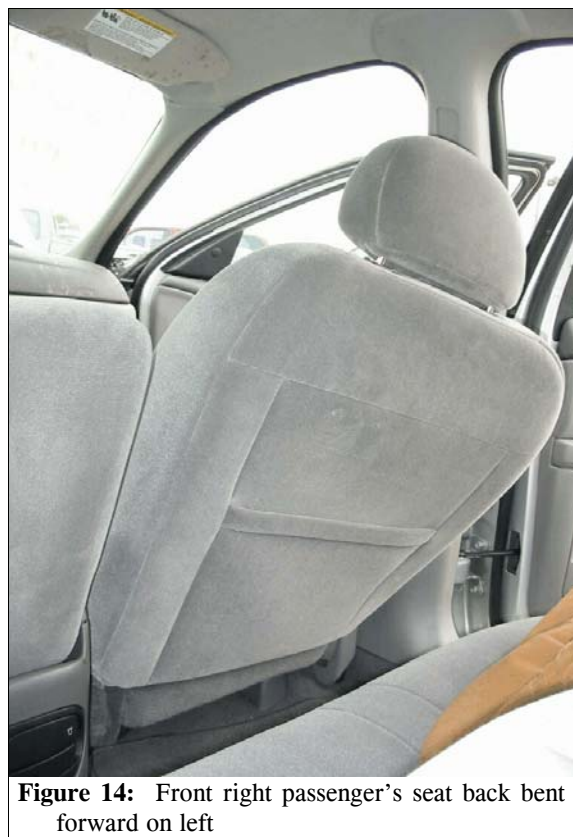
Figure 14: Front right passenger's seat back bent forward on left

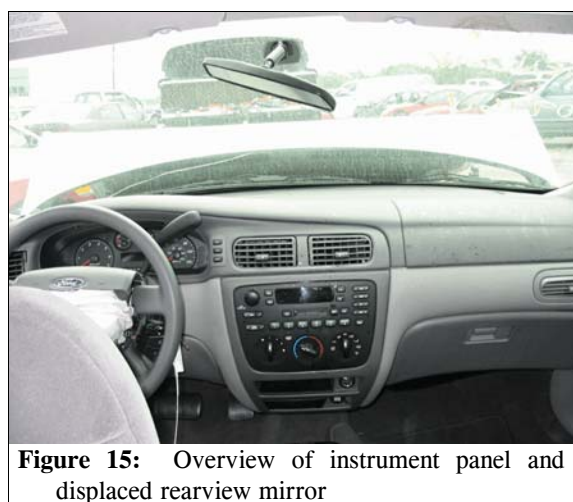
Figure 15: Overview of instrument panel and displaced rearview mirror
