**CALSPAN ON-SITE CERTIFIED ADVANCED 208-COMPLIANT VEHICLE
CRASH INVESTIGATION**

CALSPAN CASE NO: CA05-002

VEHICLE: 2004 CHEVROLET SILVERADO

CRASH DATE: DECEMBER 2004

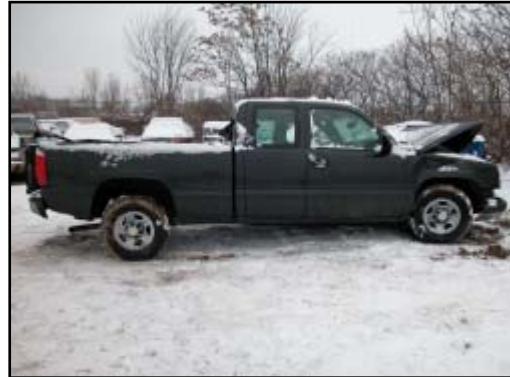
Figure 1. Subject vehicle 2004 Chevrolet Silverado.

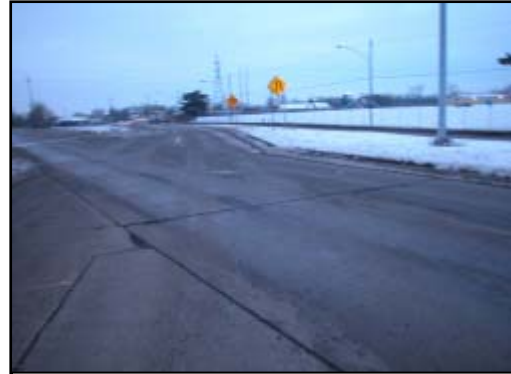
The front aspect of the Silverado impacted the frontal aspect of the Express in the intersection (**Figure 4**). The resultant directions of force were 11 o'clock for the Silverado and 1 o'clock for the Express. The WINSMASH damage algorithm was used to calculate a delta V for this impact. The total calculated delta V for the Silverado was 26.0 km/h (16.2 mph). The longitudinal and lateral components were -19.9 km/h (-12.4 mph) and 16.7 km/h (10.4 mph), respectively. The total calculated delta V for the Express was 27.0 km/h (16.8 mph). The longitudinal and lateral components were -25.4 km/h (-15.8 mph) and -9.2 km/h (-5.7 mph), respectively. This impact resulted in the EDR recorded Deployment event which indicated that the maximum-recorded delta V was -41.4 km/h (-25.7 mph) for the Silverado. The EDR Deployment event for the Express shows that the maximum-recorded delta V for the Express was -53.4 km/h (-33.2 mph).

Figure 4. Northbound view of initial area of impact.

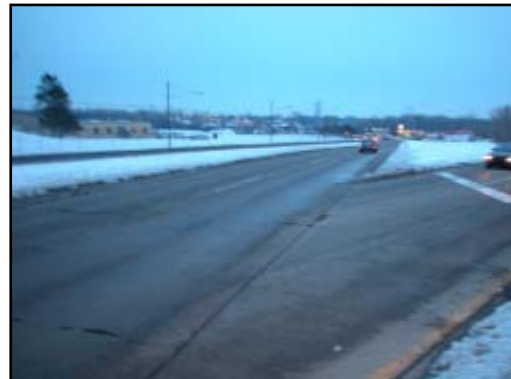
The Silverado initiated a counterclockwise rotation and the Express rotated clockwise as they continued in an eastbound direction. The left rear aspect of the Silverado impacted the right rear aspect of the Express (**Figure 5**). The resultant directions of force for this impact were 9 o'clock for the Silverado and 3 o'clock for the Express. The WINSMASH damage algorithm was used to calculate a delta V for the impact. The total calculated delta V for the Silverado was 10.0 km/h (6.2 mph). The longitudinal and lateral components were 0.0 km/h and 10.0 km/h (6.2 mph), respectively. The total calculated delta V for the Express was 10.0 km/h (6.2 mph). The longitudinal and lateral components were 0.0 km/h and -10.0 km/h (-6.2 mph), respectively.

Figure 5. Eastbound view of the secondary area of impact.

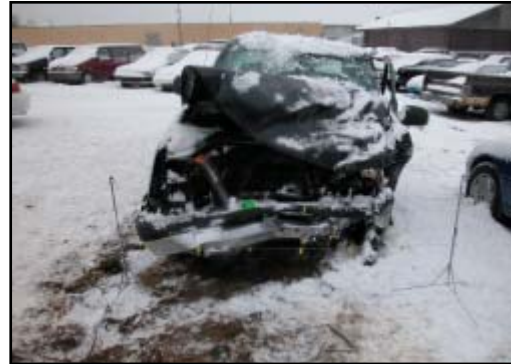
The 2004 Chevrolet Silverado sustained severe frontal damage as a result of the initial impact with the Chevrolet Express cargo van (**Figure 6**). The damage consisted of longitudinal and lateral displacement of the frontal components. The lateral displacement resulted from the 11 o'clock direction force. The direct contact damage measured 132.0 cm (52.0") and began at the front left bumper corner and extended right. The maximum crush measured 57.0 cm (22.4") and was located at the front left bumper corner. The SCI investigator utilized six equidistant crush measurements to document the crush along the front bumper using a combined direct and induced damage width of 155.0 cm (61.0") and were as follows: C1 = 57.0 cm (22.4"), C2 = 43.0 cm (16.9"), C3 = 42.0 cm (16.5"), C4 = 24.0 cm (9.4"), C5 = 3.0 cm (1.2"), C6 = 0.0 cm. The Collision Deformation Classification (CDC) for this impact was 11-FDEW-3.

Figure 6. 2004 Chevrolet Silverado frontal damage.

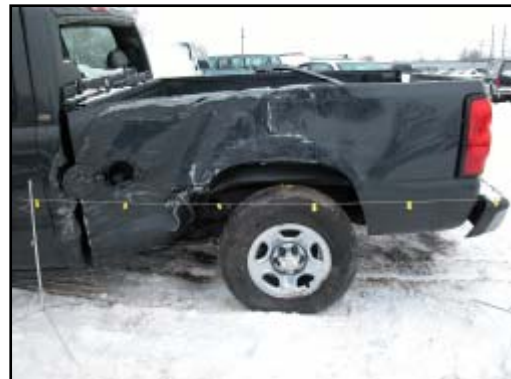
The Silverado sustained moderate severity left side damage as a result of the sideslap impact (**Figure 7**). The damage consisted of lateral deformation to the left rear aspect of the bed, longitudinal abrasions to the bed and rear of the cab area, and abrasions and minor deformation to the left rear wheel rim. The direct contact damage measured 155.0 cm (61.0"), which began 35.6 cm (14.0") rear of the left rear axle and extended forward. The maximum crush measured 39.0 cm (15.4") and was located 34.3 cm (13.5") forward of the left rear axle. Six crush measurements was used to document the damage from this impact using a combined direct and induced damage width of 212.1 cm (83.5") and were as follows: C1 = 14.0 cm (5.5"), C2 = 17.0 cm (6.7"), C3 = 35.0 cm (13.8"), C4 = 39.0 cm (15.4"), C5 = 23.0 cm (9.1"), C6 = 3.0 cm (1.2"). The CDC for this impact was 09-LBEW-3.

Figure 7. Left side damage from secondary impact with the Chevrolet Express.

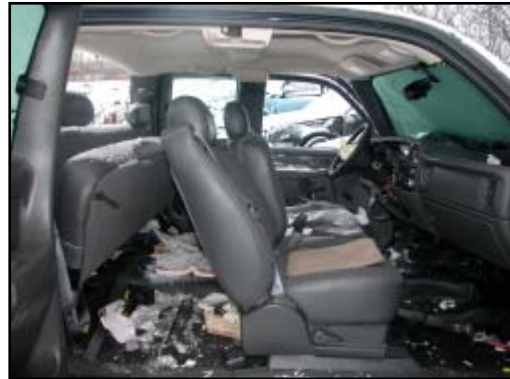
Figure 8 is an overall view of the passenger compartment. At impact with the Chevrolet Express, the driver's frontal air bag deployed. The driver initiated a forward and left trajectory in response to the 11 o'clock direction of force. The driver's abdomen loaded the safety belt, which was evidenced by loading and a light colored clothing transfer on the lap portion of the safety belt. The driver's left thigh contacted and scuffed the left door panel mounted armrest and his left knee contacted the manual window lever, which was fractured from the contact.

Figure 8. Overall view of the passenger compartment.

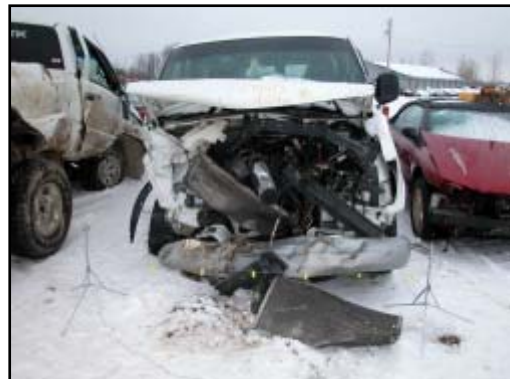
The 2002 Chevrolet Express sustained severe frontal damage as result of the frontal impact with the Silverado (**Figure 9**). The direct damage consisted of longitudinal deformation of the frontal structure and minor lateral left displacement. The direct contact damage measured 142.0 cm (56.0"), which began at the front right bumper corner and extended left. The maximum crush measured 33.0 cm (12.9") and was located at the front right bumper corner. Six crush measurements were utilized to document the crush along the front bumper using a combined direct and induced damage width of 160.0 cm (63.0") and were as follows:

Figure 9. 2002 Chevrolet Express frontal damage.

C1 = 0.0 cm, C2 = 11.0 cm (4.3"), C3 = 16.0 cm (6.3"), C4 = 29.0 cm (11.4"), C5 = 32.0 cm (12.6"), C6 = 33.0 cm (13.0"). The CDC for this impact was 01-FDEW-3.

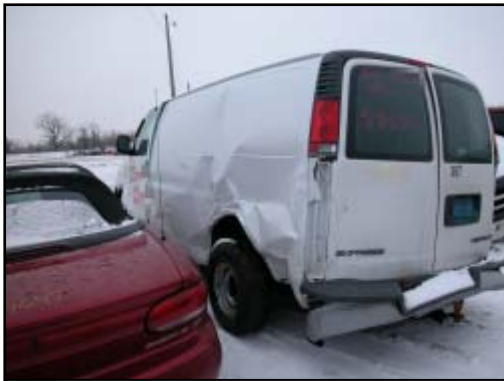
The Express sustained moderate severity damage to the left rear aspect from a subsequent impact with an unidentified vehicle (**Figure 10**). The damage consisted of longitudinal and lateral displacement of the left rear sheet metal. The direct damage from this impact measured 170.2 cm (67.0”) and was approximately 25.4 cm (10.0”) in depth. The CDC for this impact was 09-LBEW-2.

Figure 10. Damage from the impact with the unknown vehicle.

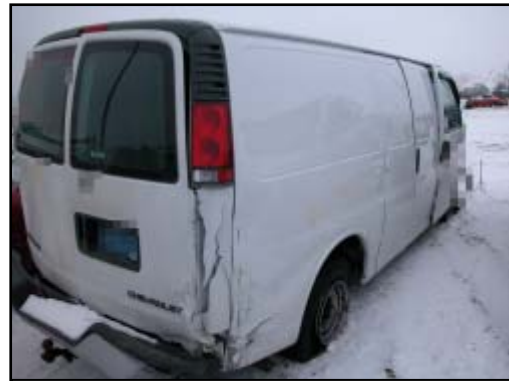
The Express sustained minor severity damage to the right rear corner as a result of the secondary impact with the Silverado (**Figure 11**). The damage consisted of lateral deformation to the right rear aspect. The direct damage measured 71.1 cm (28.0”) which began at the right rear corner and extended forward. The maximum crush measured 23.0 cm (9.1”) and was located at the right rear corner. Six equidistant crush measurements were utilized to document the damage from this impact using a combined direct and induced damage width of 73.6 cm (29.0”) and were as follows: C1 = 23.0 cm (9.1”), C2 = 11.0 cm (4.3”), C3 = 6.0 cm (2.4”), C4 = 3.0 cm (1.2”), C5 = 0.0 cm, C6 = 1.0 cm (0.4”). The CDC for this impact was 03-RBEW-2.

Figure 11. Damage from the secondary impact with the Silverado.

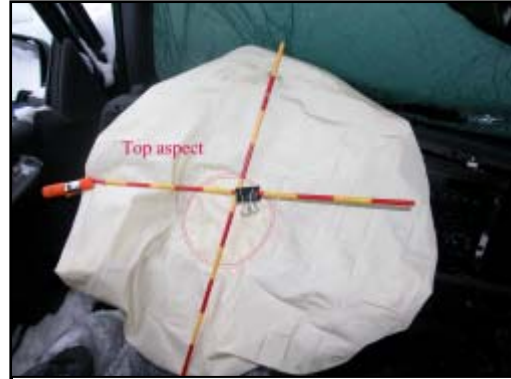
The driver's air bag was conventionally located in the center of the steering wheel hub (**Figure 12**). Two symmetrical I-configuration cover flaps concealed the air bag. Both cover flaps measured 12.0 cm (4.7") in height at the center tear seam and 8.0 cm (3.1") in width. The air bag membrane was 60.0 cm (23.6") in diameter in its deflated state and was vented by two vent ports that were located on the rear aspect of the air bag at the 11 and 1 o'clock positions. The driver's air bag was tethered by two wide band tethers at the 9 and 3 o'clock positions. There were no occupant contact points present on the air bag membrane; however, dirt transfers were present on the air bag face at the 1 o'clock position from post-crash handling of the air bag.

Figure 12. Deployed driver's frontal air bag.

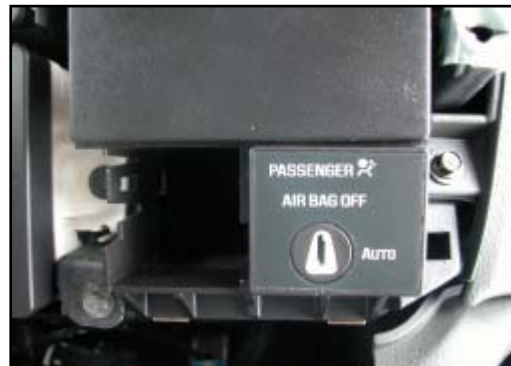
In addition to the CAC system, the Silverado was equipped with a center instrument panel-mounted cut-off switch for the front right air bag (**Figure 13**). The cut-off switch was manually operated by the driver using the vehicle ignition key. The cut-off switch could be utilized in either of two settings "Off" and "Auto". At the time of the crash, the switch was in the "Off" position. This was supported by the EDR summary data that reported the "Automatic Passenger SIR Suppression System Status" as "Air Bag Suppressed". Furthermore, the driver stated to the SCI investigator that the switch was in the "Off" position at the time of the crash.

Figure 13. Manual cut-off switch.

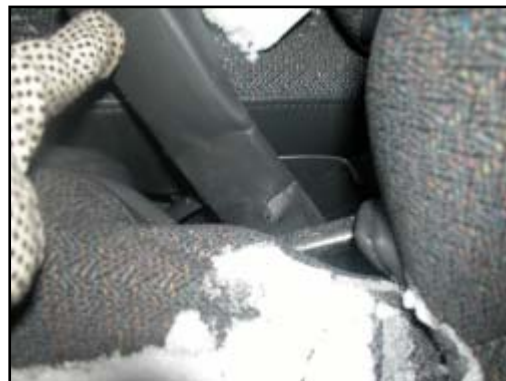
Figure 14. Damage to the driver's safety belt buckle sleeve.

buckle sleeve (**Figure 14**), which resulted from the driver loading the sleeve against the seatback bracket. Although the sleeve was cut, no failures were noted to the safety belt buckle assembly. The front right safety belt was configured with a sliding latch plate and a switchable ELR/Automatic Locking Retractor (ALR). The rear outboard safety belts were configured with sliding latch plates and switchable ELR/ALR. The front and rear center safety belts were configured with locking latch plates and no retractors.

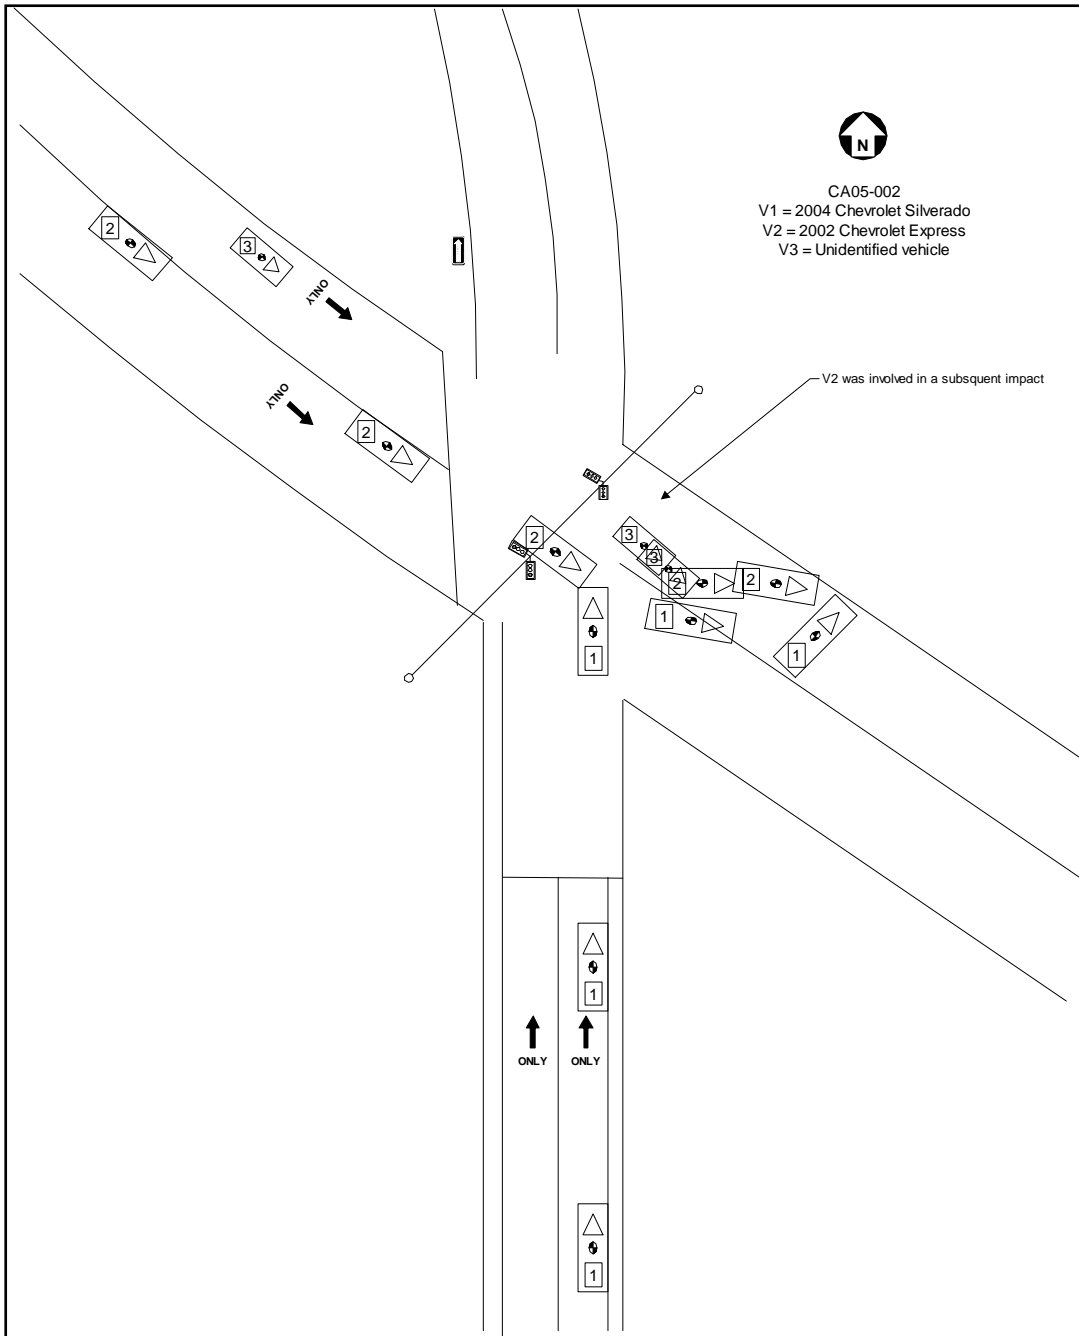
Figure 15. Scene Schematic

This intersection crash occurred during the daylight hours of December 2004. At the time of the crash, the weather was cloudy and the roadway was wet from prior precipitation. The crash occurred at a signalized intersection of two local roadways. Both roadways were one-way and were configured with two travel lanes and were bordered by concrete barrier curbs. The northbound lanes had a slight uphill grade prior to the intersection. The westbound roadway had a slight left curve prior to the intersection. Traffic flow through the intersection was controlled by a three-phase traffic signal. The posted speed limit for both roadways was 80 km/h (50 mph). The scene schematic is included as **Figure 15** of this report.
