Child Safety Seat Investigation / Vehicle to Object
Dynamic Science, Inc. / Case Number: DS05009
1996 Ford Taurus
Arizona
May/2005

1. Report No. DS05009	2. Government Accession No.		3. Recipient Catalog No.	
4. Title and Subtitle Child Safety Seat Investigation			5. Report Date April 4, 2006

This on-site investigation focused on a rearward facing infant seat that was installed in the second seat, middle position of a Ford Taurus. The Taurus was occupied by a restrained 31-year-old female driver and a 16-day-old male infant. The infant had been seated in a rear facing Graco Snug Ride infant seat with a detachable base. The base had been anchored to the case vehicle's fabric bench seat by the use of the vehicle's lap belt. This single vehicle crash was precipitated by the vehicle entering a sharp left curve and having the infant seat slide off its base. The driver reached behind her to grab the sliding infant seat, and upon doing so involuntarily steered to the right, thus resulting in a loss of control of the case vehicle. The vehicle departed the roadway to the right while in a clockwise yaw and struck a post before impacting a fence. The car then rolled three quarter turns onto

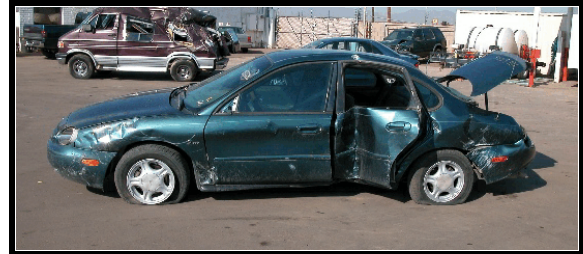
Figure 1. Left side, Ford Taurus

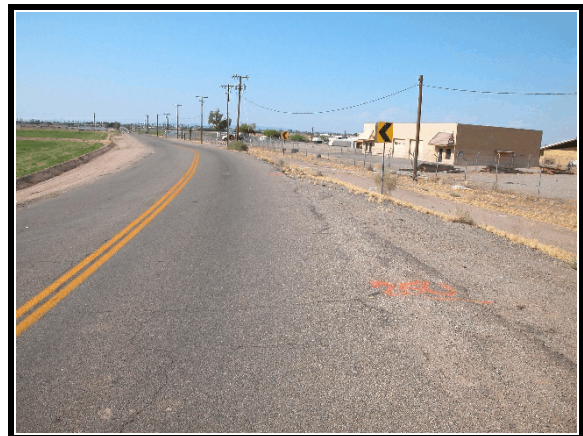
Figure 2. Approach to area of roadway departure. Approximately 63 m (200 ft) from impact area.

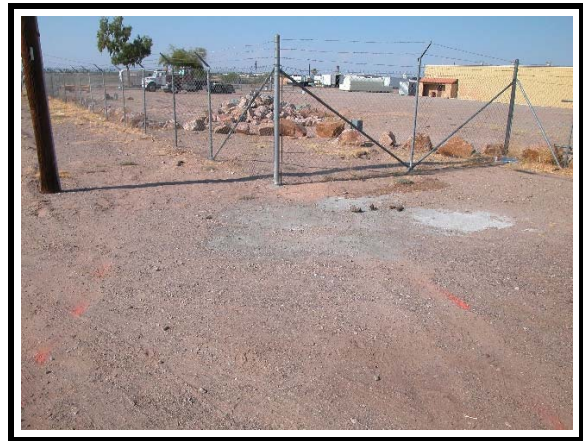
Figure 3. Area of rollover and impact with fence and pole

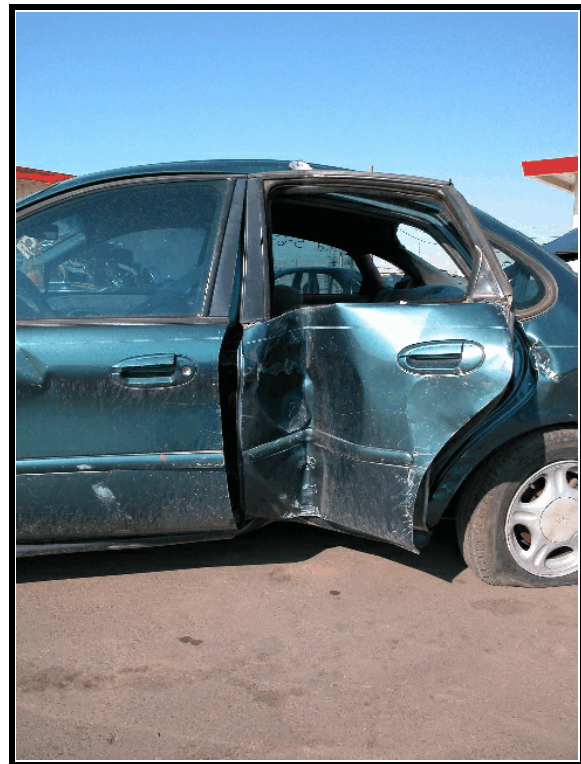
Figure 4. Pole impact to left rear door

The 1996 Ford Taurus sustained moderate damage to the left side as a result of the impact with the post. This direct damage began 44.0 cm (17.3 in) forward of the rear axle and extended for a distance of 80.0 cm (31.5 in). Four crush measurements were taken along this left side plane: C1=0 cm, C2=5.0 cm (1.9 in), C3=28.0 cm (11.0 in) and C4=0 cm. This impact occurred to the left door area, and resulted in intrusions to that vehicular component. It also resulted in disintegration of the left side glazing. The Collision Deformation Classification (CDC) for the impact with the post was 09LPAN3.

The left side was deformed by impact with the pole, which resulted in the left rear intruding inside the passenger compartment. The right rear C pillar was moved vertically a total of 2.0 cm (0.8 in).

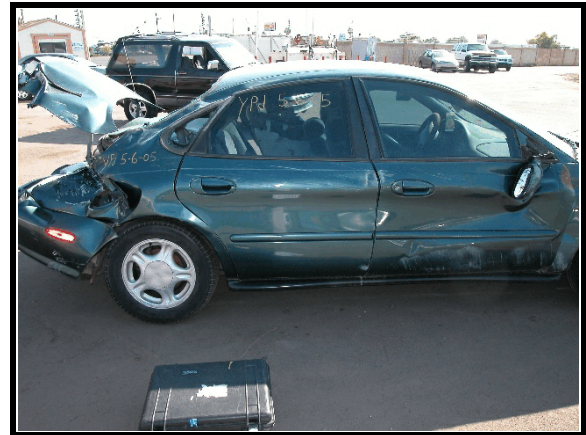
Figure 5. Right side rollover damage

The last event, that of the vehicle rolling over, encompassed the entire right side plane, which was in contact with the ground at final rest. The maximum crush from this event was sighted into the second extent zone. The windshield sustained stress fractures but there was no integrity loss through this avenue. Both the left rear windows and the backlight glazing fractured. Both the left side tires were flattened as a result of tripping during the vehicle roll; none of them were found to be defective. The CDC for the rollover was 00RDAO2.

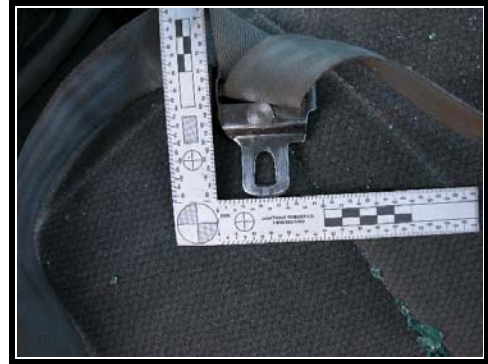
Figure 6. Lap portion of second row center seat belt.

The second row center safety belt was used to secure the occupied rear facing infant seat base. This seat belt is designed to be used as either a lap belt or a lap and shoulder belt combination. In the latter case, the belts are joined using the metal stud on the lap belt with the slot on the shoulder belt. The manual center belt has a locking latch.

The entire child seat system had been removed afterwards and was later inspected at the residence of the driver. There were no safety problems noted to the center lap belt during the inspection. The webbing showed no signs of any failures, and the latch plate and the buckle also were defect free. The metal latch plate had numerous scratches across its face which were supportive of historical usage.

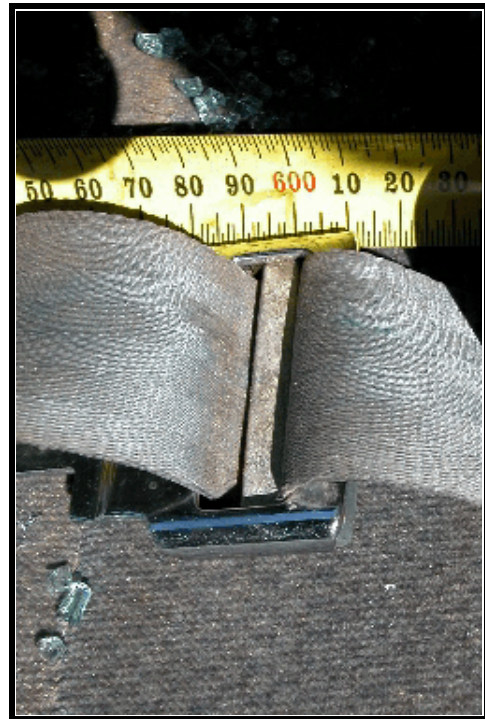
Figure 7. Back of center rear seat latch

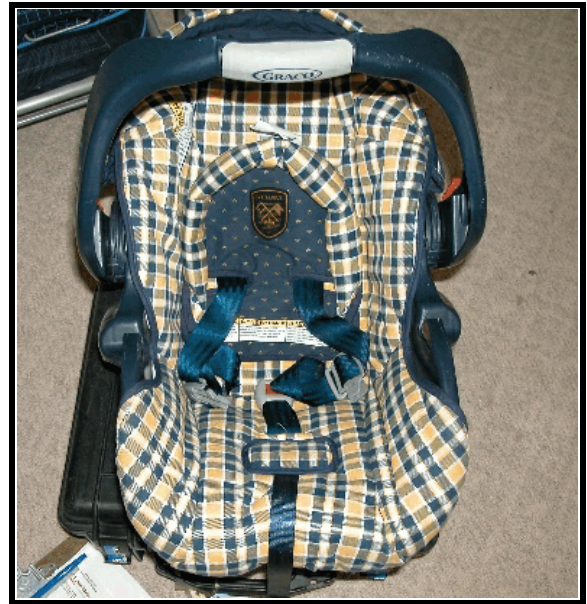
This particular crash involved a Graco SnugRide infant seat (Ivy League designer package) that was installed in the center rear seat. This infant seat, with a detachable base, had been purchased new. The date of manufacture was 11/01/04. The serial number of the seat was 8446LIVY and the model number was LAPC0074A. The infant seat was equipped with two sets of slots so that the 5-point internal harness could be raised as the child grew. At the time of the crash the webbing was in the lower slots. The retainer clip was locked into place.

Figure 8. Graco Snug Ride infant seat - forward view

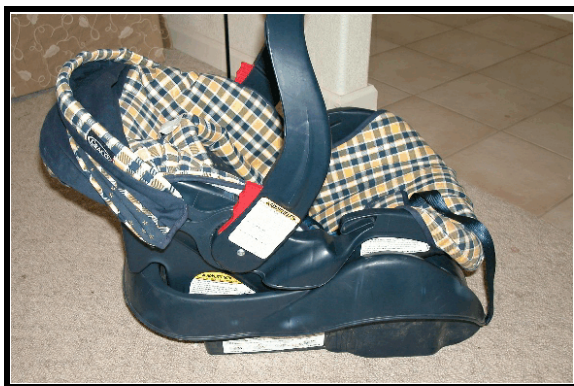
Figure 9. Graco Snug Ride infant seat - side view

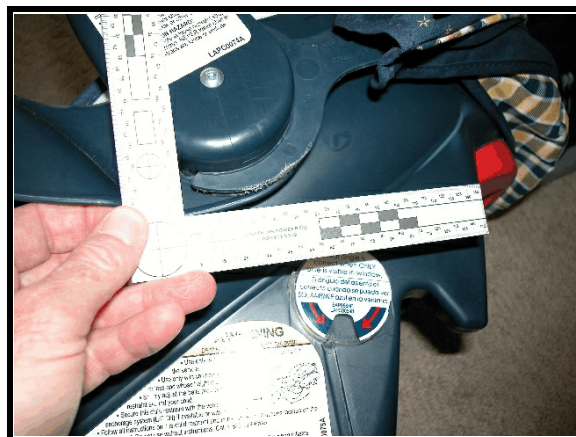
The driver indicated that she had left the base in the car, and had placed the infant seat onto the base prior to driving away. The base was anchored to the vehicle using the manual lap belt. The driver also indicated that the infant seat handle was in the full upright position. She stated that the infant seat had been properly locked into the base, but this does not appear to have been the case. The inspection of the base and the child seat itself show no failures or broken components. There was minor scuffing damage found on the top of the carrying handle and on right side of the seat.

Figure 10. Scuffs to right side of seat

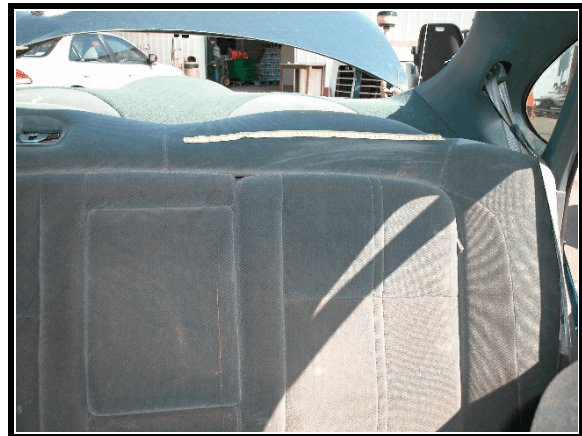
The 16-day-old male was seated in a rear facing infant seat. He was kept in the child seat by the use of the infant seat's internal 5-point harness. Prior to the crash the infant seat had likely not been locked onto the detachable base properly. During the crash sequence the child seat, with the infant still in it, was ejected through the left rear glazing (PAR in error) and came to rest in the grassy area adjoining the case vehicle. The path of ejection appears to have been from the right to the left with portions of the seat scuffing the rear seat back. The child sustained no injuries. He was transported to a local hospital as a safety precaution and examined in the emergency room; no trauma was noted.

Figure 11. Possible ejection path marks to back of rear seat
