ON-SITE CHILD SAFETY SEAT INVESTIGATION

CASE NUMBER - IN-05-014

VEHICLE - 1990 FORD THUNDERBIRD

CRASH DATE - March 2005

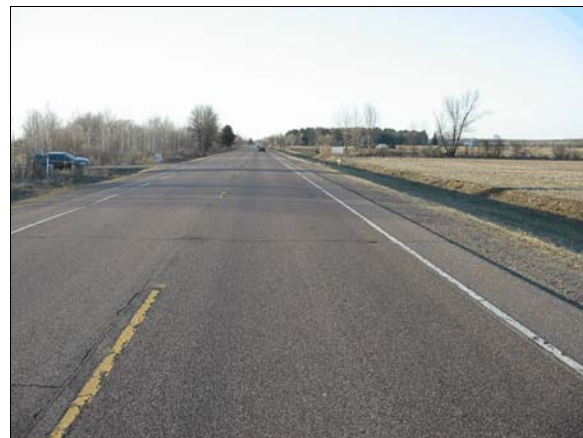
Figure 1: Approach of case vehicle northbound to driveway on left

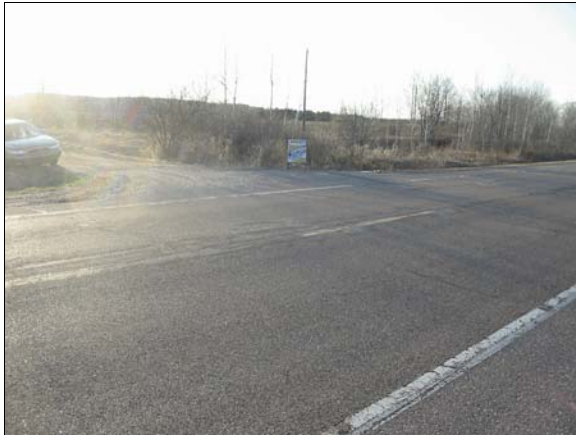
Figure 2: Overview of case vehicle's approach turning left into driveway

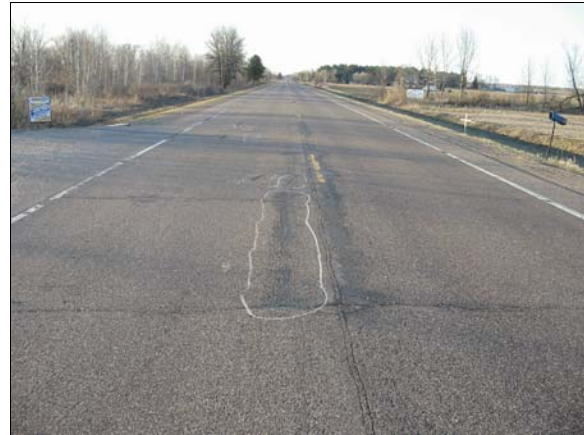
right just prior to impact. The police crash report indicated the Dodge's driver was intoxicated. The crash occurred in the southbound lane of the roadway (Figure 3).

Figure 3: Dodge's approach to impact

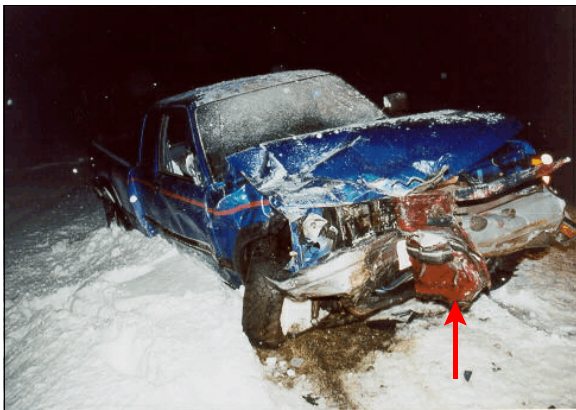
Crash: The front of the Dodge (Figure 4) impacted the left side of the case vehicle (Figure 5). The impact caused the case vehicle driver's door latch and striker to separate. The driver's door intruded into the case vehicle and was then opened as the vehicles separated from impact. The door's outer sheet metal was stuck on the Dodge's front bumper (Figure 4).

Figure 4: On-scene photo of front damage to Dodge, arrow shows outer sheet metal of case vehicle's driver door stuck to bumper

Exterior Damage: Based on the police on-scene photographs, the Dodge’s impact with the Ford involved the front of the vehicle. The front bumper and hood were directly damaged and crushed rearward. Induced damage involved the hood, right fender and right front door.

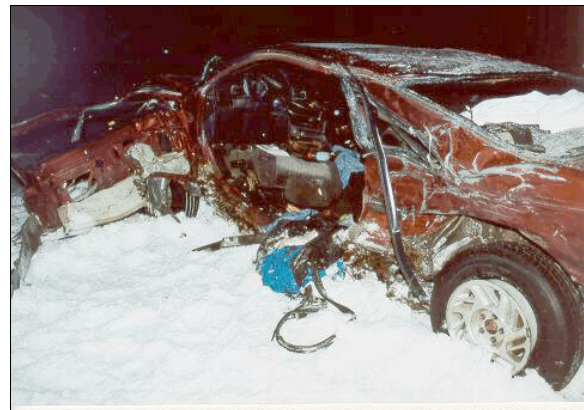
Figure 5: On-scene photo of damage to left side of case vehicle due to impact with the Dodge

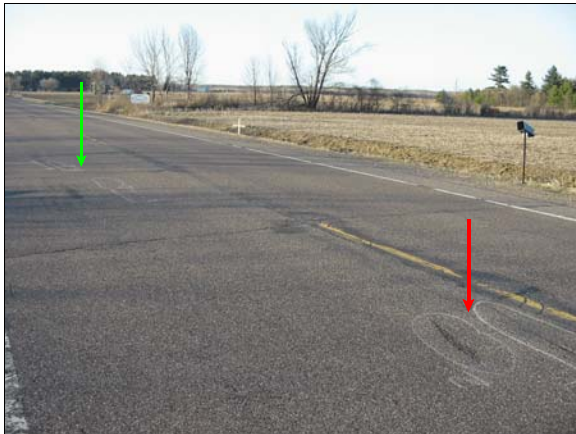
Post-Crash: The case vehicle rotated clockwise, separated from impact, departed the east side of the roadway (Figure 6 below) and slid down the front slope of a snow covered ditch. The case vehicle came to final rest at the bottom of the ditch heading slightly northwest (Figure 7 below), approximately 7 meters (23 feet) east of the roadway. The impact caused the Dodge to rotate clockwise and depart the west side of the roadway. The Dodge came to rest on the snow covered west shoulder facing southeast (Figure 8 below).

Figure 6: View to northeast to post-impact path of case vehicle and rest position of case vehicle (cross in ditch), red arrow show gouges from case vehicle, green arrow show gouges from Dodge

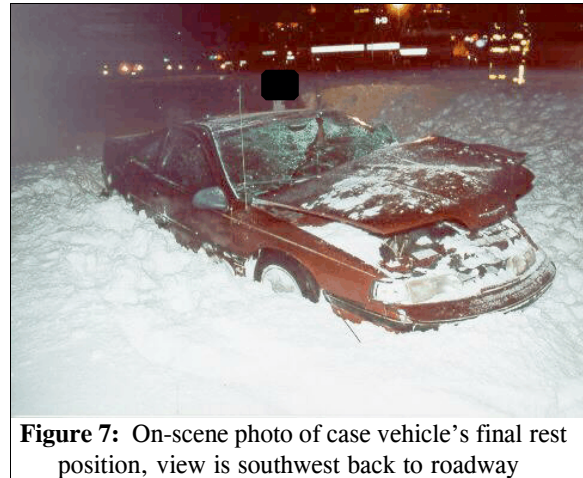
Figure 7: On-scene photo of case vehicle's final rest position, view is southwest back to roadway

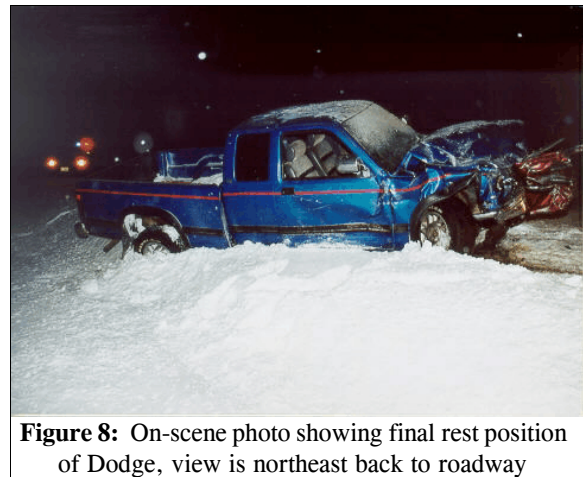
Figure 8: On-scene photo showing final rest position of Dodge, view is northeast back to roadway

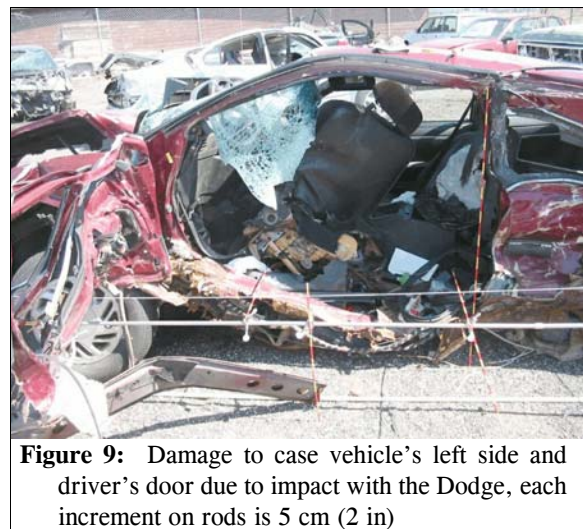
Exterior Damage: The case vehicle's contact with the Dodge involved most of the left side (**Figure 9** and **Figure 10** below). The left fender, door,

Figure 9: Damage to case vehicle's left side and driver's door due to impact with the Dodge, each increment on rods is 5 cm (2 in)

windows, quarter panel, and left rear wheel were directly damaged and crushed inward. Direct damage began 45 centimeters (17.7 inches) rear of the left front axle and extended 298 centimeters (117.3 inches) rearward along the left side. The Field-L was measured as 442 centimeters (174 inches). Residual maximum crush was measured as 67 centimeters (26.4 inches) occurring midway between C₃ and C₄. The crush measurements at C₃, C₄ and the maximum crush are estimates based on the damage to the vehicle because the left front door was pulled out and displaced forward during the crash. The table below shows the case vehicle's left side crush profile.

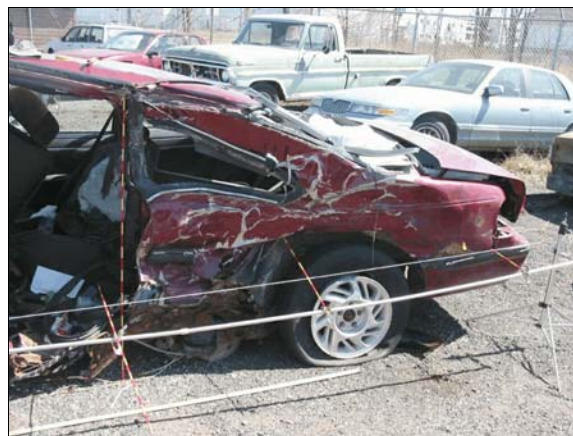
Figure 10: Damage to case vehicle's left quarter panel due to impact with the Dodge

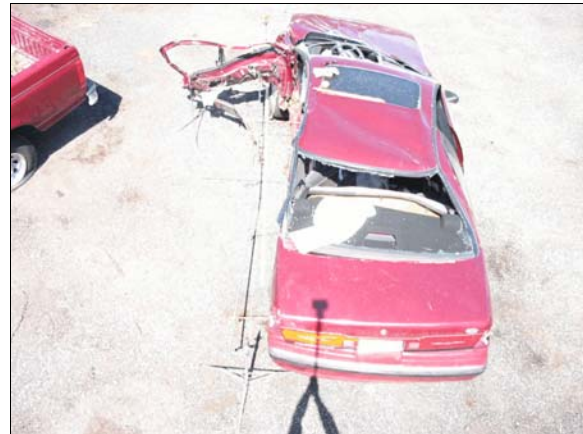
Figure 11: Top back view of damage to the case vehicle

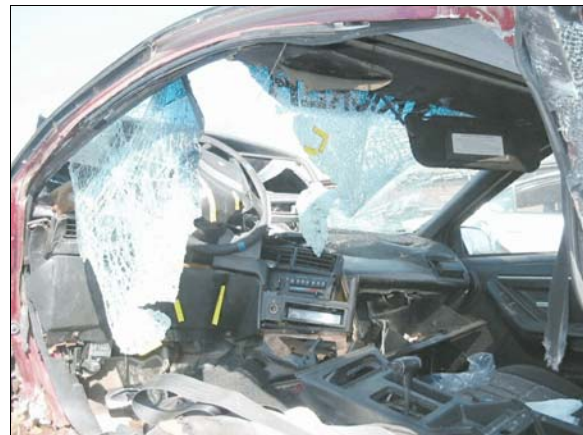
Vehicle Interior: Inspection of the case vehicle's interior (**Figure 12**) revealed significant evidence of driver contact to the steering wheel (**Figure 13**), windshield, driver's sun visor and lower instrument panel. The driver's door was forced significantly inward and forward into the driver's seat position during the crash displacing the driver's seat forward (**Figure 14** below) and forcing the driver into these components. There was also evidence of contact by the back left passenger's booster seat with the intruded left rear side panel, rear of the B-pillar (**Figure 15** below). Intrusions were found in the driver and left rear seat positions. Primary intrusion into the driver's occupant space involved the driver's door. However, the intrusion could not be measured due to the door being pulled outward and forward as the vehicles separated from the crash. In addition, the specific extent of the driver's seat back intrusion could not be determined due to the post-crash condition of the seat. The primary intrusions into the back left passenger's occupant space were 37 centimeters (14.6 inches) of lateral B-Pillar and rear side panel intrusion and 31 centimeters (12.2 inches) of lateral left rear seatback intrusion.

Figure 12: Overview of case vehicle's instrument panel, steering wheel and windshield

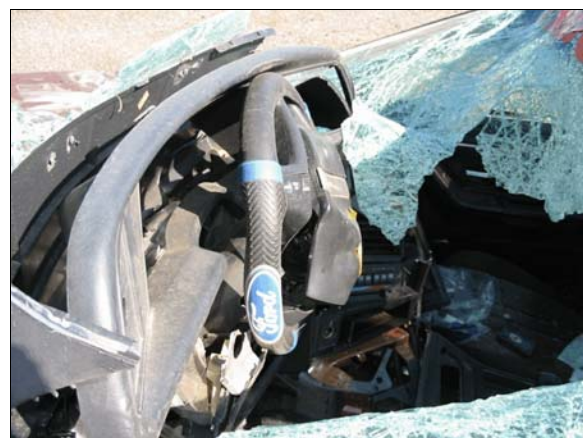
Figure 13: Left side view of deformation to the steering wheel and steering column

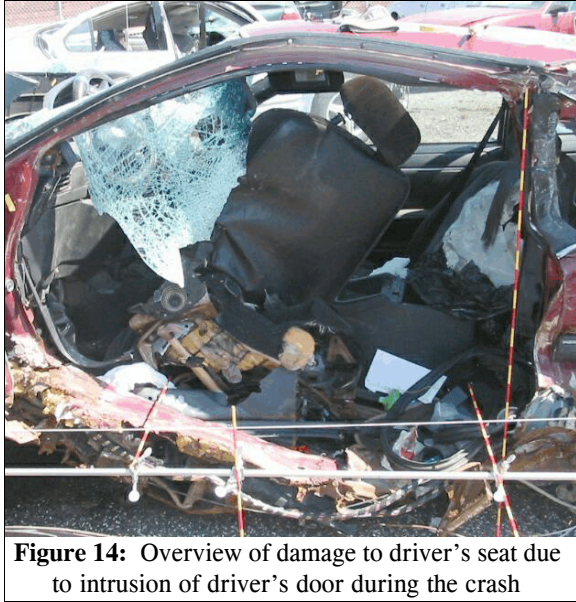
Figure 14: Overview of damage to driver's seat due to intrusion of driver's door during the crash

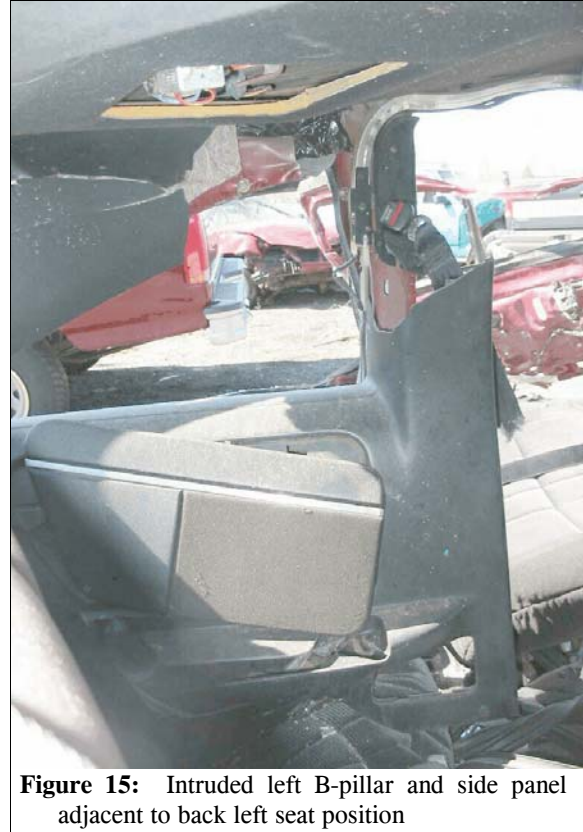
Figure 15: Intruded left B-pillar and side panel adjacent to back left seat position

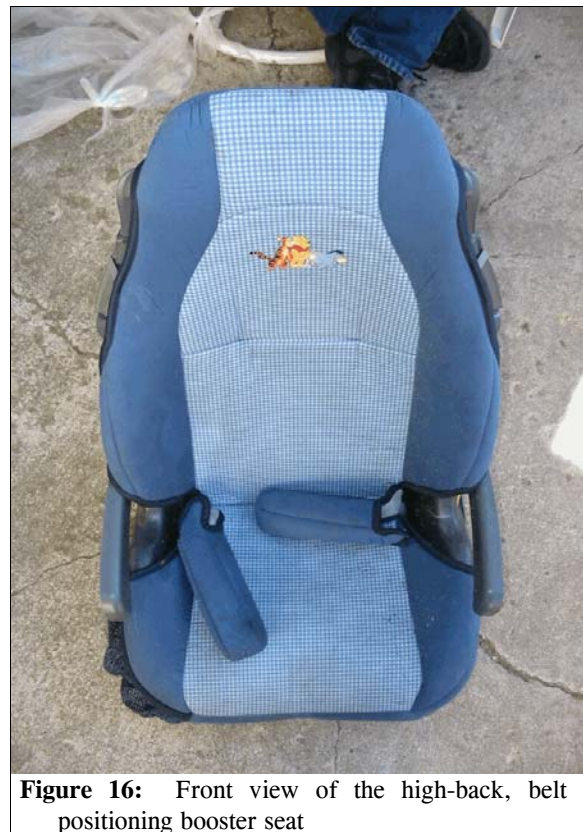
A high-back belt positioning booster seat (**Figure 16**) was used to restrain the case vehicle's back left passenger. It was positioned in the case vehicle in the forward facing orientation at the time of the crash. The booster seat was a Dorel "Vista", model number 22-920-LVP, manufactured by the Dorel Juvenile Group, Inc., on September 15, 2004. The booster seat was purchased new approximately five months before the crash and was used on a daily basis. It is not known if the driver had read the booster seat instruction manual or the case vehicle's owner manual regarding installation of child seats. The booster seat was designed without a shield, harness straps or LATCH system. It was designed to be used with the vehicle's lap-and-shoulder

Figure 16: Front view of the high-back, belt positioning booster seat

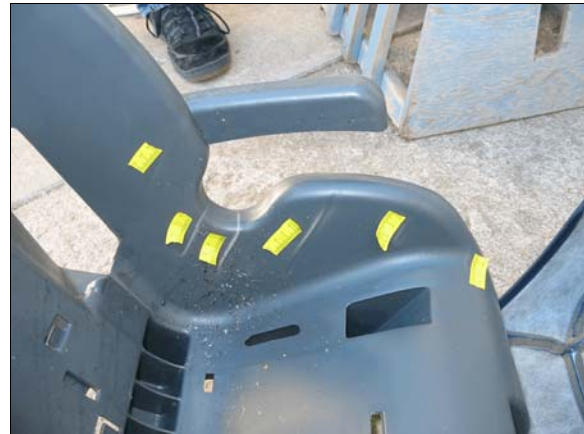
Inspection of the booster seat revealed evidence of loading to the left side (**Figure 17**) from the intruding left side panel, as well as scuffs on the left side of the booster seat (**Figure 18**) due to impact with the side panel. As the child and booster seat were moving leftward due to the impact, the side panel behind the left B-pillar was being intruded into the child seat. This, along with the restraining force of the case vehicle's lap and shoulder belt, deformed the left side of the child seat inward and resulted in white stress marks along the outside and inside of the left side of the booster seat. Abrasions were also found on the child seat's left lap belt guide (**Figure 19**) due to loading of the lap belt against the guide during the crash.

Figure 17: White stress marks in plastic shell of booster seat from deformation of the left side of seat during the crash

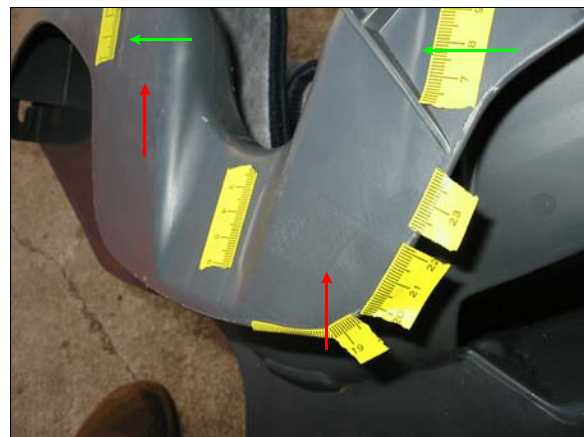
Figure 18: Scuffs and abrasions (arrows) on the left side of the booster seat due to impact with the intruding left side panel, green arrows show white stress marks in plastic

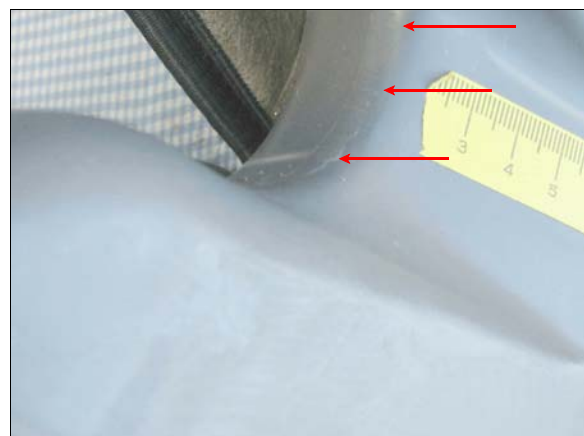
Figure 19: Arrows show safety belt abrasion in booster seat's left lap belt guide

Based on this contractor's vehicle inspection, booster seat inspection and interview data, the case vehicle's back left passenger (i.e., driver's daughter) was restrained in the booster seat by the manual, three-point, lap-and-shoulder safety belt system. There was no mention by the interviewee of belt pattern bruising and/or abrasions to the child's body, but inspection of the safety belt webbing, "D"-ring, latch plate, and the booster seat's left lap belt guide showed evidence of loading. The safety belt webbing appeared to be stretched (**Figure 21** below) and there was an abrasion on the lap belt guide (**Figure 19** above).

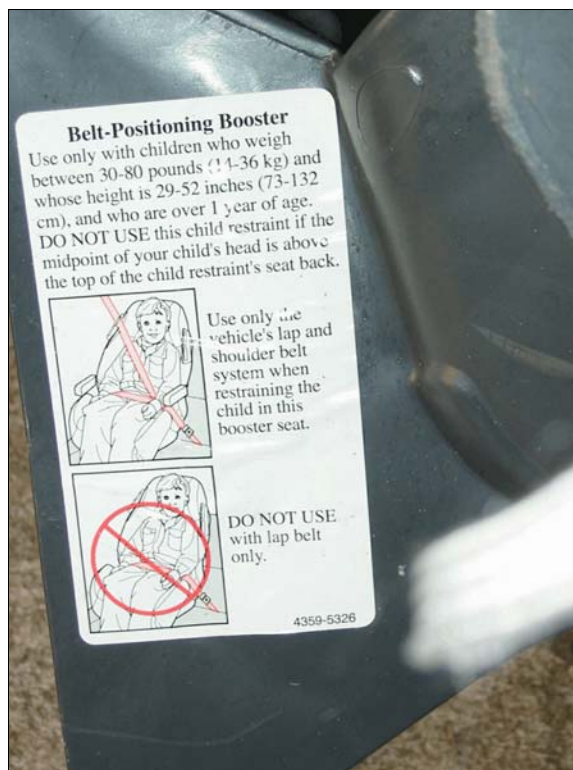
There were manufacturer's information and warning labels affixed to the right side of the booster seat giving the seat's weight, height, and age limitations in addition to illustrations depicting proper usage. The recommended weight and height range were indicated as 14 to 36 kilograms (30 to 80 pounds) and 73 to 132 centimeters (29 to 52 inches). **Figure 20** below shows the information label addressing proper booster seat usage, as well as child weight and height limitations for the seat.

Figure 20: Manufacturer's booster seat information and warning label

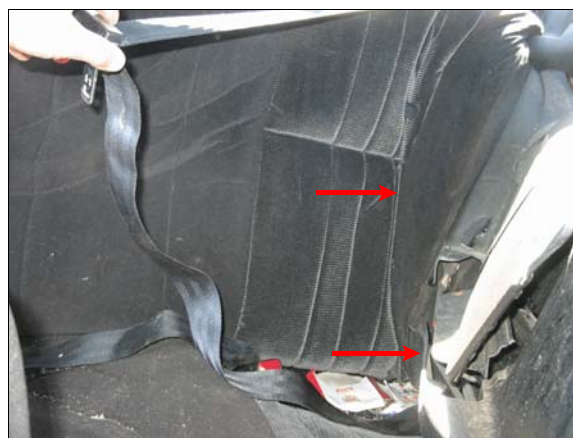
Figure 21: Case vehicle's back left safety belt appeared stretched, arrows show intrusion of seat back and left side panel rear of the B-pillar, view front to rear

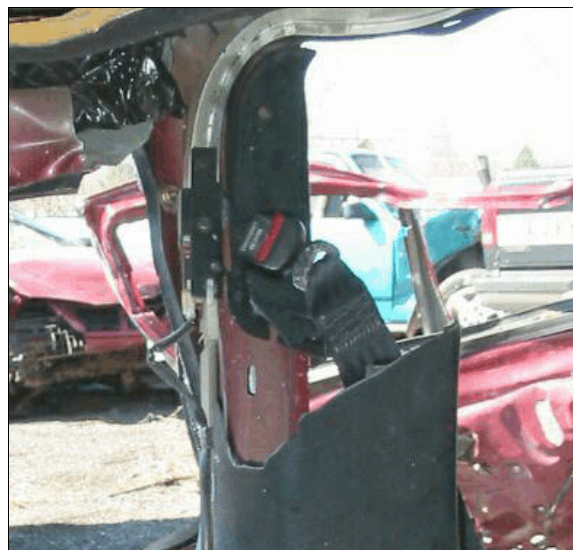
The case vehicle’s driver was restrained by her automatic, motorized, two-point shoulder safety belt. The case vehicle inspection revealed that the buckle was still retained within the lockbox on the left B-pillar and the latch plate was still buckled (**Figure 22** below). In addition, the shoulder belt webbing was broken due to loading as the driver’s door intruded and pushed the driver’s seat back and the driver forward. There was no evidence of usage of the driver’s manual lap belt.

Figure 22: Driver's buckle in B-pillar lock box, automatic shoulder belt in restrained position
