Child Safety Seat Fatality Investigation / Vehicle to Vehicle
Dynamic Science, Inc. / Case Number: DS05020
1998 Mitsubishi Eclipse
Colorado
July 2005

1. Report No. DS05020	2. Government Accession No.		3. Recipient Catalog No.	
4. Title and Subtitle Child Safety Seat Fatality Investigation			5. Report Date June 8, 2006

**Dynamic Science, Inc.
Crash Investigation
Case Number: DS05020**

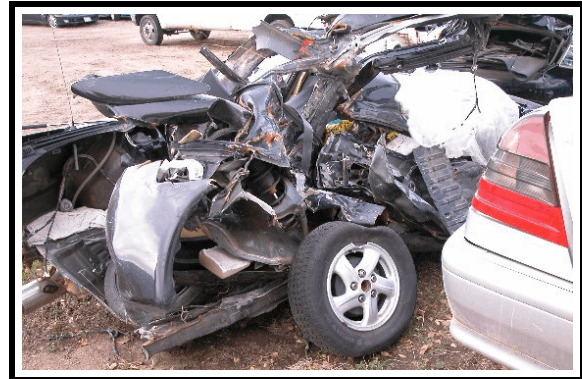
Figure 1. Right rear, 1998 Mitsubishi Eclipse

Damage Description: The 1998 Mitsubishi Eclipse sustained major right side damage as a result of the impact with the Dodge pickup. Due to the height difference between the front bumper of the Dodge Ram pickup and the sill of the Mitsubishi Eclipse, the sill was overridden and the front of the Dodge penetrated the Eclipse. The exterior damage from this initial impact began at the front right passenger's door. During the impact, the front right passenger's door, the roof, the right rear quarter panel, the trunk lid, rear bumper, and the right rear tire assembly were all torn away from the vehicle. After the initial impact, the Eclipse went into rotation and struck a metal sign post with its left front fender and then struck a chain link fence with its rear end. There was also damage to the left side that measured 24.0 cm (9.4 in) wide and was located 50.0 cm (19.7 in) forward of the rear axle. This damage was possibly related to the chain link fence impact as the vehicle penetrated the fence.

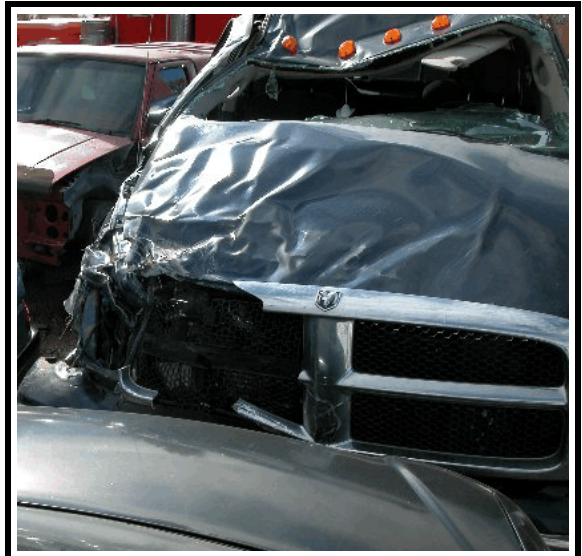
Figure 2. Front, 2004 Dodge Ram pickup

Description:	2004 Dodge Ram 3500 quad cab 4x4 pickup	
VIN:	3D7LU38C94Gxxxxxx	
Odometer:	Unknown	
Engine:	5.9 liter, six cylinder	
Reported Defects:	None noted	
Cargo:	Unknown	
Damage Description:	Extreme damage to front right, according to police report	
CDC:	Impact 1: 12FZEW1 Impact 2: 00TYDO3	
Delta V:	Total	Unknown
	Longitudinal	Unknown
	Latitudinal	Unknown
	Energy	Unknown

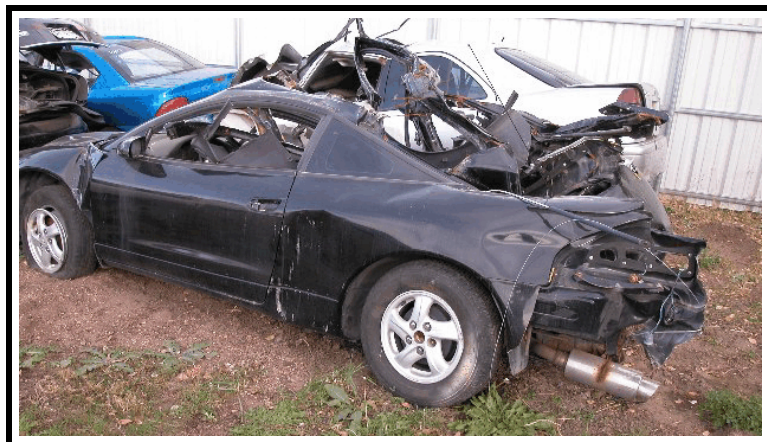
Figure 5. Left side, Mitsubishi Eclipse

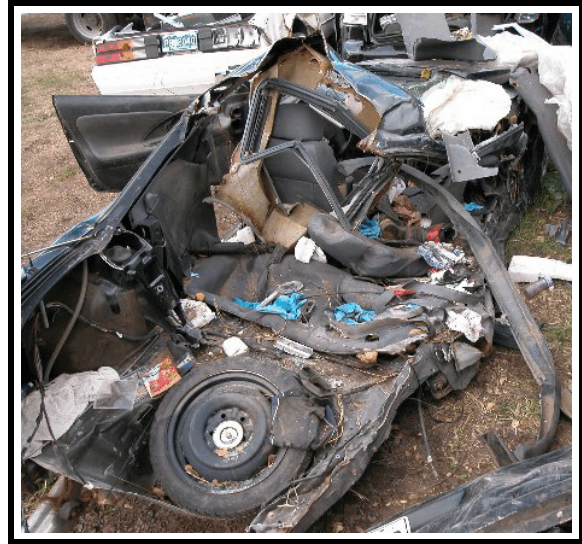
The 1998 Mitsubishi Eclipse sustained major intrusion and integrity loss as a result of the impact with the Dodge pickup. There was intrusion along the entire right side. The integral right side structure, the right door, and the roof were all torn away during the crash.

Figure 6. Overview of interior damage

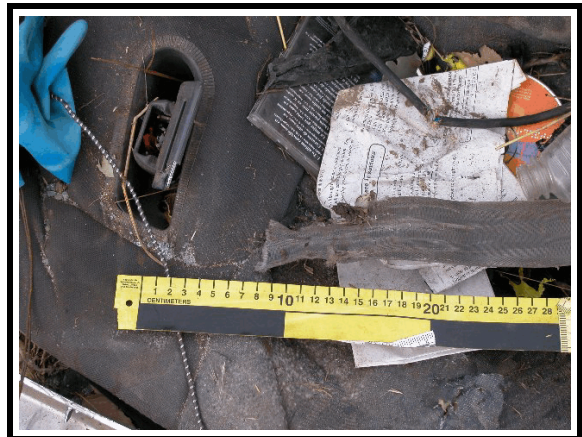
The second row right seat belt was used to anchor a forward facing child safety seat. The seat belt webbing was torn during the impact. The seat belt latchplate was still in the buckle at the time of the vehicle inspection. The child seat was ejected.

Figure 7. Second row right seat belt

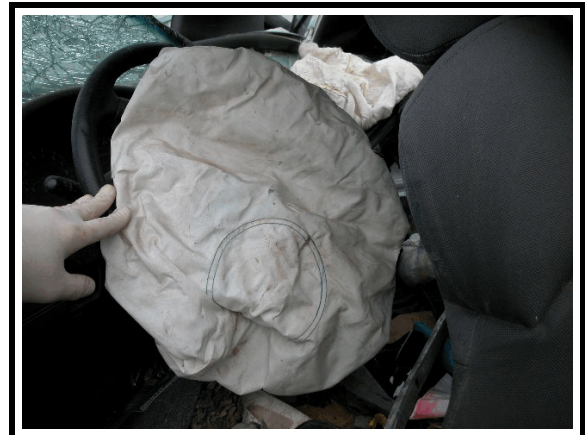
The driver's air bag deployed from the center symmetrical module cover flaps. Each flap measured 17.0 cm (6.7 in) in width and 6.5 cm (2.5 in) in height. The deployed driver's air bag measured 54.0 cm (21.2 in) in its deflated state. The air bag was equipped with two internal tethers. There were no vent ports.

Figure 8. Driver's air bag

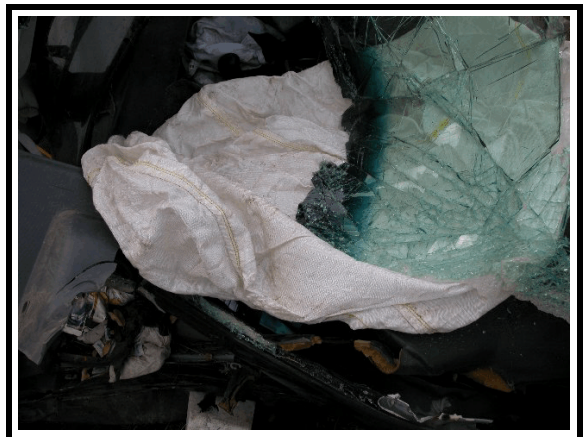
The front right passenger's air bag deployed from a top mount module with a rectangular cover flap that was hinged at the forward aspect. The module cover measured 35.0 cm (13.8 in) wide by 16.0 cm (6.3 in) high. The deployed front right passenger's air bag measured 45.0 cm (17.7 in) seam to seam and was approximately 60.0 cm (23.6 in) high and had an excursion of 64.0 cm (25.2 in) in its deflated state. There were no vent ports and no tethers.

Figure 9. Front right passenger's frontal air bag

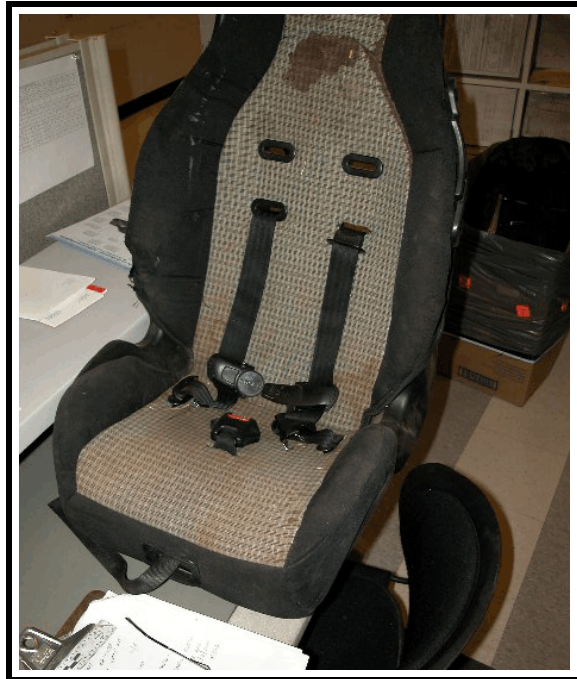
The Cosco high-back forward facing only seat was positioned in the left rear seat of the Mitsubishi Eclipse. The model number was 22-208. The date of manufacture was August 18, 2004. The seat was equipped with a five-point harness. The seat was being used in a forward facing fashion. The manufacture recommends that this child seat be used with children weighing between 9 and 18 kg (20 and 40 lbs) and who are between 74 and 102 cm (29 and 40 in) in height. The child seat harness was in the bottom slot. The seat was not anchored to the vehicle. The child was not using the child seat harness. There were no indications of stress to the child seat frame and no seatbelt loading. The locking clip was not used and was still attached to the seat. There was contact to the right side child seat back. This was caused by contact from the right rear child seat. There was blood found at the top seat back. The seat was equipped with a top tether and lower LATCH attachments which were not used.

Figure 10. Cosco high back booster seat

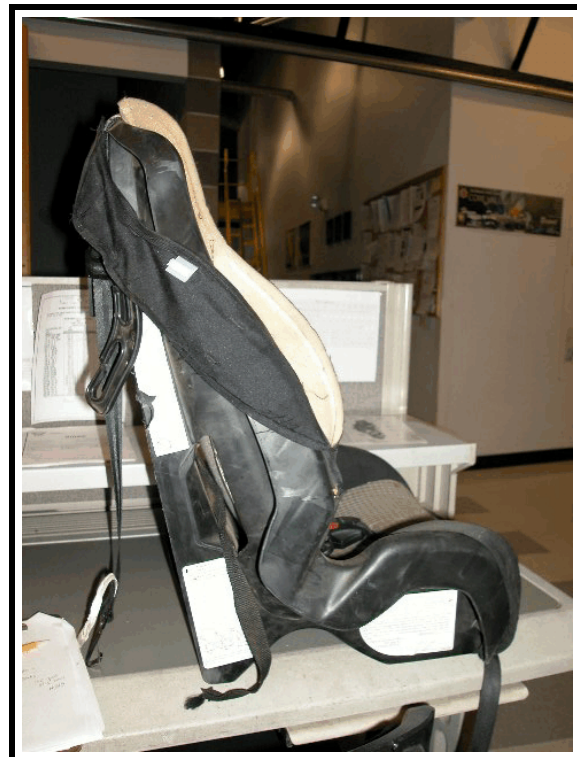
Figure 11. Cosco forward facing only seat

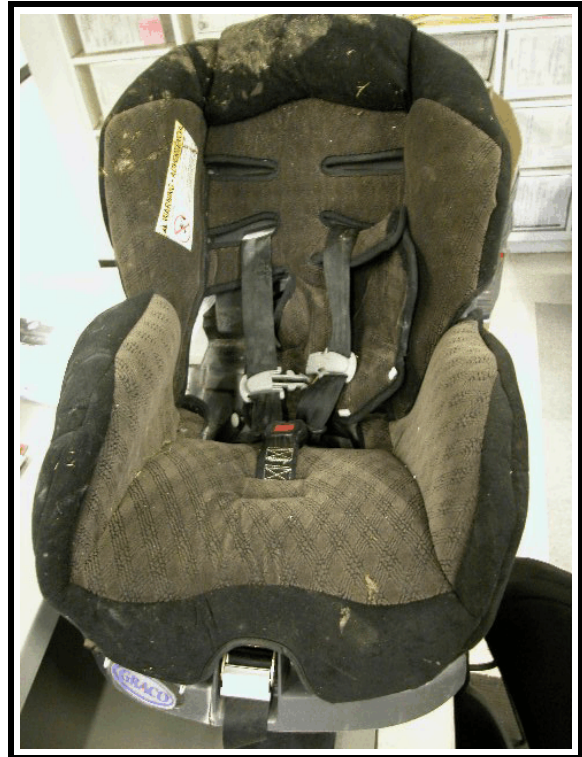
The convertible Graco ComfortSport child safety seat was positioned in the second row right seat position of the Mitsubishi Eclipse. The model number was 8639 BEU and the date of manufacture was May 9, 2005. The convertible child seat was configured with a five-point harness system and a two-piece locking harness retainer clip. The harness was threaded through the middle slot position. The chest clip was positioned 5.0 cm (1.9 in) from the harness straps latch plates. The manufacturer recommends that this convertible child seat be used rear facing for infants weighing up to 14 kg (30 pounds) and can be used forward facing for children between 9 and 18 kg (20 and 40 pounds) and up to 102 cm (40 in) tall. The manufacturer also recommends that the top of the child's ears must be below the top edge of the seat and the child's shoulders must not be above the top harness slots. The child seat was being used in the forward facing fashion. The child was belted in the child safety seat. The child seat was anchored to the vehicle using the available lap and shoulder belt. It is not know if the seat belt was in the ALR or ELR mode. There was a 3.5 cm (1.4 in) crack on the front face of the bottom of the child seat. The entire right side of the child seat base showed signs of stress and the seat was deformed. The right harness was torn 20.0 cm (7.9 in) above the latch plate. The child remained in the child seat throughout the crash. Both the child and the child seat were fully ejected from the vehicle. The seat was equipped with a top tether and lower LATCH attachments which were not used.

Figure 12. Graco ComfortSport child safety seat

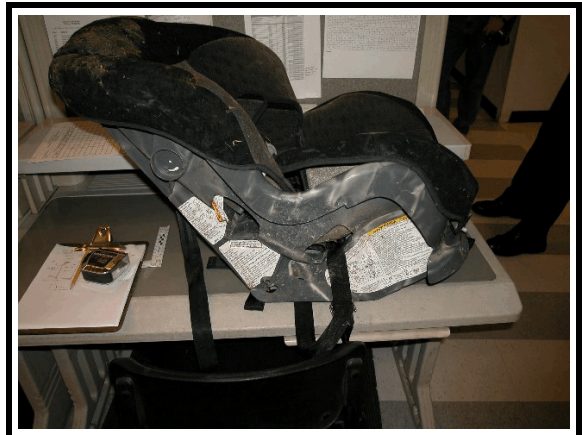
Figure 13. Deformation to the right side of the Graco child safety seat

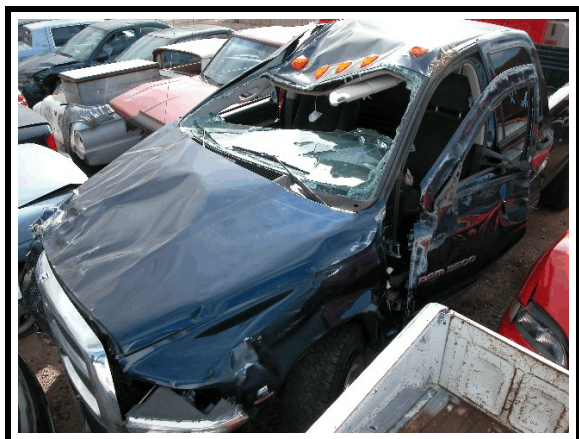
Figure 14. Rollover damage

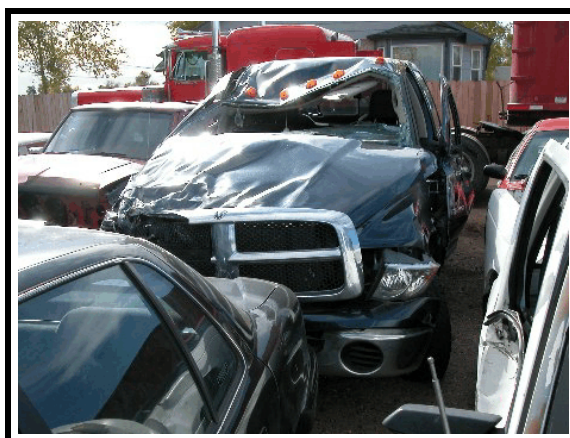
Figure 15. Front view, Dodge pickup
