## ON-SITE CERTIFIED ADVANCED 208- COMPLIANT VEHICLE INVESTIGATION

CASE NUMBER - IN-06-006

VEHICLE - 2005 CHEVROLET SILVERADO, EXTENDED CAB

CRASH DATE - March 2006

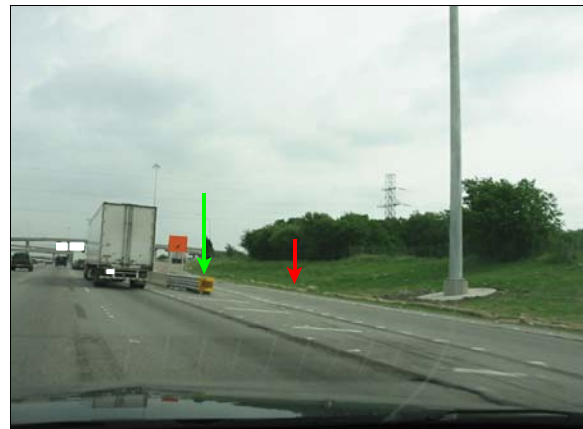
**Figure 1:** Overview of exit lane and impact attenuator at the end of the gore (green arrow), the impact attenuator has been repaired, red arrow shows police reported area of case vehicle's final rest

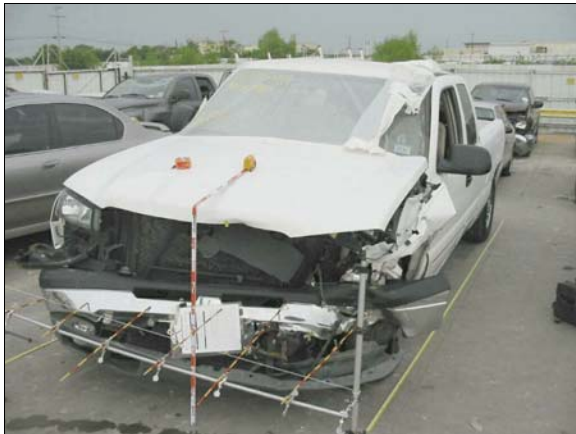
**Crash:** The front left of the case vehicle (**Figure 2** below) impacted the attenuator (**Figure 3** below) causing the case vehicle's driver and front right passenger air bags to deploy. Based on the downloaded EDR data, both stages of the dual stage air bags deployed.

**Figure 2:** Front damage from impact with the impact attenuator, each increment of tape on hood is tenth of meter, each increment on rods is 5 cm (2 in)

**Exterior Damage:** The case vehicle's impact with the impact attenuator involved the left portion of the front plane. The case vehicle's front bumper, lower bumper trim, grille, radiator, hood, left fender and left turn signal and headlamp assemblies were directly damaged and crushed rearward. Direct damage began at the left front bumper corner and extended 66 centimeters (26 inches) along the front bumper. Residual maximum crush was measured as 75 centimeters (29.5

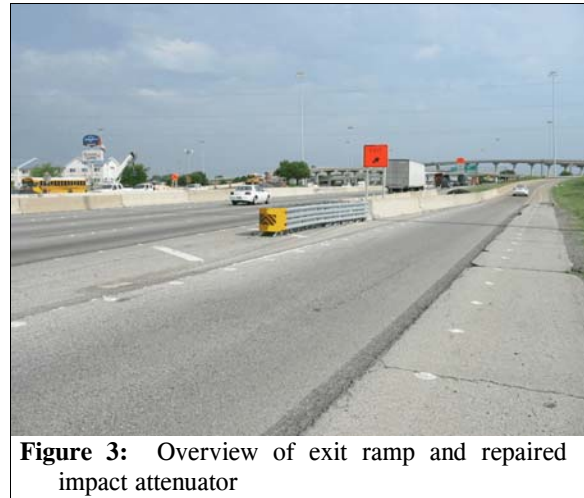
**Figure 3:** Overview of exit ramp and repaired impact attenuator

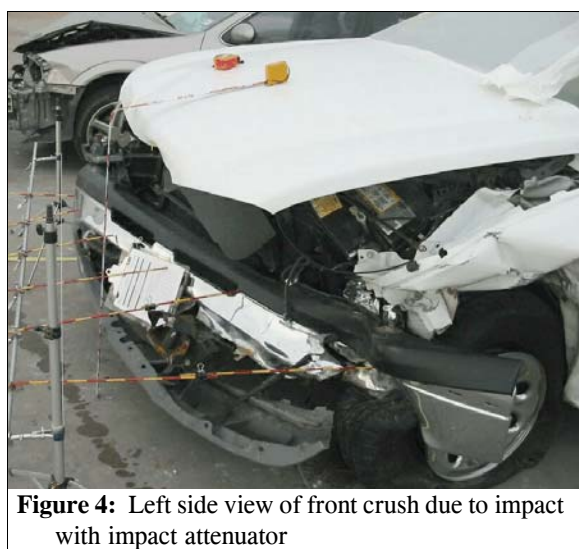
inches) occurring at C<sub>1</sub> (**Figure 4**). The case vehicle also had sideswipe-type damage to the left sill below the driver’s door (**Figure 5**). Based on the evidence and the reconstruction, this damage was determined not to be related to this crash. It did not appear associated with the crash attenuator impact because the damage was not continuous with the front damage, and the impact caused the case vehicle to rotate counterclockwise away from the attenuator. In addition, the height of the damage was not consistent with the height of the attenuator, and there were no objects in the case vehicle’s area of final rest that could have caused the damage to the left sill. The table below shows the case vehicle’s front crush profile.

**Figure 4:** Left side view of front crush due to impact with impact attenuator

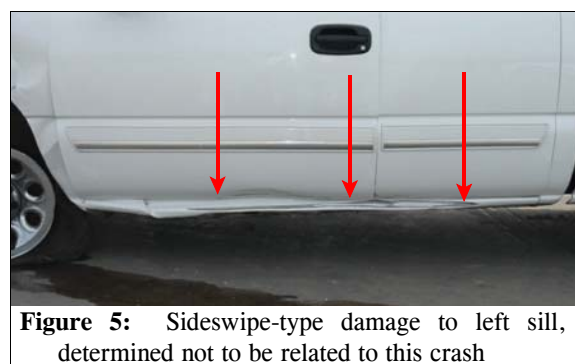
**Figure 5:** Sideswipe-type damage to left sill, determined not to be related to this crash

and a deployment event were recorded. The EDR reports for both events are presented in **Figures 17-22** at the end of this report. The EDR data indicated that the non-deployment event occurred greater than 25.4 seconds prior to the deployment event. The source of the non-deployment event may be associated with the narrow sideswipe-type damage on the sill below the driver's door. The evidence indicated that the sideswipe damage was most likely not associated with this crash.

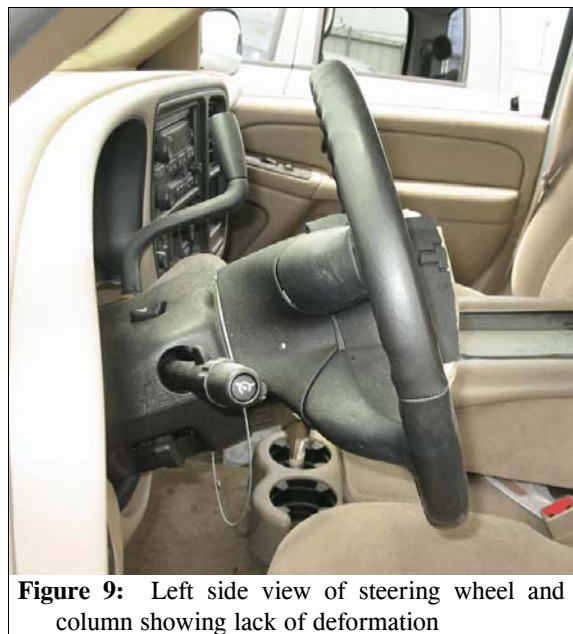
**Vehicle Interior:** Inspection of the case vehicle’s interior (Figures 6, 7 and Figure 8 below) revealed some light occupant contact marks to the back of the driver’s seat due to contact by the back left passenger. The driver also stated in the interview that the left rear passenger contacted the back of his seat back during the crash. One passenger compartment intrusion was documented. The driver’s toe pan intruded longitudinally 10 centimeters (3.9 inches). Lastly, no evidence of deformation of the steering wheel or compression of the energy absorbing steering column was observed (Figure 9 below).

**Figure 9:** Left side view of steering wheel and column showing lack of deformation

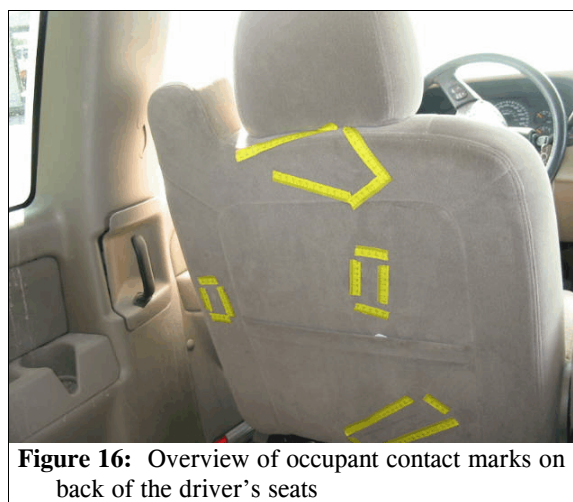
As the driver attempted to steer the case vehicle left and back onto the expressway, the back left passenger most likely moved slightly to his right. The impact to the impact attenuator caused the back left passenger to move forward along a path opposite the case vehicle's 0 degree direction of principal force as the vehicle decelerated. He impacted the back of the driver's seat (**Figure 16**) causing a small laceration on top of his head near his forehead and a neck strain. As the case vehicle rotated counterclockwise, he most likely moved to the right and may have moved out of his seat position. His final rest position within the vehicle is not known. He was able to exit the case vehicle with some assistance. The back left passenger's non-use of his safety belt system exposed him to impact with the back of the driver's seat.

**Figure 16:** Overview of occupant contact marks on back of the driver's seats

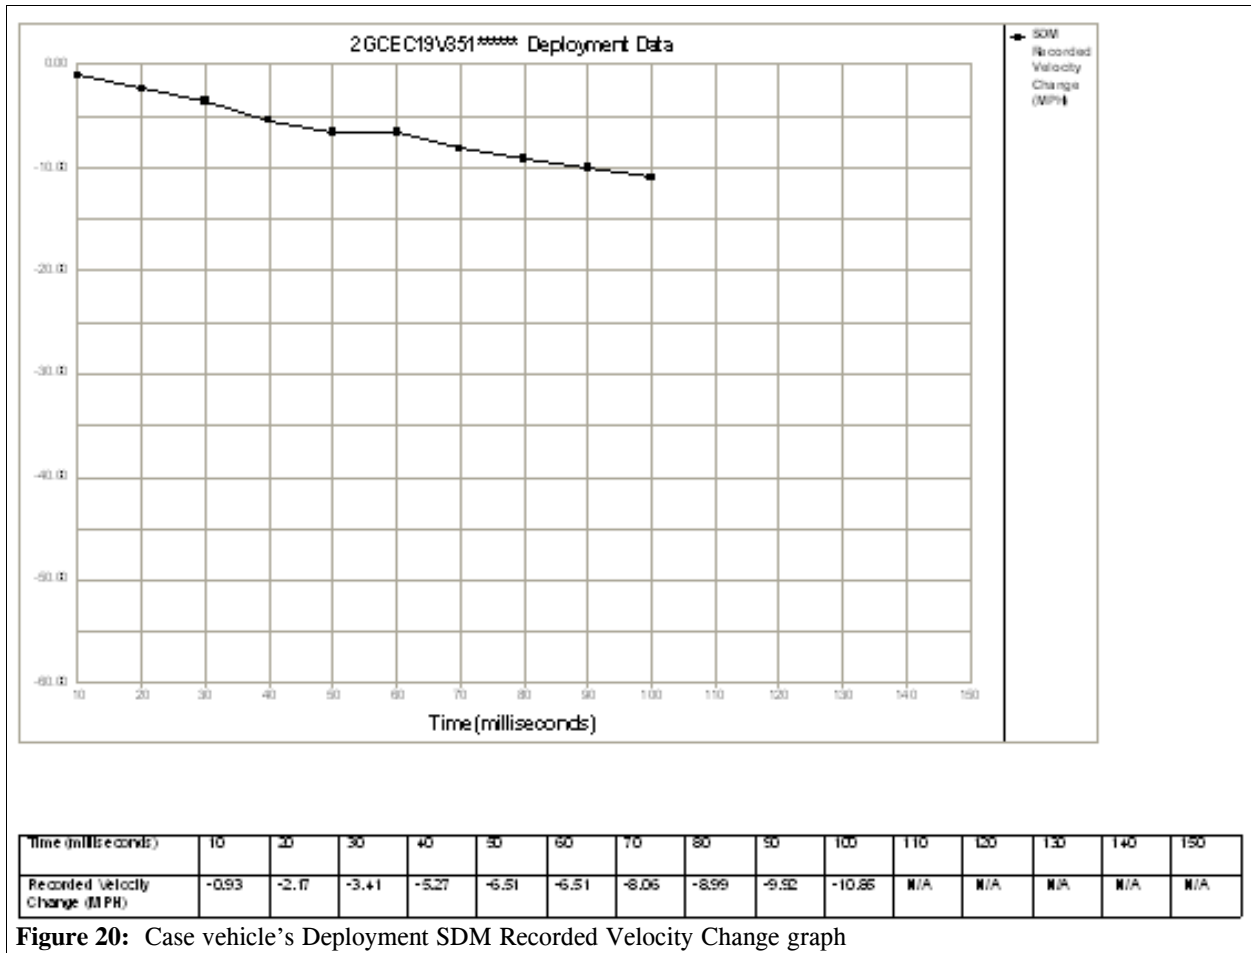
Figure 20: Case vehicle's Deployment SDM Recorded Velocity Change graph

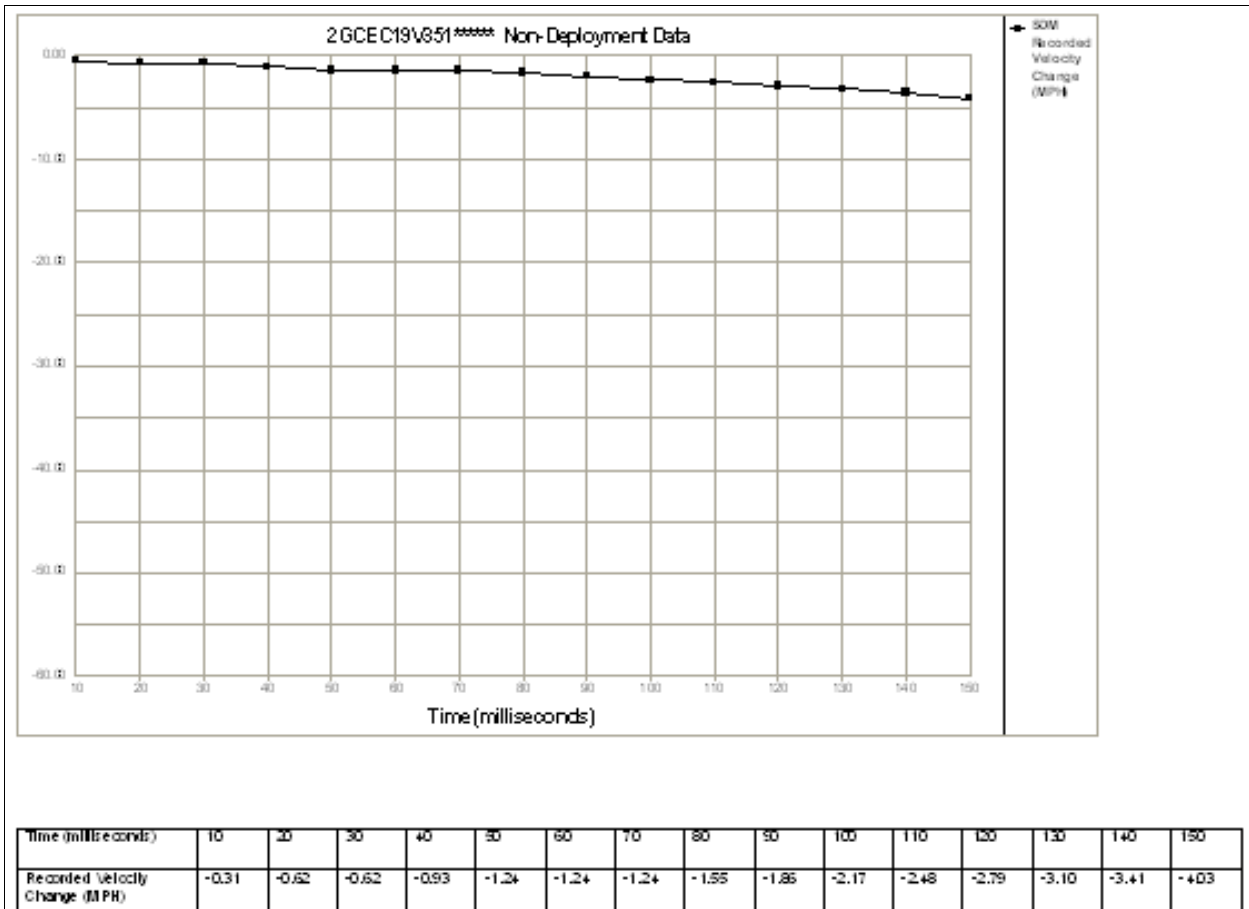
Figure 22: Case vehicle's Non-Deployment SDM Recorded Velocity Change graph
