SCI/NASS COMBINATION SIDE AIR BAG NON-DEPLOYMENT INVESTIGATION

CASE NUMBER - 2007-11-162K

VEHICLE - 2001 FORD TAURUS SE

CRASH DATE - October 2007

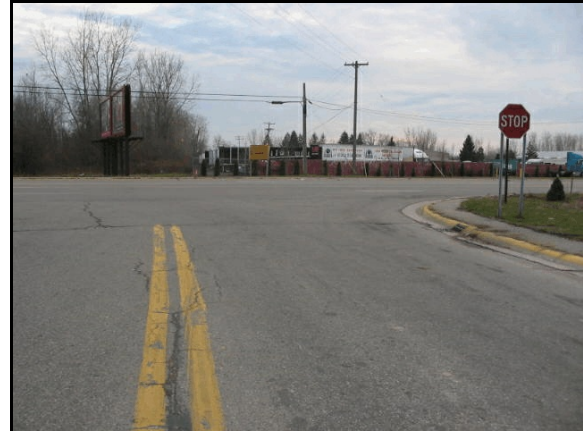
Pre-Crash: The Ford had been traveling south in the southbound lane of the local road, approaching the three-leg intersection, and the driver had stopped at the stop sign with the intention of turning left to travel eastward on the highway (**Figure 1**). The Dodge was traveling west in the outside westbound lane on the highway, approaching the three-leg intersection and intending to pass through the intersection and continue west (**Figure 2**). Starting from a stop, the Ford began the intended left turn, entering the intersection across Dodge's path. The Dodge's driver observed the Ford and braked without lockup. There was no evidence that the Ford's driver attempted any avoidance maneuver.

Figure 1: Ford's southbound approach toward stop and intended left turn

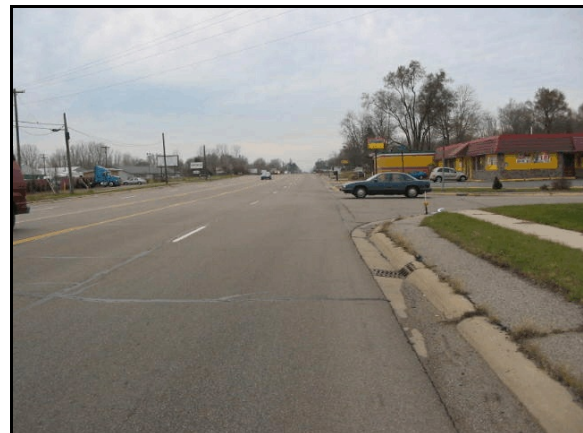
Figure 2: Dodge's westbound approach

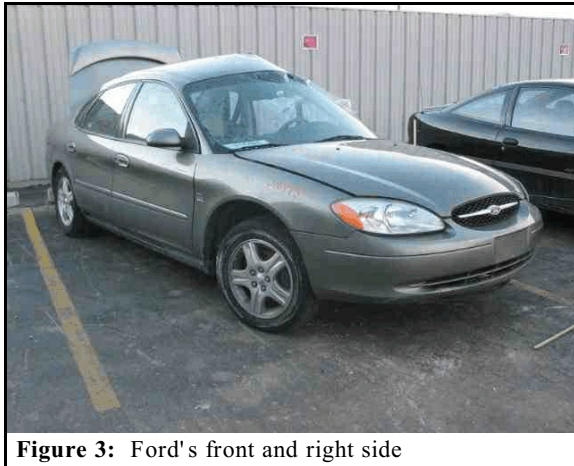
**Figure 3:** Ford's front and right side

Exterior Damage: The Ford's first impact involved direct contact to all structures below the belt line on the two left side doors, extending from the left A-pillar to the left C-pillar (**Figures 3 - 6**). The two doors, the B-pillar and the sill were crushed laterally. This direct contact damage caused the two door window frames to deform outward. There was also induced displacement of the roof side rail, buckling of the roof and minor damage on the left quarter panel. The two left side doors were jammed shut. The glazing in the two left door windows disintegrated and the windshield was cracked along its junction with the left A-pillar and the header. The wheelbase was shortened by 4 centimeters (1.6 inches) on the left and lengthened by 9 centimeters (3.5 inches) on the right. The crush profile was measured along the sill (**Figure 4**), with maximum crush identified as 49 centimeters (19.3 inches) at C3, near the junction of the B-pillar and the door sill.

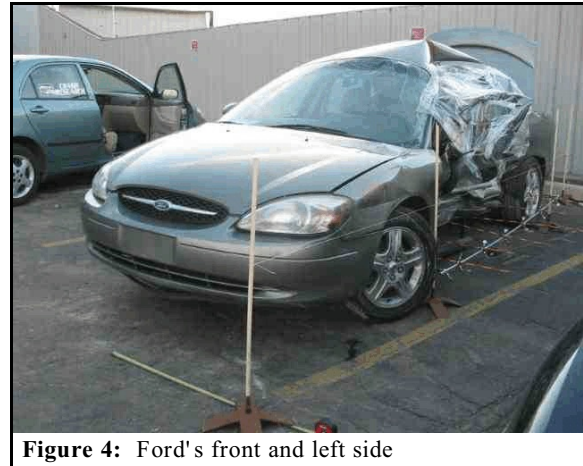
**Figure 4:** Ford's front and left side

The Ford also sustained minor side slap damage on the left fender (**Figure 4**). This consisted of denting and scraping on the fender, with maximum crush measured as 6 centimeters (2.4 inches) at C3, directly above the front left axle.

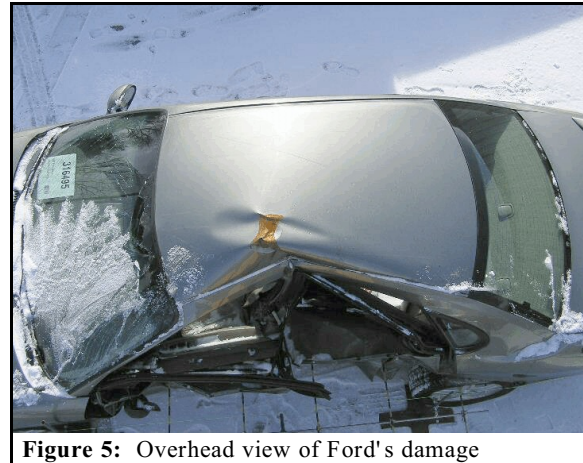
**Figure 5:** Overhead view of Ford's damage

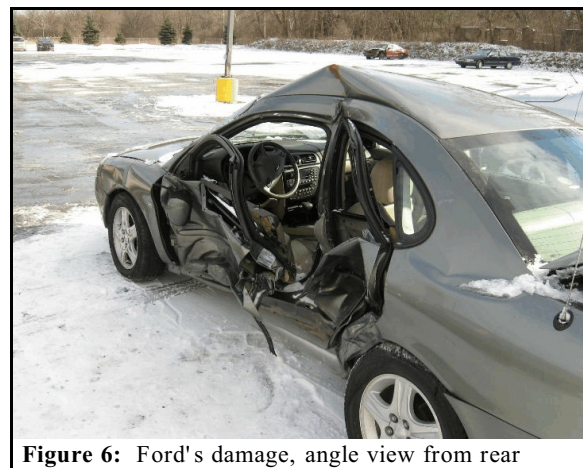
**Figure 6:** Ford's damage, angle view from rear

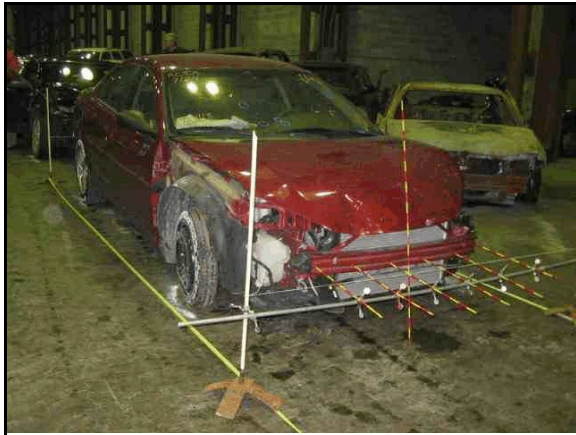
Exterior Damage: The Dodge was under repair at the time of the inspection and both fenders, the front bumper cover and the grille with both headlamp/turn signal assemblies had been removed (**Figures 7 and 8**). The right front tire had been removed and a compact temporary spare tire and rim were mounted on the right front wheel.

Figure 7: Dodge's front and right side

The Dodge sustained direct contact across its entire front from event #1 (**Figures 7 and 8**). The steel bumper was crushed rearward against the radiator, with both bumper support brackets slightly deformed. The engine hood was crushed downward and rearward at its front and buckled upward across its center. The front bumper was removed thereby inhibiting a more thorough inspection. The crush profile for the first event was measured along the steel bumper.

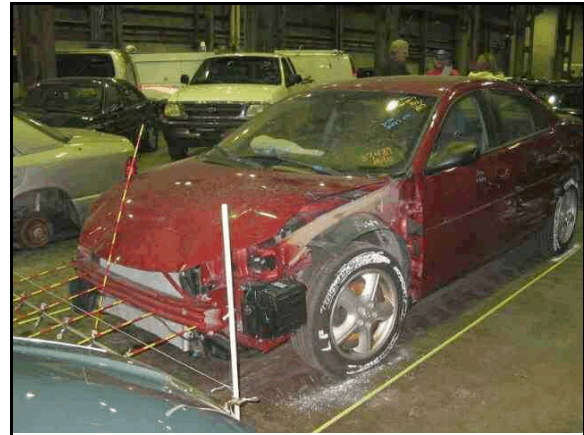
Figure 8: Dodge's front and left side

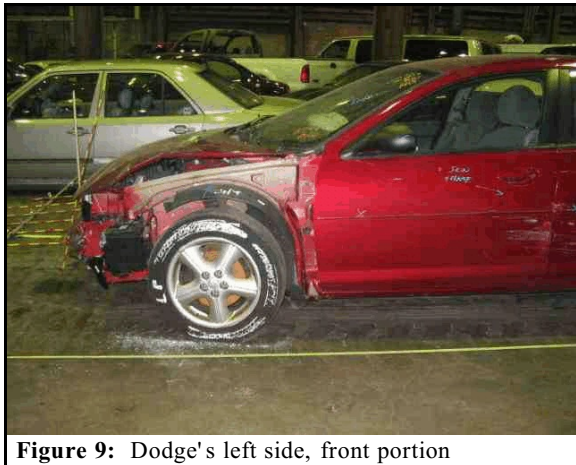
Figure 9: Dodge's left side, front portion

The Dodge also sustained direct contact on its left side, extending from approximately the rearward portion of the driver's door to the left tail light area, from the event #2 side slap impact (**Figures 9 and 10**). This was a minor event that caused surface abrading and minor denting, with maximum crush measured as 3 centimeters (1.2 inches) at C5, approximately the middle of the left back door. The crush profile for the second event was measured at the mid-door level.

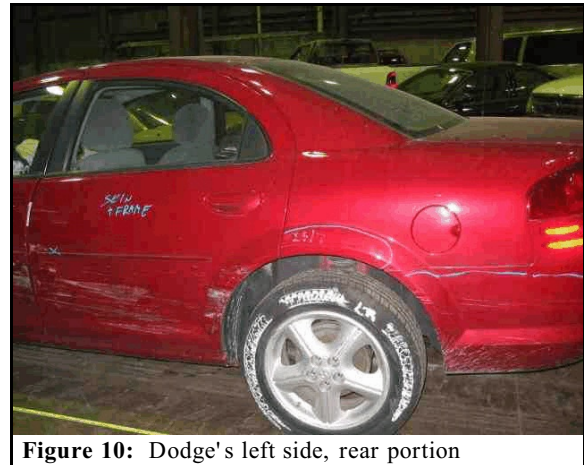
Figure 10: Dodge's left side, rear portion
