On-Site Rollover / Child Safety Seat Investigation
Dynamic Science, Inc. (DSI), Case Number (DS08005)
2003 Mercedes-Benz ML500
Oregon
January 2008

1. Report No. DS08005		2. Government Accession No.		3. Recipient Catalog No.	
4. Title and Subtitle Rollover/Child Safety Seat Investigation				5. Report Date April 24, 2008

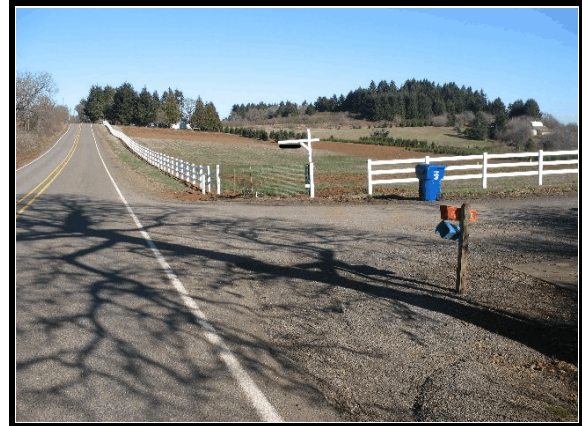
The Mercedes traversed the driveway and struck the plastic fence with its left side. The Mercedes then tripped with its left side leading and began to overturn. The left side tires likely dropped into the sinkhole which caused the tripping motion. The Mercedes rolled over two quarter turns and came to rest on its roof in the sinkhole in a nose down configuration.

Figure 3. Area of impact with fence and rollover

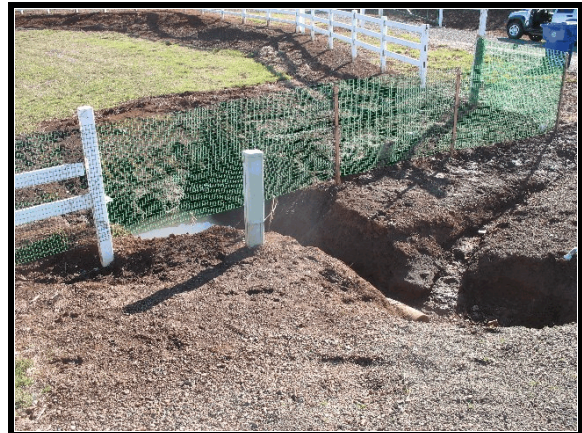
irregularly shaped sink hole that was perpendicular to the roadway and extended beyond the fence to the east. The sink hole contained running water.

Figure 4. Side view of sink hole (east)

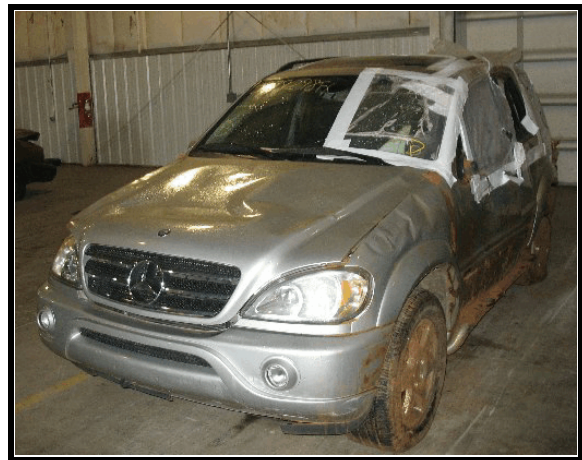
The 2003 Mercedes-Benz ML500 sustained minor left side damage from the impact with the fence and the rollover. There was 420.0 cm (165.3 in) of direct contact to the left side of the vehicle. The maximum crush to the side was located at the driver's door and measured 3.0 cm (1.2 in). The contact evidence from the fence impact was largely masked by the rollover damage. There were three patches of white transfer evidence located on the left side of the vehicle (at the left rear door panel, left front door panel, and left lower corner of the front bumper). There were also white transfers found on the left upper portion of the tailgate and along the left front bumper. The rear bumper fascia was torn from the vehicle. A Collision Deformation Classification (CDC) for the impact with the fence was 11LDEW1. There was caked mud found on both left side tires. The left rear tire was de-beaded. The damage to the top of the vehicle measured 152.0 cm (59.8 in) laterally. The maximum crush was located at the left A pillar and measured 2.0 cm (0.8 in). There was light contact along the left edge of the hood, along the right edge of the hood, along the right A pillar, and along the right roof rail. The left upper portion of the windshield was cracked. The CDC for the top damage was 00TDYO2.

Figure 5. Front left side damage

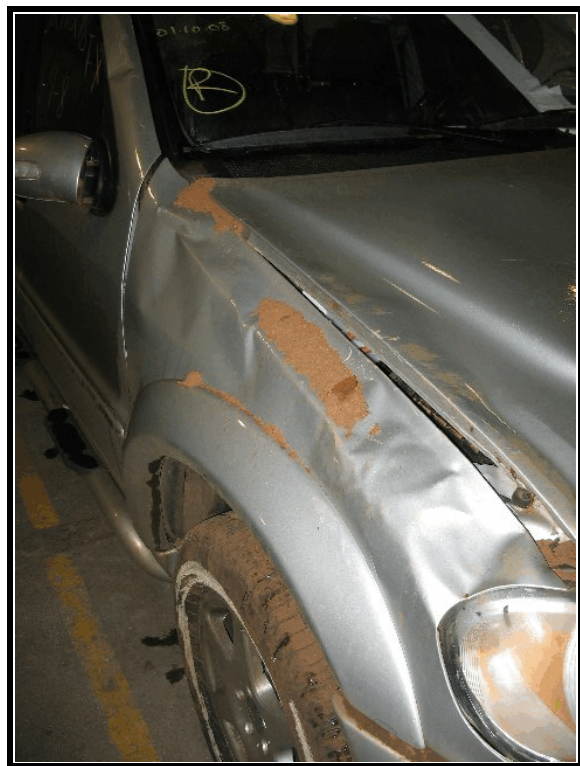
Figure 6. Right front/top damage

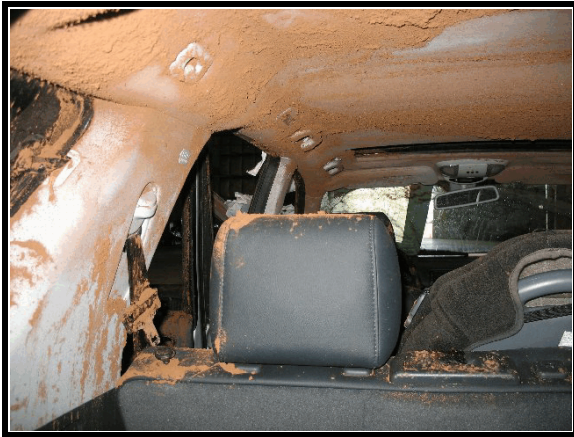
The 2003 Mercedes-Benz ML500 sustained moderate interior damage from the water and mud. All the doors remained closed and operational. All the glazing on the left side was disintegrated with the exception of the rear most glazing. The tailgate glazing was also disintegrated. There was 4.0 cm (1.6 in) of intrusion at the sill level on the left side.

Figure 7. Overview of water/mud damage

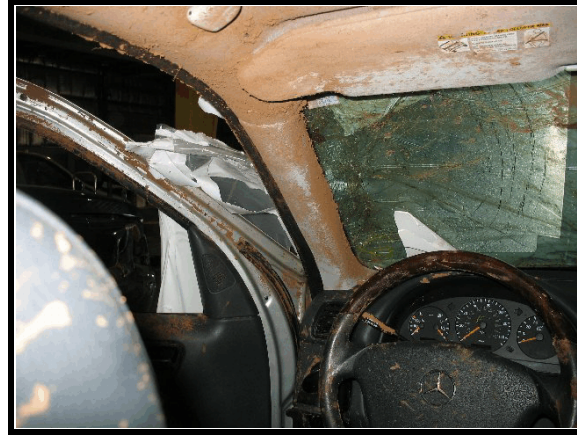
Figure 8. Windshield damage

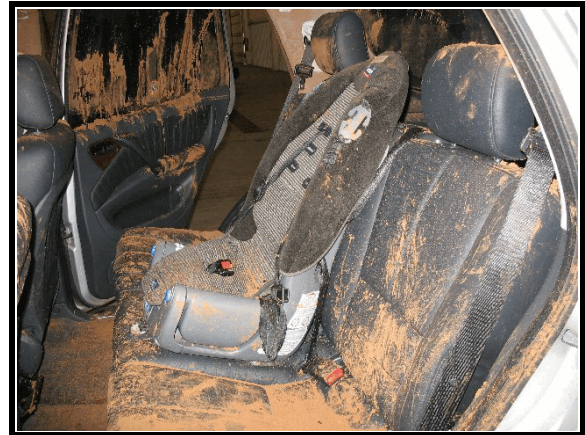
The child seat was installed in a forward facing configuration and anchored to the vehicle using the Mercedes' 3-point manual lap and shoulder belt. The father of the child had installed the CSS several months earlier. The safety belt was found to be in the ALR mode and the seat was secured inside the vehicle. There was approximately 5.0 cm (1.9 in) movement in the forward direction and approximately 7.0 cm (2.8 in) movement laterally.

Figure 9. Century Next Step child seat as located in the vehicle

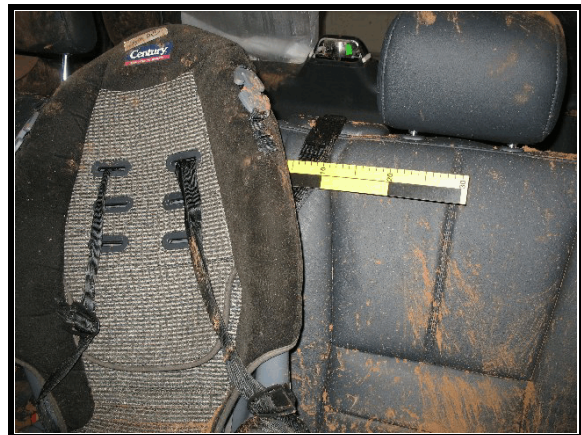
Figure 10. Side to side movement of booster seat

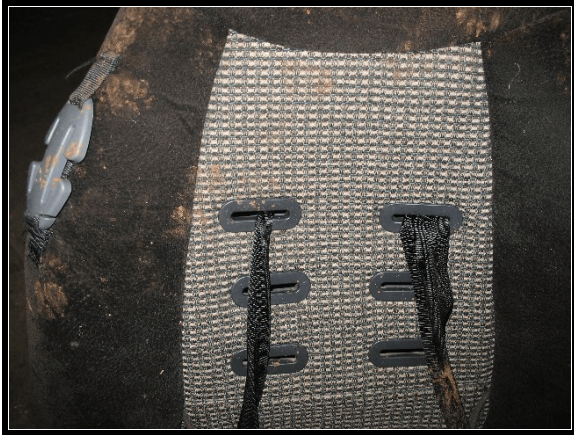
At the time of the child seat inspection, the harness straps were routed through the top set of harness slots. The straps were twisted and doubled over in several locations.

Figure 11. Twisted harness straps

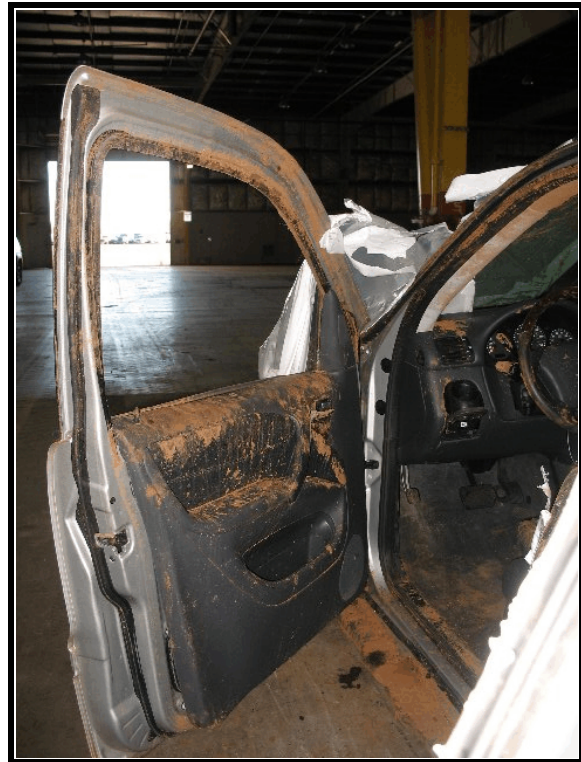
<u>Injury</u>	<u>OIC Code</u>	<u>Injury Mechanism</u>	<u>Confidence Level</u>
Contusions, left leg	890402.1,2	Door panel	Probable
Minor lacerations, left hand	790602.1,2	Flying glass	Possible

Figure 13. Interior, driver's door
