On-Site Rollover Investigation
Dynamic Science, Inc. (DSI), Case Number DS08032
2007 Chevrolet C1500 Silverado
California
July 2008

1. Report No. DS08032		2. Government Accession No.		3. Recipient Catalog No.	
4. Title and Subtitle On-Site Rollover Investigation			5. Report Date August 14, 2009

**Dynamic Science, Inc.
Crash Investigation
Case Number: DS08032**

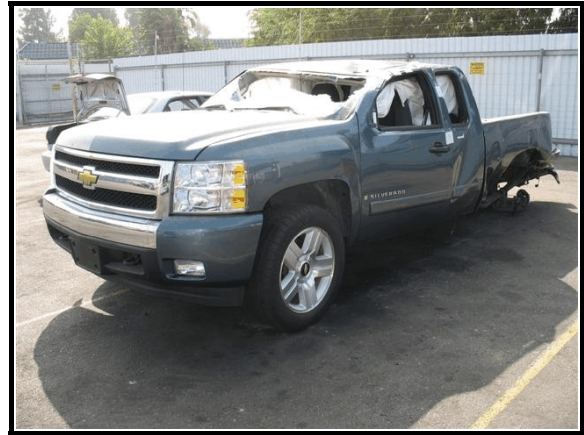
Figure 1. Subject vehicle, 2007 Chevrolet C1500 Silverado

This on-site rollover investigation focused on the dynamics of a 2007 Chevrolet C1500 Silverado pickup truck that was involved in a vehicle-to-vehicle crash and a rollover (**Figure 1**). The other vehicle was a 2007 Ford Fusion sedan. The crash occurred on a five-lane north/south roadway. The Chevrolet was occupied by a driver and front right passenger, and was traveling southbound. The Ford was occupied by a driver and a front right passenger, and was traveling northbound. The driver of the Ford reportedly fell asleep. The Ford departed the northbound lane over the left lane line, crossed the center turn lane, and the front end of the Ford impacted the left side of the Chevrolet. The Chevrolet was displaced to the right, traveled to the west curb, and impacted a curb and a sign post. The vehicle then tripped, overturned two quarter turns with its right side leading, and came to rest on its roof. During the crash, the left and right side curtain air bags deployed. The Ford traveled to the west curb, impacted the curb and a small tree, and came to rest at the curb.

The driver and passenger of the Chevrolet sustained minor injuries and the driver and passenger of the Ford sustained non-incapacitating injuries. Both vehicles were towed due to damage and the Chevrolet was later declared a total loss by the insurance company.

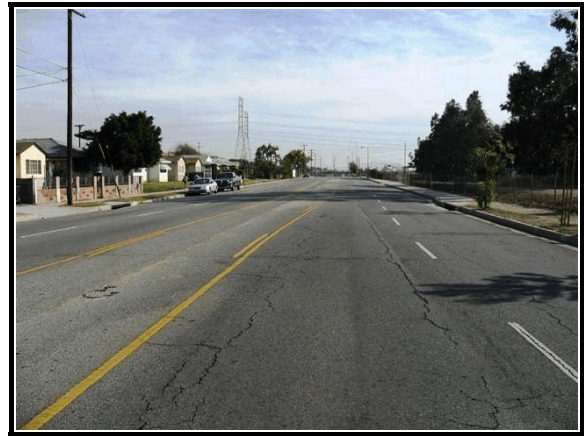
Figure 2. Crash site, southbound approach

The crash site was a five-lane north/south roadway that included two lanes in each direction and a two-way center left turn lane (**Figure 2**). The two-way left turn lane was 3.1 m (10.2 ft) in width, the inboard lanes were 3.5 m (11.6 ft) in width, and the outboard lanes were 4.4 m (14.5 ft) in width. The roadway composition was asphalt, the alignment was straight, and the profile was level. Bordering the roadway on the east and west were raised concrete curbs that measured 20 cm (8.0 in) in height. The roadside environment consisted of level ground, small trees, and paved sidewalks. The crash occurred during daylight at 0650 hours, the weather was cloudy and the roadway was dry.

Streetlights were present but not illuminated. The posted speed limit was 56 km/h (35 mph).

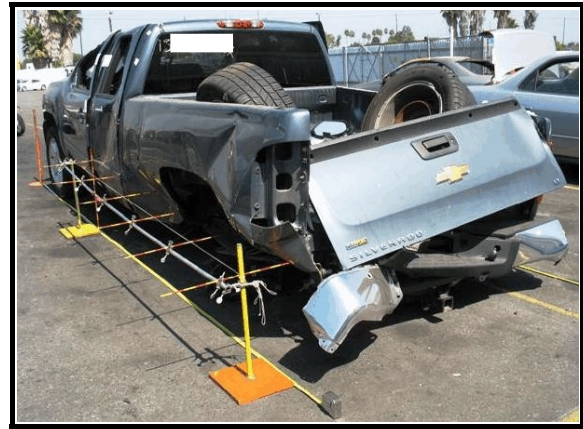
Figure 3. Crush measurement to left side

The Chevrolet sustained direct and induced damage to the left and right sides, back end, undercarriage and top. The vehicle-to-vehicle impact resulted in damage to the left side and the direct damage began at 164 cm (64.6 in) aft of the front axle and extended rearward 293 cm (115.4 in). The Field L began at 175 cm (68.9 in) aft of the front axle, extended rearward 290 cm (114.2 in), and ended at the back left bumper corner. The left rear tire and rim were displaced from the vehicle during the impact and the rear axle was deformed. Damage to the tire included holes in the tread and sidewall; the rim was fractured along the perimeter of the flange. The Chevrolet's undercarriage deposited two parallel gouge marks in the pavement that measured 22 cm (8.7 in) and 28 cm (11.0 in) in length and were 46 cm (18.1 in) apart.

Six crush measurements were taken at mid-door level as follows: C1 = 14 cm (5.5 in), C2 = 7 cm (2.8 in), C3 = 4 cm (1.6 in), C4 = 17 cm (6.7 in), C5 = 5 cm (2.0 in), C6 = 0 (**Figure 3**). Maximum lateral crush was located at C4 and the Collision Deformation Classification (CDC) for the first impact was 11LZEW2.

The vehicle-to-vehicle impact resulted in side impact damage to the front left door. The height of maximum door crush was 59 cm (3.5 in), the sill height was 42 cm (16.5 in), and the Door Sill Differential (DSD) was 11 cm (4.3 in).

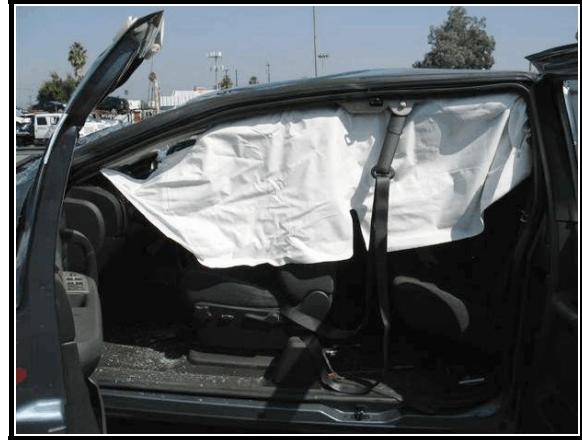
Figure 4. Deployed left side curtain air bag

The vehicle's side curtain air bags were monitored by a rollover sensor and deployed during the rollover event from the left and right roof side rails (**Figure 4**). They were designed to provide impact protection to outboard positioned occupants during both rollover and side impacts and reduce the chance of occupant ejection. The side curtain air bags were constructed of smooth coated nylon material, were generally rectangular in shape, and measured 155 cm (61 in) in length and 59 cm (23.2 in) in height. At the leading end, a woven nylon sail measuring 25 cm (9.8 in) in length connected the side curtain air bags to the A-pillars. At the trailing end of the bag a tether attached the air bags to the C-pillars. They were designed without vent ports.

The side curtain air bag's area of coverage included the front and second row side windows; vertically, the coverage extended from the roof side rail to the mid-door level. The left side curtain air bag was not damaged and revealed no occupant contacts. Dried beverage splatter was present on the inboard panel in the upper forward quadrant adjacent to the driver's seat. The right side curtain air bag was not damaged and revealed no occupant contacts. Dried beverage splatter was present on the inboard aspect of the bag in the upper forward quadrant near the A-pillar.
