**CALSPAN ON-SITE CERTIFIED ADVANCED 208-COMPLIANT
VEHICLE CRASH INVESTIGATION
SCI CASE NO.: CA08047**

VEHICLE: 2006 DODGE CHARGER

LOCATION: NEW YORK

CRASH DATE: SEPTEMBER 2008

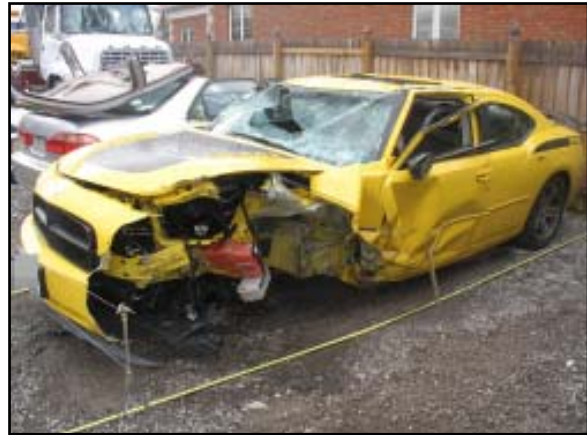
Figure 1: Left front oblique view of the 2006 Dodge Charger.

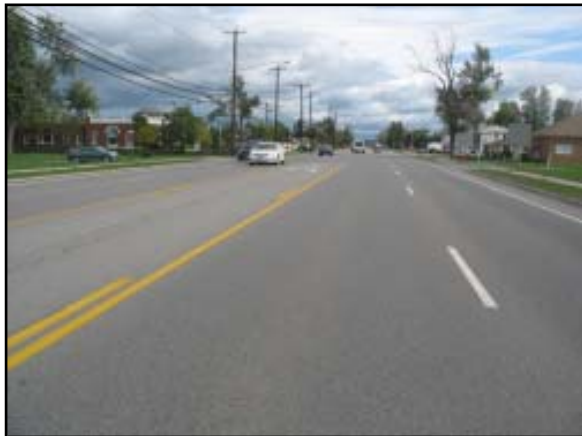
Figure 2: Eastbound trajectory view of the Dodge.

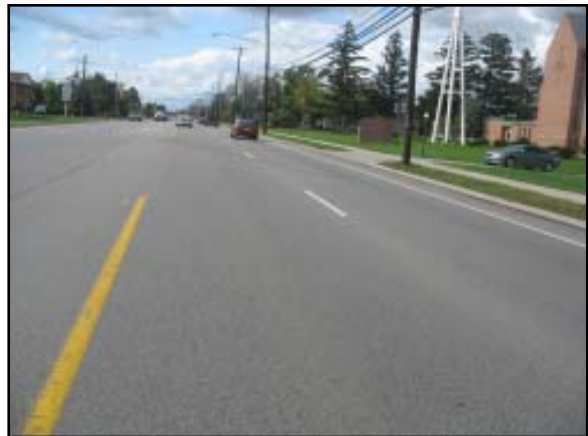
Figure 3: Westbound trajectory view of the Honda.

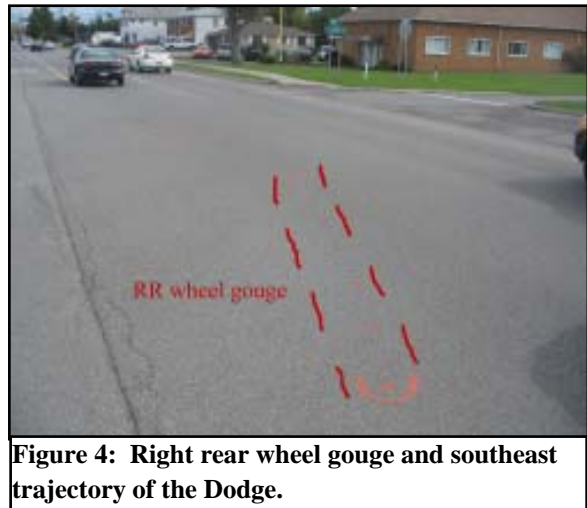
The Dodge began to rotate in a counterclockwise (CCW) as it traveled in a southeast trajectory. The right rear tire folded under the alloy rim resulting in the rim bead edge contacting the ground. A 5.4 meters (17.7 feet) gouge was noted on the asphalt road surface from the contact with the bead edge. This gouge began on the center two-way left turn lane and extended onto the outboard eastbound lane. **Figure 4** depicts the right rear wheel gouge and the southeast trajectory of the Dodge. The Dodge then tripped into a right side leading rollover event. The Dodge rolled over two-quarter turns onto its roof. The vehicle came to rest at the southeast corner of the T-intersection 20 meters (65.6 feet) from the trip point. The Honda was displaced rearward and rotated CCW coming to rest approximately 7 meters (23 feet) east of the point of impact.

Figure 4: Right rear wheel gouge and southeast trajectory of the Dodge.

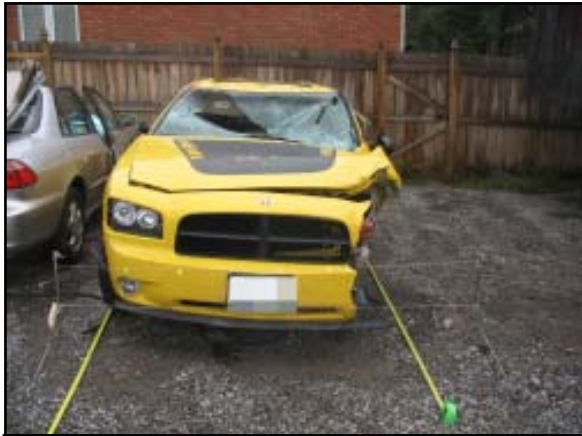
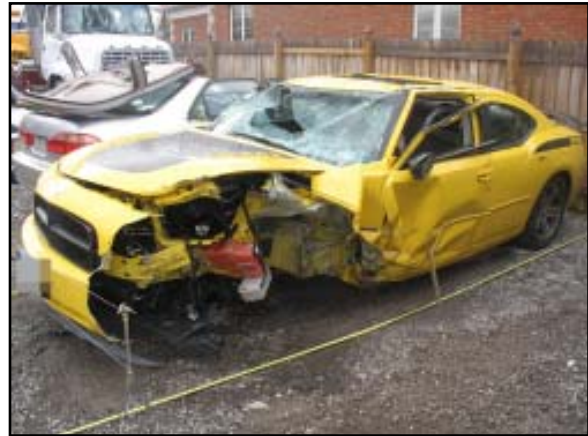
The 2006 Dodge Charger sustained moderate-severity damage to the front and left side planes as a result of the impact with the 1998 Honda Accord (**Figures 5 and 6**). The damaged components included but were not limited to the bumper fascia, bumper beam, hood, left fender, left front door, and the left front wheel and suspension components. The direct contact damage began 46 cm (18 in) left of the centerline and extended 33 cm (13 in) to the left bumper corner. Due to the corner impact configuration, the direct contact damage extended 230 cm (90.5 in) along the left plane to the left front door area. The left front wheel was directly involved in the vehicle-to-vehicle engagement, resulting in separation of the left front wheel and suspension components. The lower control arm fractured during the engagement and the inner tie rod end separated. The maximum crush measured 33 cm (13 in) and was located at the left corner of the bumper beam. The crush profile documented along the bumper beam was as follows: C1 = 33 cm (13 in), C2 = 12 cm (4.7 in), C3 = 13 cm (5.8 in), C4 = 12 cm (4.7 in), C5 = 6 cm (2.4 in), C6 = 0 cm. The Collision Deformation Classification (CDC) for this impact was 12FLEE7.

Figure 5: Frontal damage to the Dodge.

Figure 6: Direct contact damage extending down left side of the Dodge.

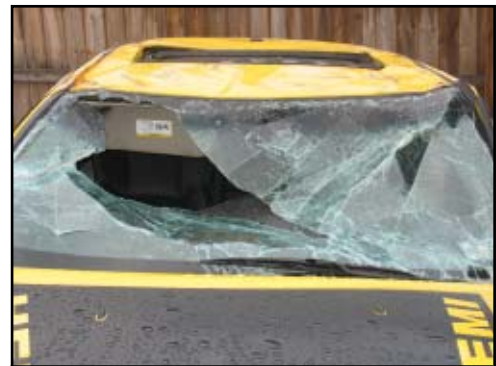
The Dodge sustained minor-severity damage to the right and top planes during the rollover event. The damage consisted of surface abrasions to both planes and vertical crush of the roof. The maximum vertical crush (**Figure 7**) occurred at the right center aspect of the windshield header and measured 8 cm (3 in). There was no lateral deformation to the roof structure. The CDC of the rollover event was 00TDDO2. The four doors of the Dodge remained closed during the crash. The left side doors were jammed in the closed position

Figure 7: Image depicting the maximum vertical roof crush at the windshield header of the Dodge.

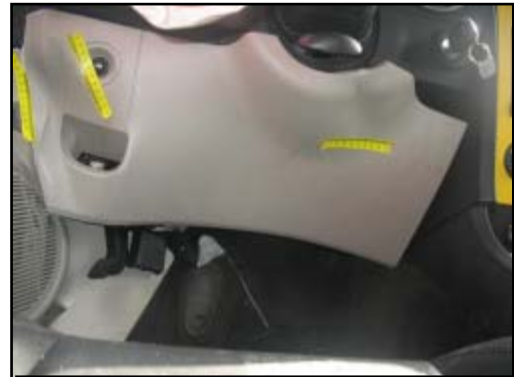
The driver’s contact points consisted of two knee impacts to the knee bolster which were evidenced by deformation of the rigid plastic panel (**Figure 8**). The first contact was attributed to the driver’s left knee and was located 34 cm (13.5 in) left of the steering column centerline. The second contact was located 8 cm (3 in) right of the centerline and was attributed to the driver’s right knee. The passenger compartment intrusions are listed in the following table:

Figure 8: Overall view of the knee bolster contacts.

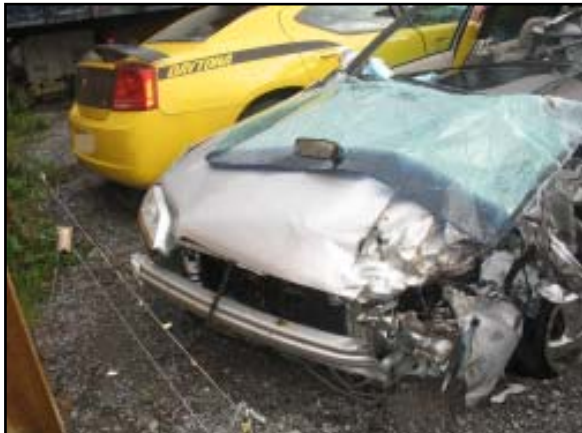
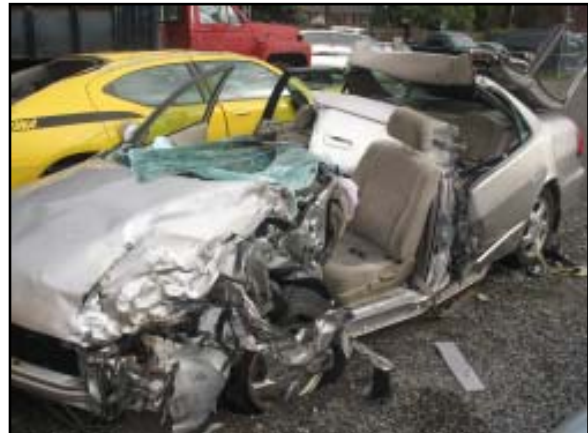
The 1998 Honda Accord sustained moderate-severity frontal damage as a result of the crash (**Figure 9 and 10**). In addition to the crash damage, the roof was cut off by rescue personnel during the extrication of the driver and the front right passenger. The direct contact damage began 37 cm (14.5 in) left of the centerline and extended 39 cm (15.5 in) to the left bumper corner. Due to the corner impact, the direct contact damage extended onto the left plane, ending at the left front door. The maximum crush measured 64 cm (25.2 in) and was located on the left end of the bumper beam. A crush profile was documented along the bumper beam which was as follows: C1 = 64 cm (25.2 in), C2 = 36 cm (14.2 in), C3 = 30 cm (11.8 in), C4 = 22 cm (8.7 in), C5 = 10 cm (3.9 in), C6 = 0 cm. The CDC for this impact was 12FLEE6.

Figure 9: Left oblique view of the frontal crush to the Honda.

Figure 10: Residual left side damage to the Honda.
