Remote Passenger Air Bag Serious Injury Investigation
Dynamic Science, Inc. (DSI), Case Number DS09002
1999 Isuzu Rodeo
Arizona
December 2008

1. Report No. DS09002	2. Government Accession No.		3. Recipient Catalog No.	
4. Title and Subtitle Remote Passenger Air Bag Serious Injury Investigation			5. Report Date December 11, 2009

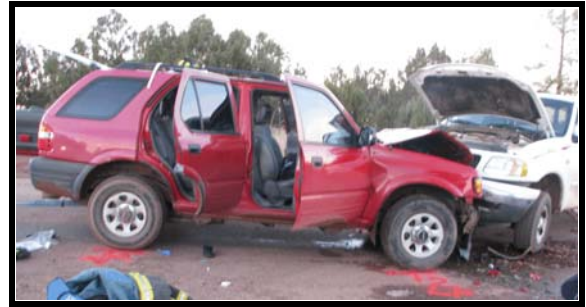
This remote Passenger Air Bag Serious Injury Investigation focused on the air bag related injuries sustained by the 5-year-old front right occupant of a 1999 Isuzu Rodeo (**Figure 1**). The crash occurred within a three-leg intersection. The Isuzu Rodeo was being driven by a 25-year-old female. There were five child occupants, ages 1 to 6, in the vehicle. The 5-year-old male child occupied the front right seat. The other vehicle was a 2003 Ford F-series pickup being driven by a 64-year-old male. The Ford made a left turn across the path of the subject vehicle. The front of the Isuzu struck the front of the Ford and the frontal air bags in the Isuzu deployed.

Figure 1. Subject vehicle, 1999 Isuzu Rodeo (police photo)

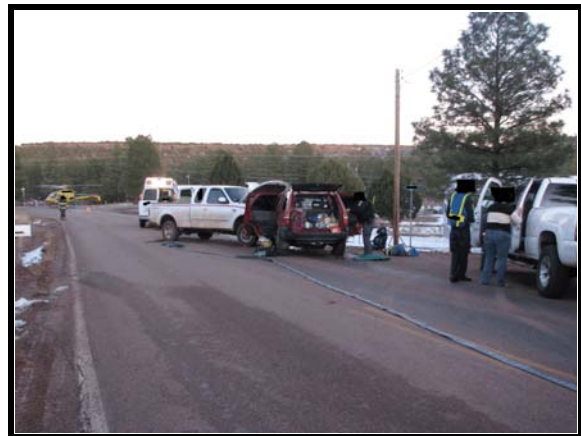
The driver of the Ford continued the left hand turn into the eastbound travel lane. The driver of the Isuzu saw the truck turning at the last moment, but was unable to apply the brakes. The right front of the Ford impacted the front of the Isuzu (**Figure 2**). The impact resulted in the deployment of the frontal air bags in the Isuzu. The CDC-Only algorithm of the WinSMASH program computed a Total Delta-V of 20.0 km/h (12.4 mph). The lateral and longitudinal components were -18.8 km/h (-11.7 mph) and 6.8 km/h (4.3 mph), respectively. The Ford was redirected slightly in a counterclockwise direction; the Isuzu was redirected slightly in a clockwise direction. Both vehicles came to rest in the intersection with their front ends fully engaged; the Ford was facing east and the Isuzu was facing southwest.

Figure 2. Area of impact and final rest (police photo)

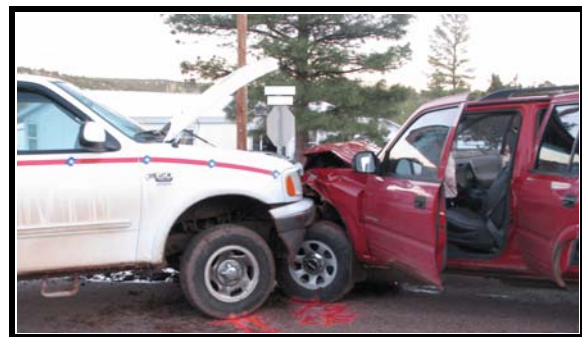
The Isuzu sustained moderate front end damage as a result of the impact with the Ford (**Figure 3**). The direct damage began at the left front bumper corner and extended laterally to the right. The grille was damaged and the hood was deformed. The right bumper corner was rotated outward. The Collision Deformation Classification (CDC) for this impact was 11FDEW2.

Figure 3. Frontal damage to Isuzu (police photo)

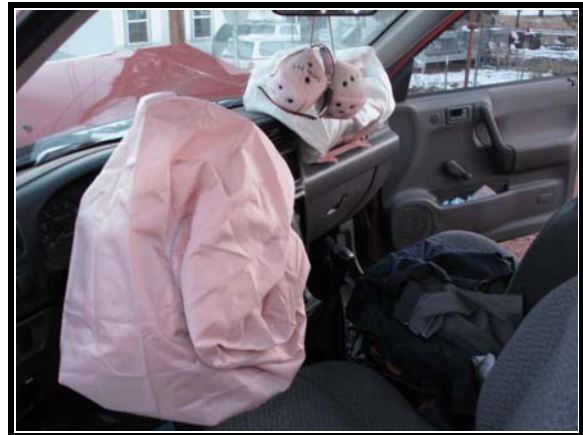
The driver’s air bag was located in the steering wheel hub and deployed during the impact with the Ford (**Figure 4**) The front right passenger’s air bag was located in the top of the instrument panel and deployed during the impact with the Ford. It is not known if there was any damage or contacts to the air bags.

Figure 4. Driver and front right passenger air bags (police photo)

<u>Injury</u>	<u>AIS Code</u>	<u>Injury Mechanism</u>	<u>Confidence Level</u>
C6/C7 transection with quadriplegia	640260.5,6	Passenger air bag	Certain
Right tibia/fibula fracture	853404.2,1 851605.2,1	Lower instrument panel	Probable
Abrasion, back of head	190202.1,8	Seat back	Probable
Abrasion, anterior neck	390202.1,5	Passenger air bag	Certain
Abrasion, chest	490202.1,9	Passenger air bag	Certain
