**CALSPAN ON-SITE ROLLOVER CRASH INVESTIGATION
SCI CASE NO: CA09004**

VEHICLE: 2009 MERCEDES-BENZ ML 350

LOCATION: STATE OF PENNSYLVANIA

CRASH DATE: DECEMBER 2008

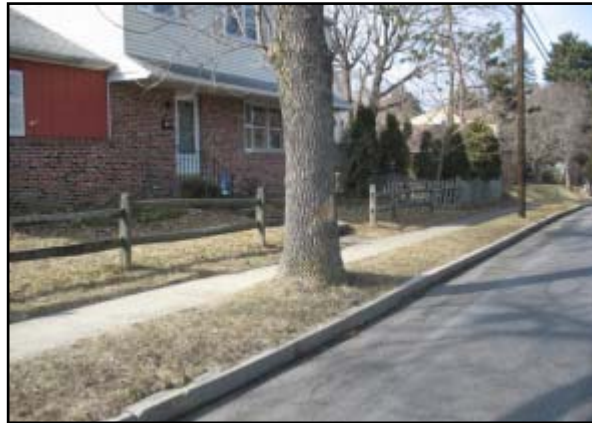
The vehicle departed the north roadside and the left front wheel impacted a curb (Event 1) that was 16 cm (6.3") in height. This impact did not alter the northeast trajectory of the Mercedes-Benz as it continued off-road. The vehicle traveled off-road 3.3 meters (10.8 feet) and impacted a 60 cm (23.6") diameter tree with the front left corner (Event 2). **Figure 3** depicts the curb and struck tree. The impact location was outboard of the left frame rail which allowed the vehicle to continue its forward movement. As the frontal components crushed, the left front wheel engaged the tree. During the engagement with the left front wheel, the rear of the vehicle began to lift off the ground. Additionally, the tree engagement induced a counterclockwise rotation. The ML 350 traveled approximately 3 meters (9.8 feet) as it continued to rotate and re-enter the westbound lane. The combination of the left front wheel engagement, rotation, lifting, and the center of gravity height caused the ML 350 to initiate a bounce-over rollover event as it returned to the roadway (Event 3). The vehicle landed on its right side and slid approximately 1 meter (3.2 feet) to final rest on its right side. As a result of the rollover event, the curtain air bags deployed in the vehicle.

Figure 3. Area of impact with the curb and the tree.

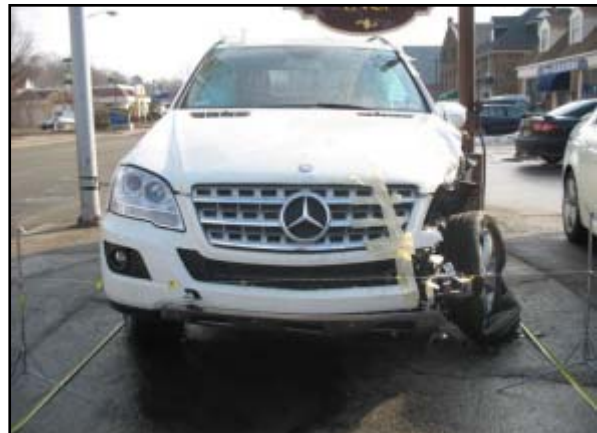
The exterior of the 2009 Mercedes-Benz ML 350 sustained moderate severity damage as a result of the multiple event crash sequence (**Figures 4 and 5**). The left front wheel impacted the 16 cm (6.3”) curb (Event 1); however the damage from this impact was masked by subsequent tree impact. The Collision Deformation Classification assigned to this impact was 12-FLWN-3.

The tree impact to the front left corner resulted in deformation to the frontal components and extended down the left fender (**Event 2**). The direct contact damage measured 40 cm (15.7”) and began 50 cm (19.7”) left of the centerline; ending at the left corner. A crush profile was documented along the front bumper beam and was as follows: C1 = 24 cm (9.4”), C2 = 7 cm (2.8”), C3 = 0 cm, C4 = 0 cm, C5 = 0 cm, C6 = 0 cm. The left wheel and tire sustained damage that consisted of a cut to the sidewall of the tire and the front part of the rim was split circumferentially approximately 80 percent. The CDC for this event was 12-FLEE-3.

Figure 4. Residual frontal damage from the tree impact.

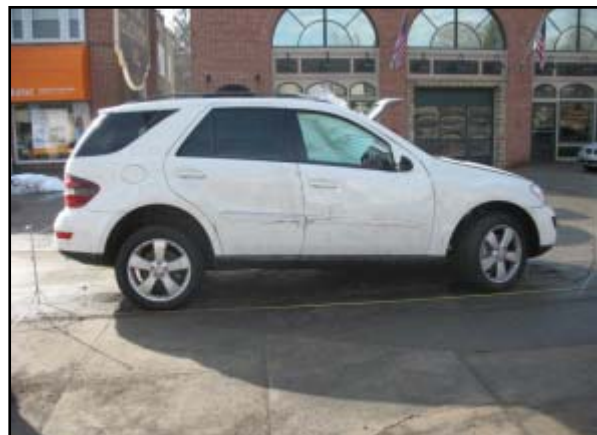
The damage from the rollover sequence (Event 3) was minor and consisted of abrasions of to the right side of the vehicle. **Figure 5** is an overall view of the right side. The abrasions were vertically oriented and scattered along the roof side rail, doors, fender, and quarter panel.

Figure 5. Overall view of the rollover damage to the right plane.

There was no deformation from the ground contact; however, the right mirror fractured off its mount and was compressed against the right front door resulting in deformation to the door. Additionally, the right front window disintegrated. The remainder of the glazing was closed and intact. All doors and the hatch remained closed during the crash and were operational post-crash. The CDC assigned to this impact was 00-RDAO-2.

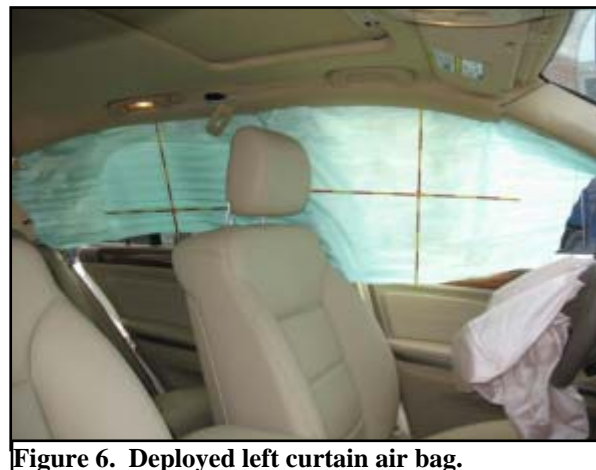
The 2009 Mercedes-Benz ML 350 was equipped with rollover sensing curtain air bags for the four outboard positions. The left and right side curtain air bags deployed during the rollover event. **Figure 6** is an overall view of the left curtain air bag.

Figure 6. Deployed left curtain air bag.

The curtain air bags deployed from the respective roof side rails. The air bag membrane measured 183 cm (72") in length. At the front left seating position, the membrane was 49 cm (19.3") in height extending 7 cm (2.8") below the top of the door panel. The height of the curtain air bag membrane at the left rear position was 45 cm (17.7") and extended 5 cm (1.9") below the top of the door panel. The height

Longitudinally, the coverage area of these curtain air bags did not span across the front glazing. A triangular shaped gap was present which began at the A-pillars and extended 27 cm (10.6") rearward and was 30 cm (11.8") in height. The curtain air bags were tethered to the D-pillar by 42 cm (16.5") tethers.

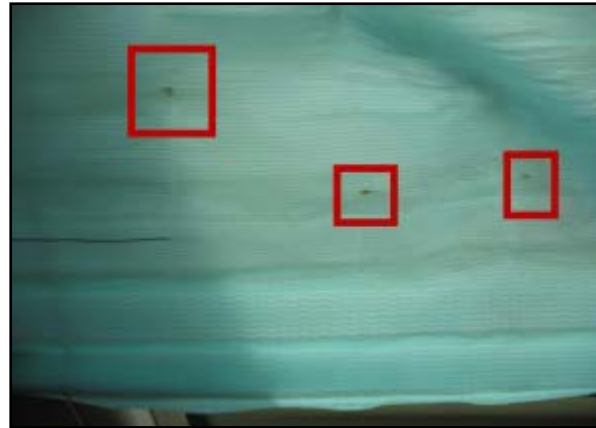
Figure 7. Close-up view of the brownish colored marks on the curtain air bag.

The curtain air bags were free of occupant contact points. Several brownish-colored marks that appeared to be burns were scattered throughout the membranes of both curtain bags. The curtain air bags were not punctured at the locations of these marks. **Figure 7** is a close-up of view of the marks on the left curtain air bag.

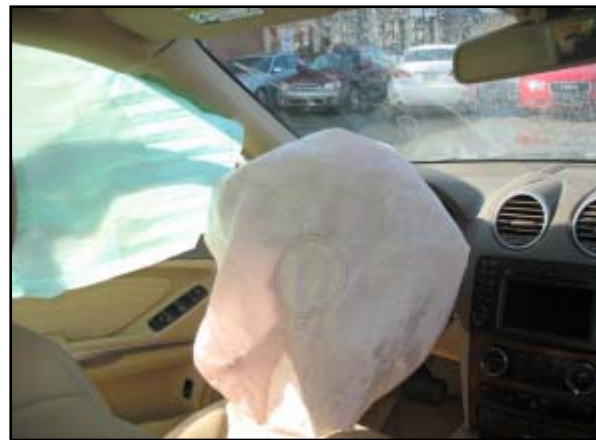
As a result of the frontal impact with the tree, the driver's frontal air bag deployed (**Figure 8**). The driver's frontal air bag was conventionally mounted within the center of the four-spoke steering wheel rim and was concealed by a five cover flap design. The top cover flap measured 9 cm (3.4") in height and 6 cm (2.4") in width. The four lower cover flaps were 4 cm (1.6") and 6 cm (2.4") in maximum width and 4 cm (1.6") and 7 cm (2.8") in height, respectively. The driver's air bag membrane measured 56 cm (22") in diameter in its deflated state. The air bag contained two tethers and was vented by two vent ports at the 11 and 1 o'clock positions. There was no damage or occupant contact points present on the air bag membrane.

Figure 8. Deployed driver's frontal air bag.
