## REMOTE CHILD AIR BAG-RELATED FATALITY INVESTIGATION

CASE NUMBER - IN09008

VEHICLE - 1987 Mercedes Benz 190E

INCIDENT DATE - December 2008

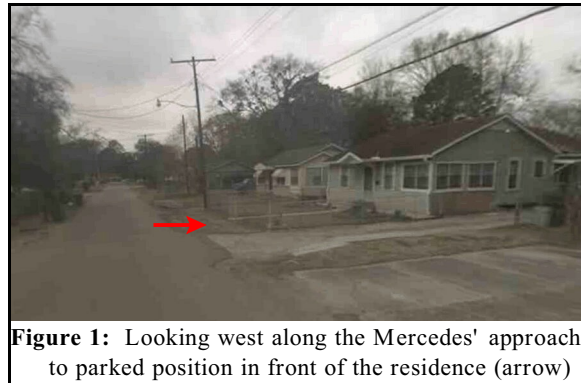
**Figure 1:** Looking west along the Mercedes' approach to parked position in front of the residence (arrow)

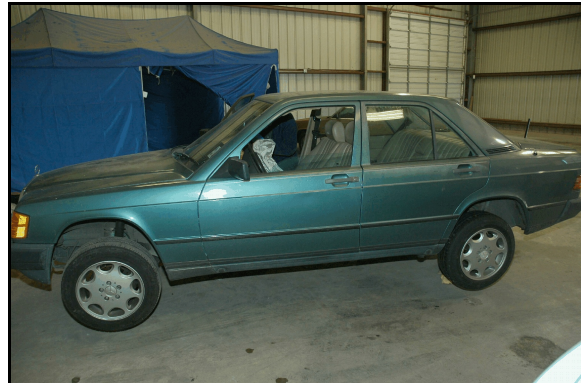
**Figure 2:** Entire left side of the Mercedes during police inspection, at impound facility

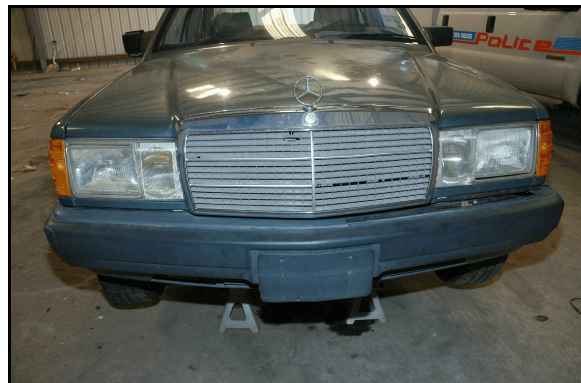
**Figure 3:** Entire front of the Mercedes at impound facility; note, absence of frontal impact damage

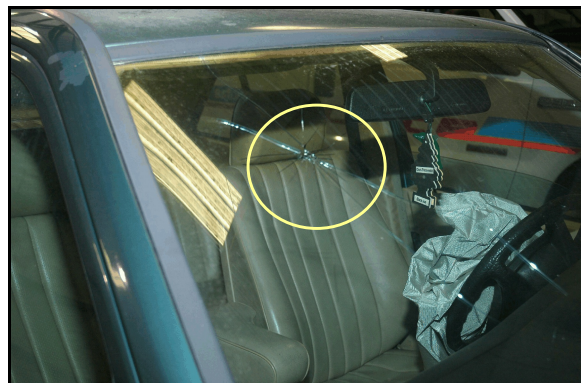
**Figure 4:** Star-shaped crack in the Mercedes' windshield, confirmed as pre-existing damage

The inspection of the Mercedes' exterior revealed minor damage in several locations. There was a star-shaped crack in the windshield, approximately 25 cms. (10 inches) below the header and right of center (**Figure 4**). The driver/owner stated that this crack had been present when she acquired the vehicle and the inspection did not reveal any evidence to contradict the driver's statement. The several exterior dents and scrapes were examined closely by the investigating officer and the manufacturer's representative. Based on the degree of oxidization in damaged areas and the presence of dirt and street grime, the investigating officer and the manufacturer's representative concluded that none of these areas of minor damage had occurred recently enough to be related to the alleged inadvertent air bag deployment, and none of damaged areas represented an impact of sufficient magnitude to cause an air bag deployment.

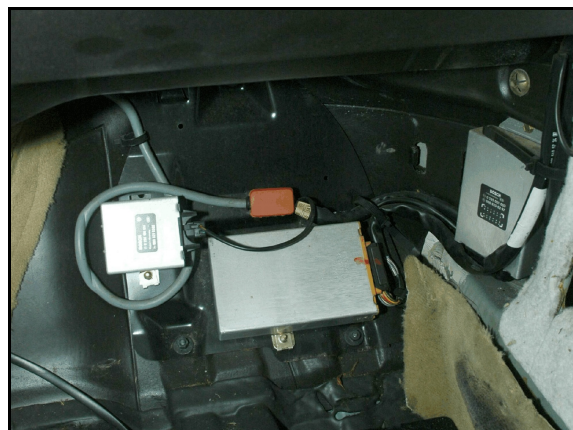
**Figure 5:** Front right foot well with carpet and panels removed, revealing electrical system components

The manufacturer's technical representative brought a kit of tools, instruments, test protocol instructions, a table of acceptable values for test readings, and a replacement restraint control module. Various cover panels and sections of the carpeting were removed to reveal portions of the vehicle's electrical system components and the SRS control module (**Figures 5 and 6**). The manufacturer's representative confirmed that all of the components were correct for this vehicle and appeared to be the originally installed equipment. During the testing procedures, the system exhibited a malfunction consistent with the driver's statement: when power was applied to the system, the SRS warning lamp remained illuminated (in a correctly functioning system, the SRS warning lamp should go off after a three-to-five second self-test procedure). One of the test procedures involved disconnecting the vehicle's control module and connecting the vehicle's wiring system to a replacement control module. When this test was performed, the SRS warning lamp went off after the self-test procedure. The manufacturer's representative concluded that the SRS warning lamp was illuminated due to a malfunction in the control unit or its connection to the wiring system, and that such a malfunction could cause an inadvertent deployment. The control module and wiring harness were not removed for further evaluation because to do so would be destructive and would exceed the scope of the search warrant under which the case vehicle was being inspected.

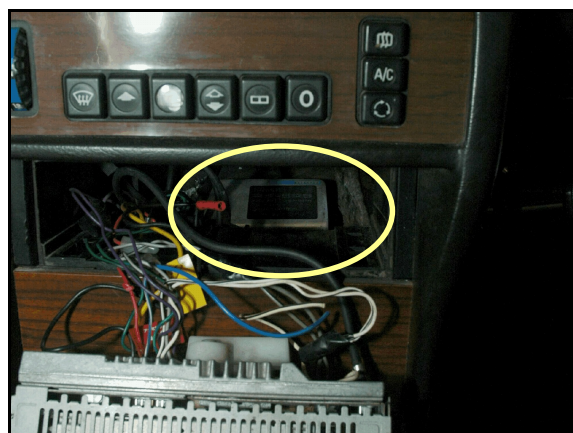
**Figure 6:** Access to the SRS control module, behind the radio in the center instrument panel console

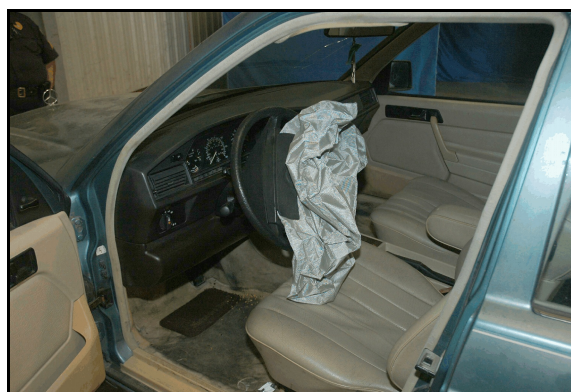
Figure 7: Driver's seat area prior to disassembly

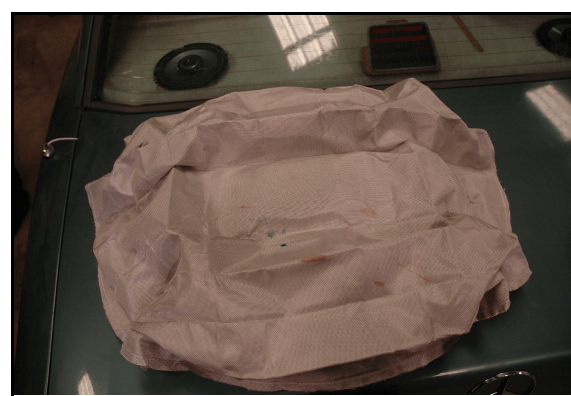
Figure 8: Driver's air bag fabric, front portion, after disassembly of the air bag module
