## ON-SITE OTHER INFLATABLE OCCUPANT PROTECTION INVESTIGATION

CASE NUMBER - IN10008

LOCATION - KENTUCKY

VEHICLE - 2008 CHEVROLET IMPALA LT

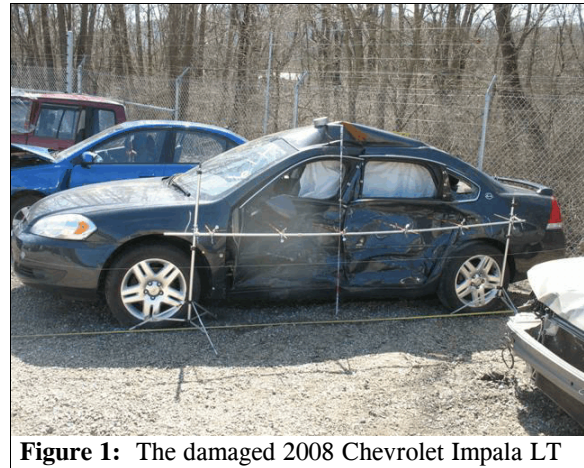
Figure 1: The damaged 2008 Chevrolet Impala LT

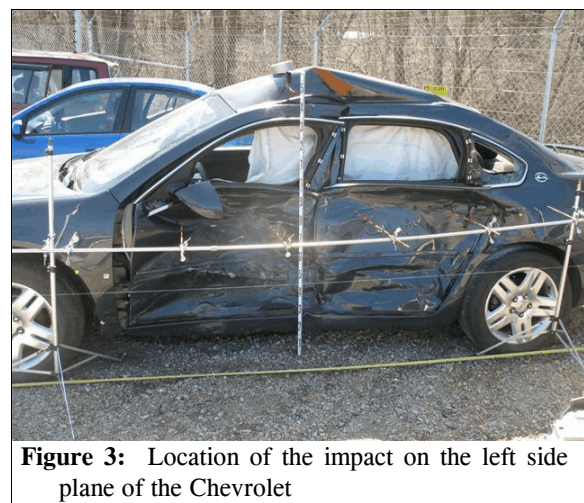
**Crash:** The front plane of the Jeep impacted the left side plane of the Chevrolet (**Figure 3**, event 1). The direction of force on the Chevrolet was within the 10 o'clock sector and the impact force was sufficient to trigger deployment of the IC air bags. The impact also triggered a first stage deployment of the driver's and front right passenger's frontal air bags. As a result of the impact, the Chevrolet rotated counterclockwise and the left fender (**Figure 4**) impacted the left side plane of the Jeep (event 2). The Chevrolet continued rotating counterclockwise and departed the south side of the roadway where the back plane impacted an embankment (event 3). The Chevrolet came to final rest heading northeast. The Jeep came to final rest on the roadway heading southwest.

**Figure 3:** Location of the impact on the left side plane of the Chevrolet

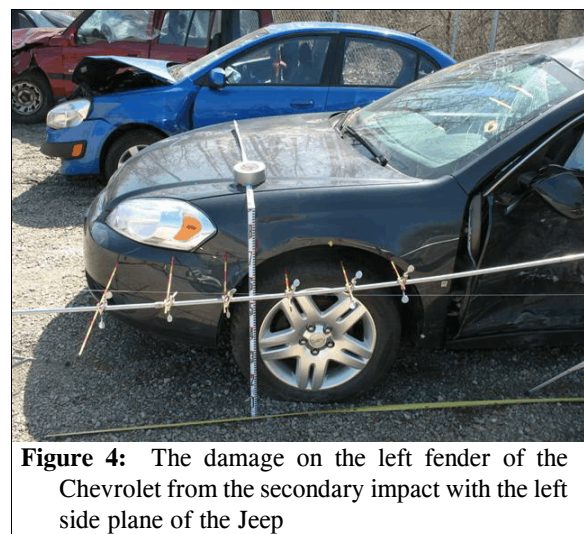
**Figure 4:** The damage on the left fender of the Chevrolet from the secondary impact with the left side plane of the Jeep

The Chevrolet sustained damage on the left fender during the secondary impact with the Jeep. The direct damage began 85 cm (33.5 in) forward of the left front axle and extended rearward 83 cm (32.7 in). The crush measurements were taken at the mid-fender level and the residual maximum crush was 1 cm (0.4 in) occurring at C<sub>5</sub>. The table below presents the crush profile on the left fender.

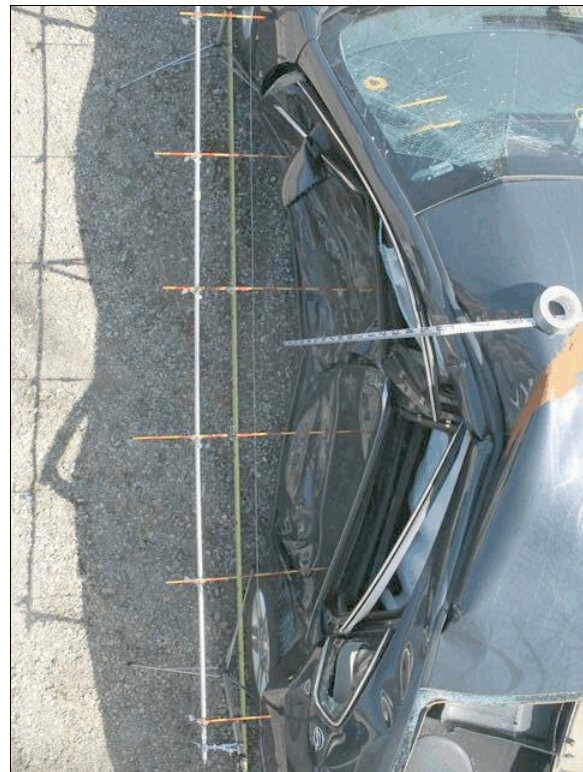
**Exterior Damage:** The Chevrolet sustained left side plane damage during the impact with the Jeep. The rear portion of the left fender, both left side doors, and the front portion of the left quarter panel were directly damaged. The direct damage began 35 cm (13.8 in) rear of the left front axle and extended 234 cm (92.1 in) rearward along the left side. The crush measurements were taken at the mid-door level and the residual maximum crush was 46 cm (18.1 in) occurring at C<sub>4</sub> (**Figure 5**). The vehicle's sill height was 25 cm (9.8 in) and the height of the maximum crush was 70 cm (27.6 in). The Door Sill Differential was 24 cm (9.4 in). The left side wheelbase was reduced 4 cm (1.6 in). The right side wheelbase was extended 1 cm (0.4 in). The induced damage involved the left roof side rail, roof, and left quarter panel. The table below presents the left side crush profile.

**Figure 5:** The crush on the left side of the Impala from the impact with the front of the Jeep

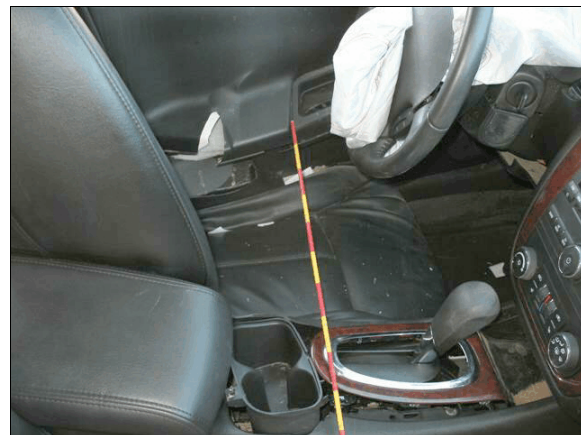
The vehicle sustained 16 intrusions of the passenger compartment. The most severe intrusions occurred in the driver’s seat position. The rear lower quadrant of the left front door

Figure 6: Intrusion of the left front door of the Chevrolet into the driver’s seat position

(Figure 6) intruded 30 cm (11.8 in), while the window frame, left B-pillar (Figure 7), and roof side rail intruded 26 cm (10.2 in) 24 cm (9.4 in) and 16 cm (6.3 in), respectively.

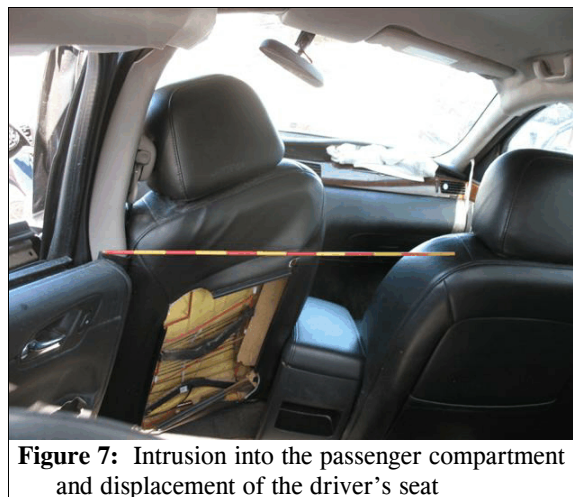
Figure 7: Intrusion into the passenger compartment and displacement of the driver's seat

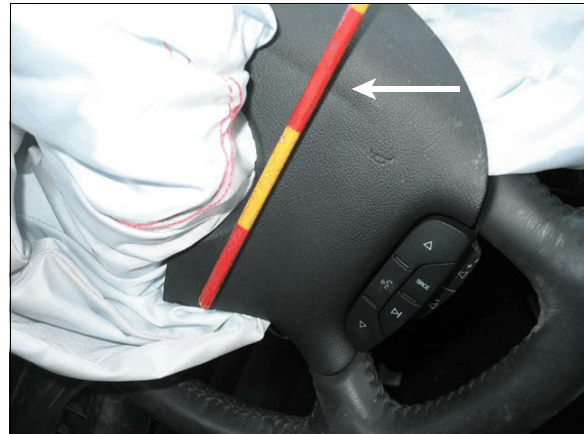
width at the top, 6 cm in width at the bottom and 13 cm (5.1 in) in height. The left cover flap opened at the designated tear seams. The upper tear seam on the right flap (**Figure 8**) did not separate and the flap did not open. The air bag partially deployed with an approximate 36 cm (14.2) x 28 cm (11 in) portion deploying through the left flap and a portion of the air bag deploying from under the top of the steering wheel hub cover (**Figure 9**). There was no discernable evidence of occupant contact on the air bag.

**Figure 8:** The top seam on the right air bag module cover flap did not separate (arrow)

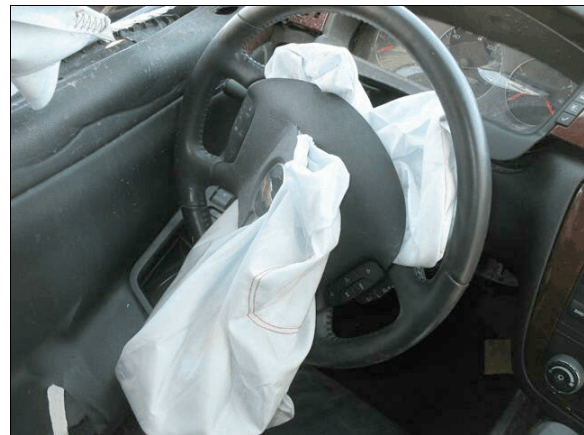
**Figure 9:** The driver's frontal air bag did not fully deploy

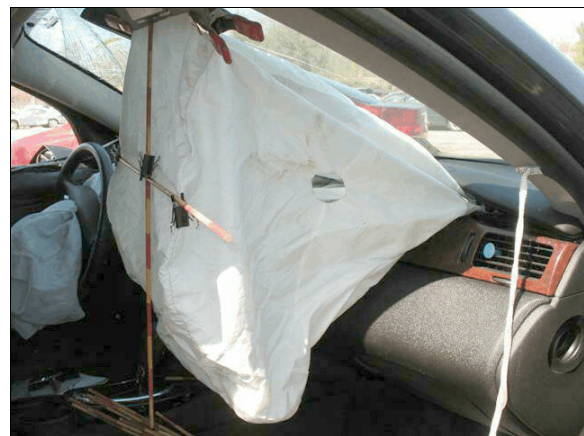
The front right passenger frontal air bag was located within the top of the instrument panel. There was no air bag cover flap. The top of the instrument panel was designed to displace vertically as the air bag deployed. The deployed air bag (**Figure 10**) was 42 cm (16.5 in) in width and 52 cm (20.5 in) in height. The air bag was designed with one internal tether and one vent port on each side of the air bag. The vent ports were located at the 3 and 9 o'clock positions and were 4.5 cm (1.8 in) in diameter. There was no discernable evidence of occupant contact on the air bag and no damage.

**Figure 10:** The front passenger's deployed frontal air bag

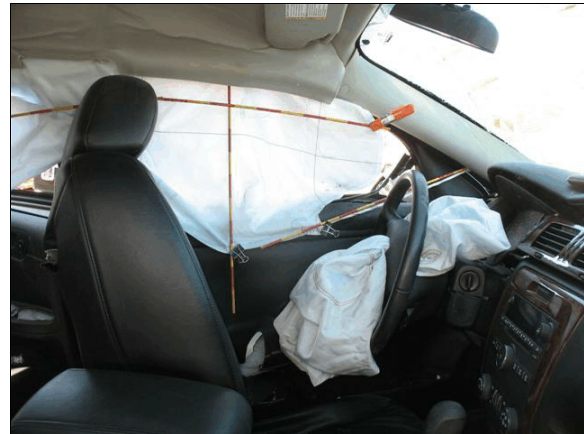
The IC air bags were located along the roof side rails inside the headliner and extended from the A-pillar to the C-pillar. There were no external vent ports. The deployed left IC air bag (**Figure 11**) was 159 cm (62.6 in) in width and 35 cm (13.8 in) in height. It was attached to the A-pillar by a 44 cm (17.3 in) nylon tether. The gap between the front of the IC air bag and the window frame was 12 cm (4.7 in). There was no gap between the back of the IC air bag and the C-pillar. The distance the IC air bag extended vertically below the beltline was 10 cm (3.9 in). The dimensions and features of the right IC air bag were the same as the left. There was no discernable evidence of occupant contact on either IC air bag. There was no damage on the left IC air bag. The right IC air bag and front tether had been cut.

**Figure 11:** The front portion of the left IC air bag

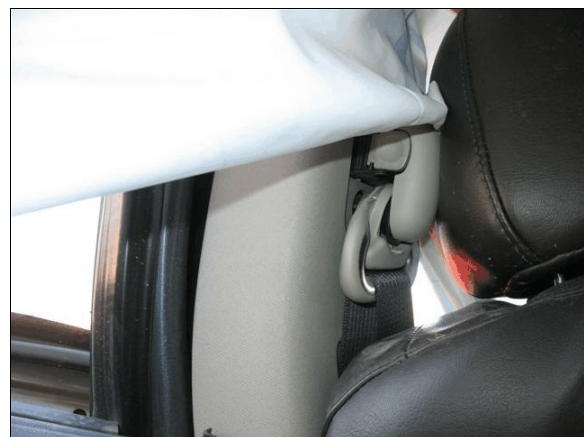
The deployment of the left IC air bag was obstructed by the intruded left B-pillar. The intrusion of the B-pillar closed the gap between the B-pillar and the driver's seat back. The IC air bag extended no further than the top of the adjustable upper anchor (**Figure 12**) in this area.

**Figure 12:** The deployment of the left IC air bag was obstructed when the intrusion of the left B-pillar closed the gap between the B-pillar and the seat back
