CALSPAN ON-SITE ROLLOVER CRASH INVESTIGATION
SCI CASE NO.: CA10034

VEHICLE: 2008 CHEVROLET SILVERADO CREW CAB 4X2

LOCATION: NORTH CAROLINA

CRASH DATE: AUGUST 2010

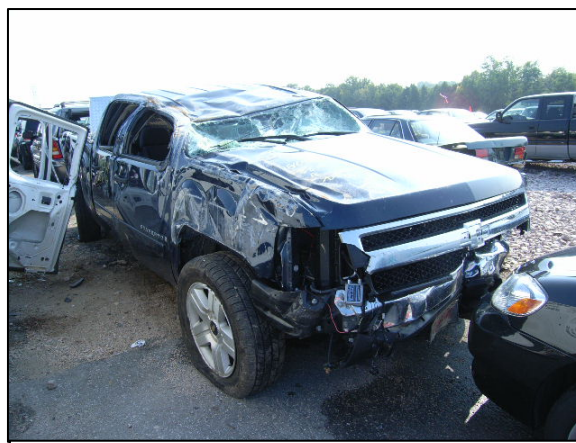
This on-site investigation focused on the multiple-event/rollover crash of a 2008 Chevrolet Silverado (**Figure 1**). The Chevrolet was equipped with a Certified Advanced 208-Compliant (CAC) frontal air bag system. The Chevrolet was not equipped with optional side impact or Inflatable Curtain (IC) air bags. The manufacturer of the Chevrolet certified that the vehicle was compliant with the advanced air bag portion of Federal Motor Vehicle Safety Standard (FMVSS) No. 208. The CAC system includes dual-stage frontal air bags for the driver and front right passenger positions, seat track

Figure 1: Right front oblique view of the 2008 Chevrolet Silverado

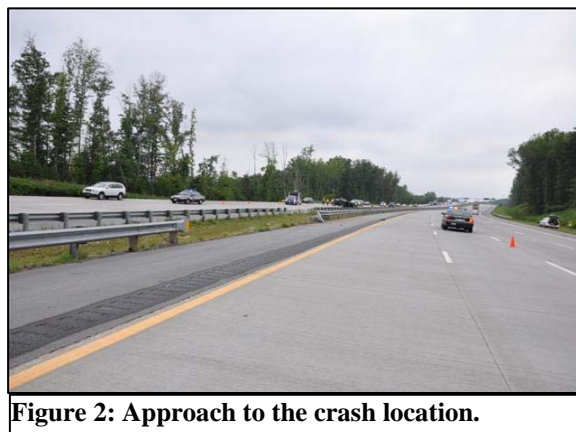
This crash occurred during daylight hours on a four-lane north/south interstate highway divided by two W-beam guardrails and a grass median. The roadway was straight in the pre-crash area and transitioned to a large radius right curve immediately prior to the roadside departure (**Figure 2**). There was a positive grade of 1% in the area of the crash. The concrete-surfaced traffic lanes were 4.4 m (14.4 ft) in width and were bordered by asphalt shoulders 4 m (13.1 ft) in width. A rumble strip had been applied onto the shoulder. Outboard of the asphalt shoulders stood metal W-beam guardrails 86 cm (34 in) in height. There was a maintenance opening in the guardrail at the point of the roadside departure. The grass median measured 3.9 m (9.9 ft) in width. The speed limit in the area in which this crash occurred was 105 km/h (65 mph). The environmental conditions were cloudy and dry. A crash schematic is included as **Figure 10** of this report and includes measurement data points taken by the police reconstruction team the day of the crash.

Figure 2: Approach to the crash location.

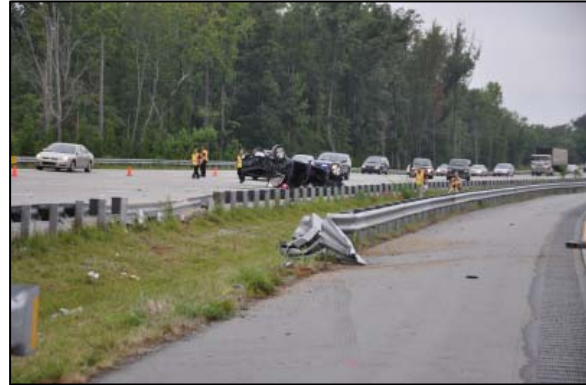
The front bumper of the Chevrolet impacted the blunt end of the guardrail (**Figure 3**). There was evidence of a guardrail post impact on the front bumper located 17 cm (6.7 in) left of the vehicle centerline. The direction of force was within the 12 o'clock sector. This initial impact resulted in the actuation of the safety belt pretensioners and deployed the frontal air bags in the Chevrolet. The Barrier algorithm of the WinSmash program was used to calculate a Barrier Equivalent Speed of 22 km/h (14 mph) for the first point of impact. The guardrail collapsed and the Chevrolet was redirected into an upward trajectory by the initial impact. The vehicle overrode the first guardrail and traveled through the grass median. The Chevrolet impacted and overrode the top of the second guardrail protecting the southbound traffic lanes with its undercarriage. The vehicle was redirected into a clockwise yaw as it entered the southbound traffic lanes. The Chevrolet yawed approximately 60 degrees Clockwise (CW) and tripped into a left side leading rollover. Based on scene evidence, the Chevrolet rolled 10-quarter turns over a distance of 47 m (154 ft). The vehicle came to rest on its roof facing northeast on the most-inboard southbound lane. **Figure 4** is an overall police image of the crash site.

Figure 3: Trajectory view of the Chevrolet at Event 1.

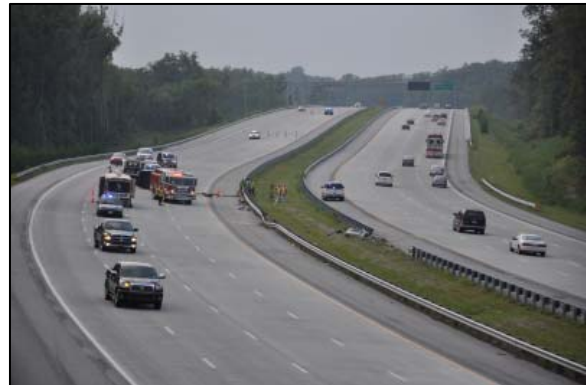
Figure 4: Overall police image of the crash site.

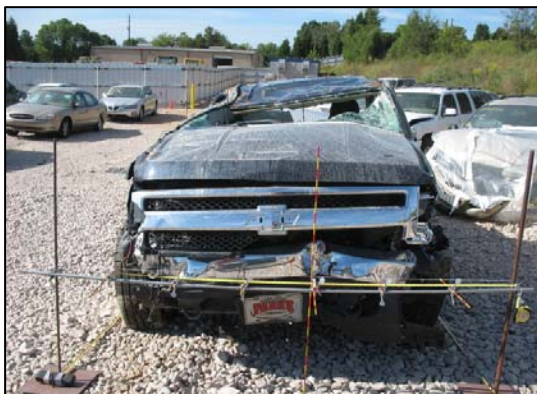
The Chevrolet sustained moderate damage to its front plane as a result of the initial impact with the guardrail (**Figure 5**). On the front plane, the direct and induced damage extended the full width of the bumper beam. The maximum bumper level crush was located at C3, 17 cm (6.7 in) left of the centerline and measured 20 cm (7.9 in). A residual crush profile was documented along the full width of the damaged front bumper. This profile was as follows: C1 = 12 cm (4.7 in), C2 = 12 cm (4.7 in), C3 = 20 cm (7.9 in), C4 = 8 cm (3.1 in), C5 = 5 cm (2 in), C6 = 16 cm (6.3 in). The Collision Deformation Classification (CDC) for this impact was 12FDEW1.

Figure 5: Frontal damage to the Chevrolet taken during the SCI inspection.

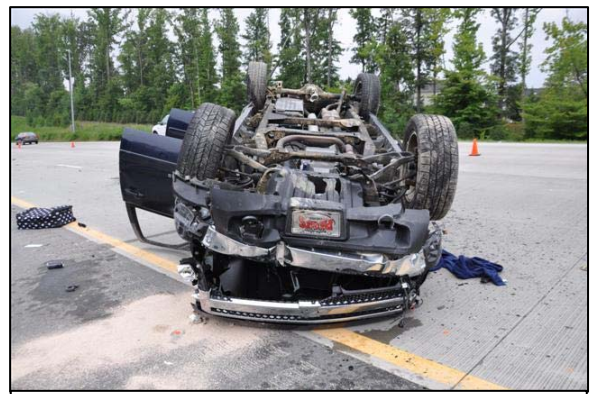
The forward aspect of the Chevrolet's undercarriage impacted the top of the second guardrail as the vehicle overrode the structure. This non-horizontal damage was outside the scope of the WinSMASH program. **Figure 4** was taken on-scene and depicts the undercarriage damage to the Chevrolet. The CDC assigned for the second event was 00UFDW99.

Figure 6: View of the Chevrolet at final rest taken by the police investigator depicting the undercarriage damage.

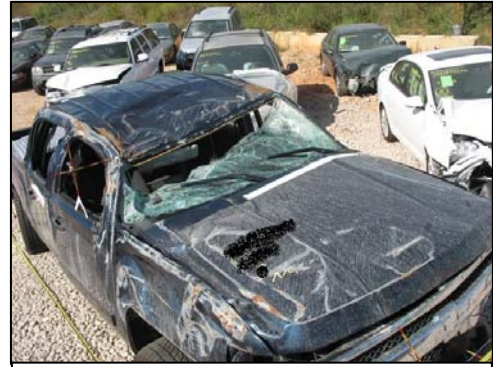
The top plane sustained the highest level of deformation in the rollover, Event 3, (**Figure 7**). On the top plane, the direct damage extended aft from the leading edge of the hood 368 cm (145 in) and across the full lateral width of the top from the left roof side rail to the right roof side rail.

The greatest vertical deformation was located on the right side of the windshield header, at the junction with the right roof side rail. The residual vertical deformation measured 22 cm (8.7 in). The greatest lateral deformation was located at the right roof side rail at the junction with the right A-pillar. The resultant lateral deformation measured 8 cm (3.1 in). The CDC assigned to the rollover event was 00TYDO4.

Figure 7: Rollover damage to the top plane of the Chevrolet.

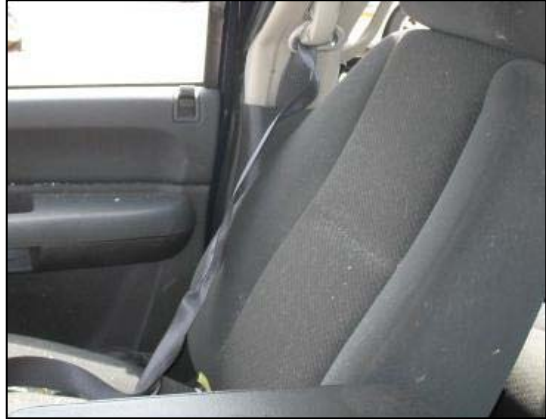
the plastic trim slot reference. An area of abrasion and creasing (**Figure 8**) was located 138 to 159 cm (54.3 to 62.6 in) above the reference point. This region of evidence was related to the pre-crash positioning of the shoulder portion of the belt behind the front right head restraint. The driver reported that the passenger wished to go to sleep and placed the shoulder portion of the webbing behind the head restraint. The actuation of the pretensioner removed the slack in the webbing which resulted in contact between the vertical bars of the head restraint and the webbing. Additionally, the belt webbing was found gathered in the D-ring.

Figure 8: Abrasion to the right front webbing from contact with head restraint posts.

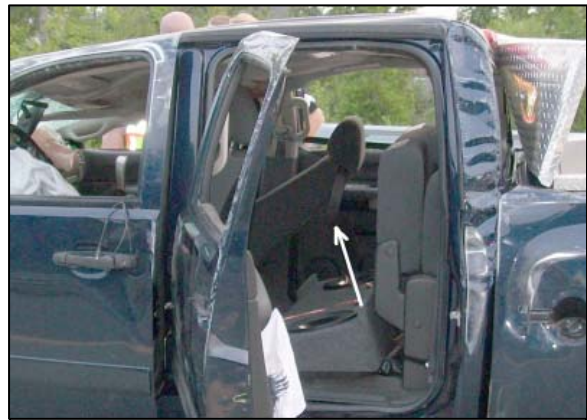
Figure 9: Front right safety belt behind front right head restraint.

During the rollover, the lack of a shoulder belt allowed a partial ejection of the passenger's head and right arm through the (now disintegrated) right front window. The head and right arm contacted the ground resulting in the concussion, the scalp laceration and hematoma, the right forearm abrasions and the right hand laceration (tendon injury). The rollover forces resulted in the intrusion of the right roof area of the Chevrolet. The reduction in the occupant space resulted in contact between the passenger's head and the right roof rail and center roof during the rollover sequence. Body fluid and hair observed at the time of the SCI inspection identified these contacts. The front right passenger came to rest inverted and restrained by the lap portion of the safety belt within the front right seating position.
