SCI/NASS COMBINATION CASE REPORT

CASE NUMBER - NASS-1997-72-103A

VEHICLE - 1996 Ford Taurus

CRASH DATE - August 1997

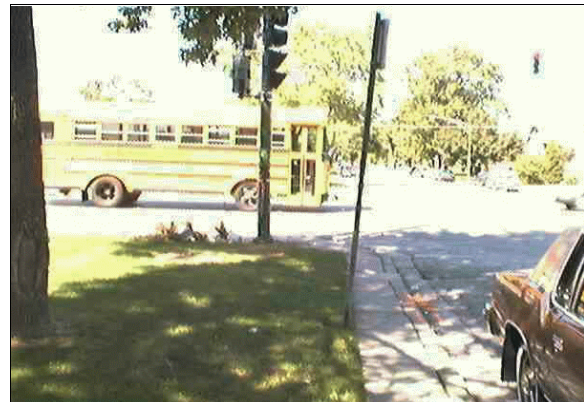
The front of the case vehicle impacted a non-breakaway traffic signal support pole, causing the case vehicle's driver and front right passenger supplemental restraints (air bags) to deploy (**Figures 1 and 2**). The crash severity to the case vehicle was moderate [24-40 km.p.h. (15-25 m.p.h.)]. The case vehicle was towed away from the scene due to disabling damage.

Figure 1: Northward view of case vehicle's north-westward travel path off left road edge (curb) into impact with signal pole

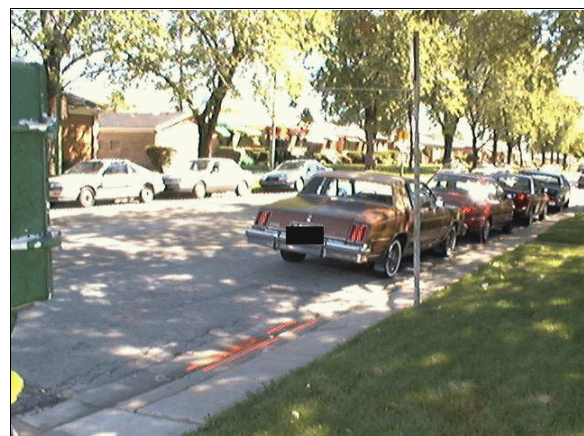
Figure 2: Southeastward view of case vehicle's north-westerly approach path, view from final rest position

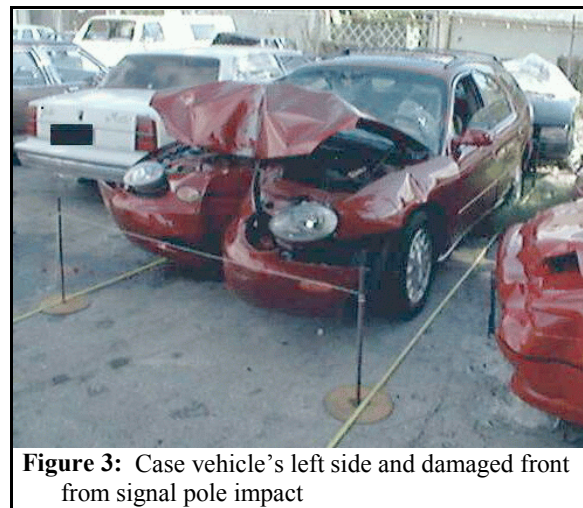
The front of the case vehicle struck a rigid (non-breakaway) steel pole slightly to the right of center (**Figure 3**), resulting in a narrow impact with maximum crush 58 centimeters [23 inches]. The pole had a diameter of approximately 20 centimeters [8 inches]. The pole was not damaged and did not move. The left and right front bumper corners were pulled inward symmetrically, approximately 40 centimeters [16 inches] on each side, and there was remote buckling on the right and left fenders. The engine hood was folded and sustained narrow crushing at the center. The folded hood was pushed against the windshield, causing extensive cracking across the entire width. In

Figure 3: Case vehicle's left side and damaged front from signal pole impact

addition, the front right passenger air bag module's cover flap struck the windshield immediately above the module, causing particularly dense cracking of the windshield in that localized area. There was no other glazing damage. The wheelbase was shortened by 4 centimeters [1.6 inches] on the left and 12 centimeters [4.7 inches] on the right. None of the tires were deflated, but the right front wheel was restricted due to having been pushed rearward against the back of the wheel well. There were no intrusions into the passenger compartment. The CDC for the pole impact was determined to be: **12-FCEN-3**, with direction of principal force 0 degrees. The WinSMASH reconstruction program, BARRIER-POLE option -- and observing the revised data input protocols (see Appendix B) -- was used on the case vehicle's most severe impact. The Total, Longitudinal and Lateral Delta Vs are, respectively: 31 km.p.h. [19 m.p.h.], -31 km.p.h. [-19 m.p.h.] and 0 km.p.h. [0 m.p.h.].

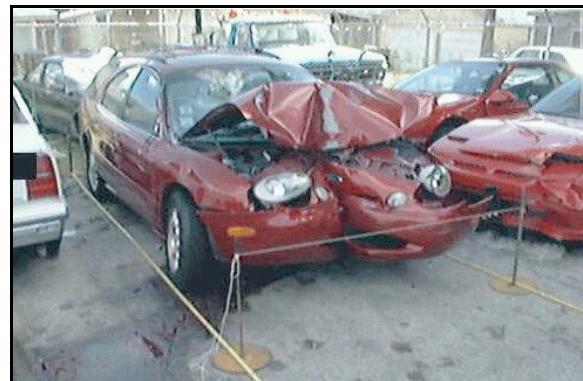
The case vehicle also had minor scraping along the midline of the right front and rear doors, and the right outside rearview mirror was torn off (**Figure 4**). It is not know if this minor damage was pre-existing, was a result of an unknown event immediately prior to the pole impact, or was a result of post-crash handling and storage. It seems likely, however, that the right side of the case vehicle scraped a parked car or other object shortly before running off the road to the left (west). The CDC for the right side damage is estimated as: **12-RPMS-1**.

Figure 4: Case vehicle's right side and damaged front from signal pole impact; Note: unknown damage exists on right side

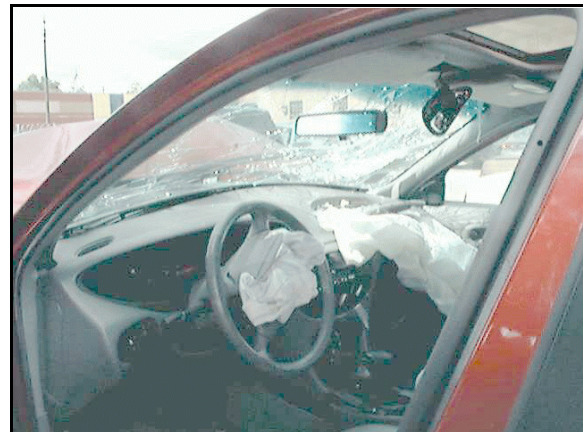
The driver's air bag was located in the steering wheel hub, with the module cover flaps in the "H" configuration (**Figures 5 and 6**). The flaps opened along the perforations, with no evidence of damage to the flaps, the adjacent structures, or the air bag itself. The deployed driver's air bag was round with diameter 63 centimeters [25 inches], with no vent ports, and two tether straps. The NASS investigator annotated several areas of apparent contact to the front of the driver's air bag, but these are not visible in the photographs. The NASS investigator concluded that the driver contacted the driver's air bag with her face and chest.

Figure 5: Case vehicle's front seating area from left showing deployed driver and front right passenger air bags

The front right passenger air bag was located in the top of the instrument panel. The NASS investigator did not record any information about the shape, size dimensions, or condition of the front right passenger air bag. The passenger air bag module's cover flap struck the windshield causing an area of dense cracking immediately above the module.

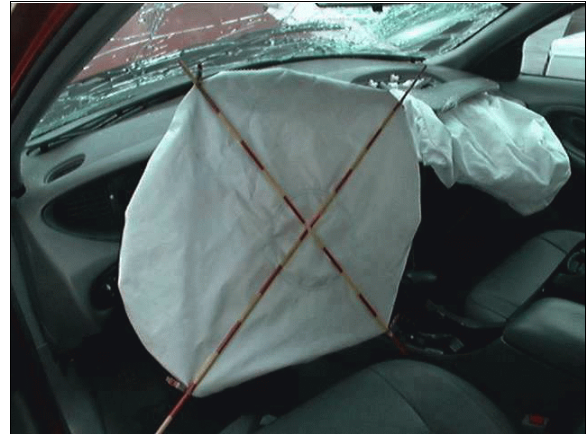
Figure 6: Case vehicle’s driver’s air bag
