Remote / Vehicle vs Tractor Trailer vs Vehicle vs Vehicle vs Vehicle vs Vehicle Dynamic Science, Inc. / Case Number: DS97023

1996 Mercedes Benz E320 4-door

California
September, 1997

Technical Report Documentation Page 1. Report No. 2. Government Accession No. 3. Recipient Catalog No. DS97023 4. Title and Subtitle 5. Report Date In-Depth Accident Investigation 6. Performing Organization Report No. 7. Author(s) 8. Performing Organization Report No. Dynamic Science, Inc. 9. Performing Organization name and Address 10. Work Unit No. (TRAIS) Dynamic Science, Inc. 530 College Parkway, Ste. K. 11. Contract or Grant no. Annapolis, MD 21401 DTNH22-94-D-27058

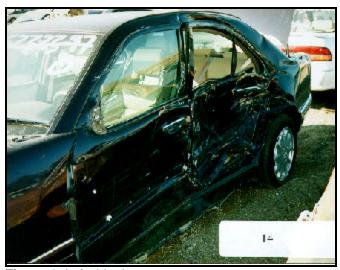
Damage Description: Major damage to the hood, grille area, both front

quarter panels, the entire left side, the back end, hood, and rear right quarter panel. There was damage to the rear axle, with both of the rear tires restricted. The vehicle was declared a total loss by the insurance

CDC Impact # 1 Vehicle 1 vs Vehicle 2 Driver's side air bag deployment event (not the highest Delta-V):

10LZEW3

Figure 1. Left side damage.

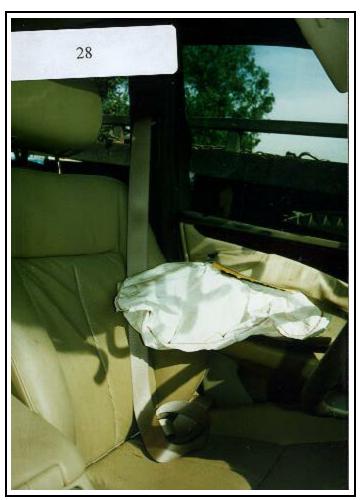
Vehicle 1 is equipped with a Supplemental Restraint System which includes a driver's and a front right passenger's air bag, dual front door mounted side air bags, electronic Emergency Tensioning Retractors (ETR) which also incorporate mechanical belt force limiters, and knee bolsters. Neither front nor side air bags will deploy if the seat is empty (less than eleven pounds detected). Neither frontal air bag deployed in this collision. The driver's door mounted side air bag did deploy, and the driver's ETR activated.

Figure 2. Driver's side ETR and air bag.

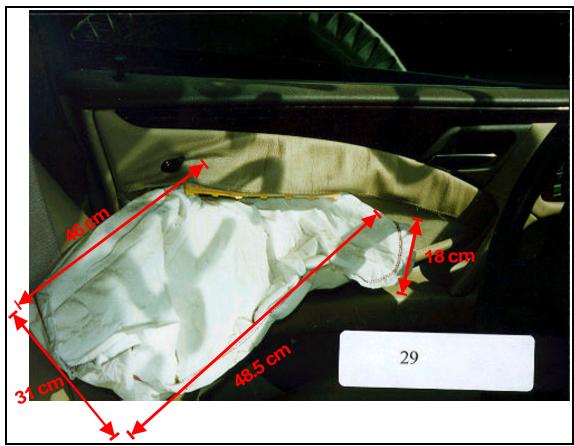
Figure 3. Driver's door mounted side air bag.
