**ON-SITE DRIVER AIR BAG RELATED SEVERE INJURY CRASH INVESTIGATION**

**VEHICLE: 1991 FORD TAURUS**

**VERIDIAN CASE NO. CA97-029**

**CRASH DATE: MAY, 1997**

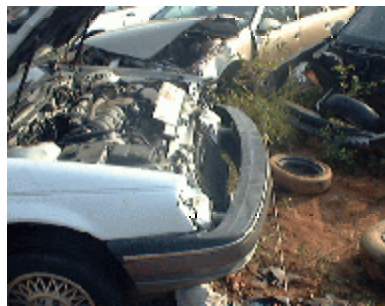
The impact resulted in a 12 o'clock/6 o'clock impact configuration to the Taurus and Explorer respectively and initiated the deployment sequence of the Taurus' driver side air bag system. The impact to the Ford Taurus compressed the front bumper Energy Absorption Devices (EAD), resulting in longitudinal striations to the male end component. Direct contact damage produced longitudinal abrasions to the top surface of the bumper fascia which extended rearward into the header panel with subsequent deformation of the upper radiator support panel. There was no residual crush at the bumper level. Crush measurements at the radiator support yielded a maximum crush value of 17.2 cm (6.75 in)

at C4 which was located 60 cm (24 in) left of the right front bumper corner. Crush values are reported in Table 1. The damage resulted in a 12 o'clock direction of force with a Collision Deformation Classification (CDC) of 12-FDEW-1. The Taurus sustained a ROLDMISS calculated total delta V of 18.4 km/h (11.4 mph).

Figure 2. Right lateral view of the crush damage to the upper radiator support of the Ford Taurus.

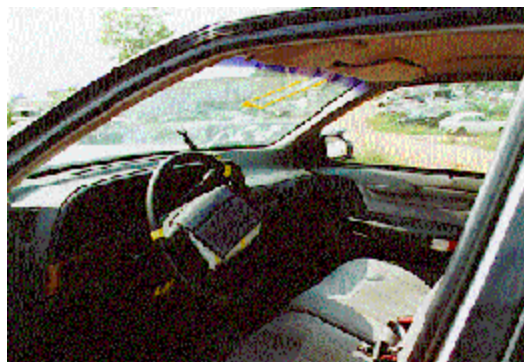
Figure 3. Overall view of the Ford Taurus' passenger compartment

**Interior:** The interior of the 1991 Ford Taurus L did not sustain intrusion damage that was associated with exterior crush damage, however, the interior did sustain minor damage that was associated with driver and right front passenger contact.
