CALSPAN ON-SITE REDESIGNED AIR BAG INVESTIGATION
CALSPAN CASE NO. CA97-51
VEHICLE: 1998 FORD TAURUS SE
LOCATION: STATE OF PENNSYLVANIA
CRASH DATE: NOVEMBER 1997

1. <i>Report No.</i> CA97-51	2. <i>Government Accession No.</i>	3. <i>Recipient's Catalog No.</i>	
4. <i>Title and Subtitle</i> Calspan On-Site Redesigned Air Bag Investigation Vehicle: 1998 Ford Taurus SE Location: Pennsylvania		5. <i>Report Date:</i> April, 2000

14. <i>Sponsoring Agency Code</i>	
15. <i>Supplementary Notes</i> On-site investigation of an intersection crash that resulted in the deployment of the frontal redesigned air bags in a 1998 Ford Taurus.

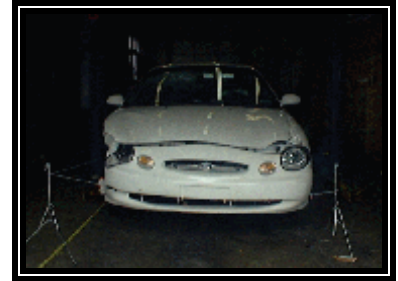
Figure 1. Frontal view of the 1998 Ford Taurus.

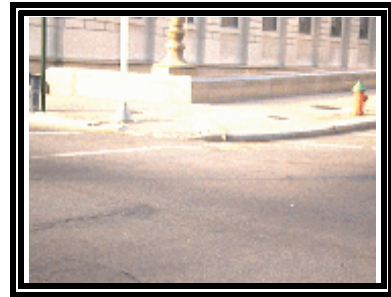
Figure 2. View from the initial impact location to the northwest quadrant of the intersection.

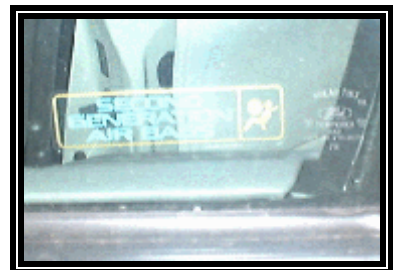
The 1998 Ford Taurus, 4-door sedan, was manufactured in 11/97 and was identified by vehicle identification number (V.I.N.) 1FAFP52U8WA (production number omitted). The fourth character (F) of the V.I.N. identified the redesigned frontal air bag system. In addition, labels were affixed to the lower rear aspect of the left front and right front door window glazing (**Figure 3**), adjacent to the “B”-pillar, identified that the vehicle was equipped with “SECOND GENERATION AIR BAGS”.

Figure 3. “SECOND GENERATION AIR BAG” label affixed to the right front door glazing.

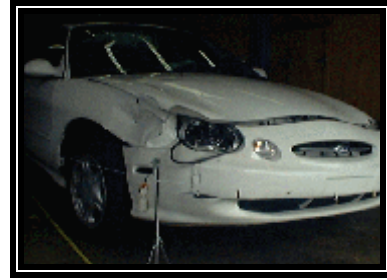
The initial frontal impact sequence resulted in direct contact damage to the front bumper fascia of the Taurus which began 45 cm (18 in) right of the center and extended 23 cm (9 in) to the right (**Figure 4**). Maximum crush was located at the front right bumper corner which yielded 7.5 cm (3.0 in) of residual crush. As the vehicle's began to rotate, the right front fender of the Taurus engaged against the corner aspect of the Tracer resulting in contact damage to the fender. This contact damage extended 43 cm (17 in) rearward of the corner with 7.6 cm (3.0") of sheet metal crush. The damage resulted in a 1 o'clock direction of force with a Collision Deformation Classification (CDC) of 01-FREE-2.

Figure 4. Initial front right corner impact damage to the Ford Taurus.

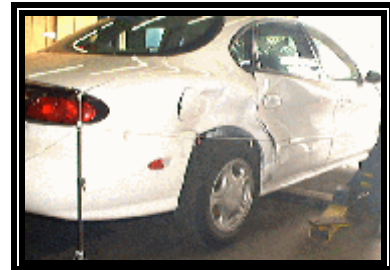
The initial impact induced a counterclockwise rotation to the Taurus and clockwise rotation to the Tracer which resulted in a sideslap impact involving the right rear passenger compartment and quarter panel of the Taurus (**Figure 5**) against the left rear quarter panel of the Tracer. The secondary impact to the Taurus generated direct contact damage that began 42.0 cm (16.5 in) forward of the right rear axle and extended forward 159.0 cm (62.6 in). Maximum crush was 22.0 cm (8.7 in) located 89.6 cm forward of the right rear bumper. This impact resulted in a 3 o'clock direction of force with a CDC of 03-RZEW-2.

Figure 5. Sideslap damage to the right rear side of the Taurus.

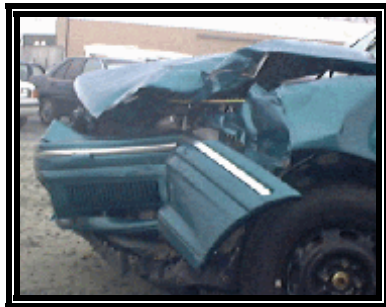
The left front damage that resulted from the initial impact with the Taurus produced approximately 27.0 cm (10.6 in) of lateral crush. The direct contact damage began 277 cm (109 in) forward of the left rear axle and extended an additional 31 cm (12 in) forward to the front bumper corner. The damage resulted in an 10 o'clock direction of force with a CDC of 10-LFEE-2 (**Figure 7**). The estimated delta V for this impact was 12-16 kph (8-10 mph).

Figure 6. Initial impact damage to the left front side area of the Mercury Tracer.

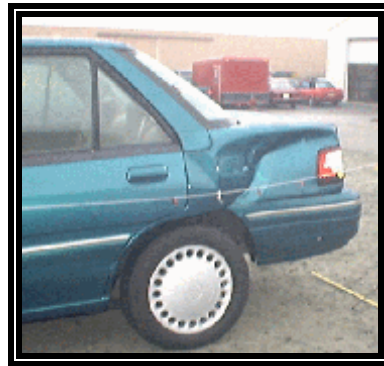
The secondary sideslap impact to the Tracer generated direct contact damage that began at the left rear bumper corner and extended forward 96 cm (38 in). Maximum crush was located 60 cm (24 in) forward of the left rear bumper corner and yielded 12 cm (5 in) of residual crush. This impact resulted in a 9 o'clock direction of force with a CDC of 09-LBEW-2.

Figure 7. Sideslap damage to the left rear of the Tracer.

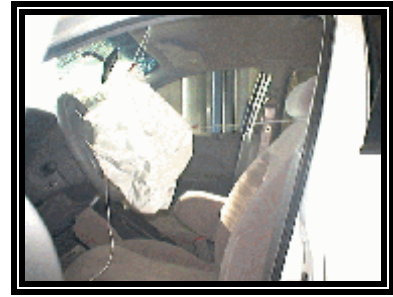
The driver of the Ford Taurus was seated in a mid track position with the seat back reclined to an angle of 17 degrees. He was not wearing the manual 3-point lap and shoulder belt system. The initial frontal impact sequence deployed the redesigned frontal air bag system. The driver responded to the 1 o'clock direction of force by moving forward and laterally to his right. He initially contacted the deployed redesigned front left air bag with his face and chest. The air bag protected the driver from contact against the steering assembly and possible injury (**Figure 8**).

Figure 8. Profile view of the driver's trajectory and the deployed front left air bag.
