CALSPAN ON-SITE AIR BAG DEPLOYMENT INVESTIGATION

NASS CDS CASE NO. 1998-05-050A

VEHICLE #1 - 1995 MITSUBISHI ECLIPSE RS

CRASH DATE - APRIL, 1998

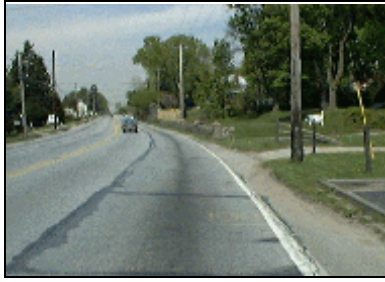
During the pre-impact trajectory, the driver attempted to regain control of the vehicle by applying full brakes and steering to the left. This was evident by the right side tire sliding gouges in the grass embankment (**refer to Figure 1**).

Figure 1- Trajectory of Vehicle #1
30 m (100 prior to the POI)

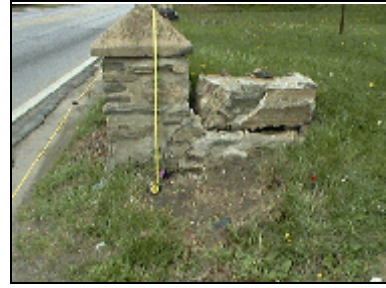
Figure 2- View of the stone wall
struck by the front of Vehicle #1

The frontal plane of Vehicle #1 contacted the stone wall (**refer to Figure 2**) resulting in a Collision Deformation Classification (CDC) code of 12-FDEW-2 (**refer to Figures 3-5**). A speed reconstruction using the WinSMASH algorithm indicated Vehicle #1 sustained a delta V of 29.1 km/h (18.1 mph) which was sufficient to actuate the Supplemental Restraint System (SRS). The vehicle came to the final rest position (FRP) against the wall.

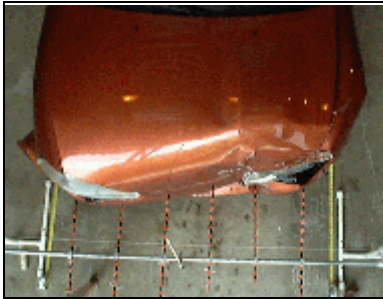
Figure 3- Overhead view of the
frontal damage to Vehicle #1

The 1995 Mitsubishi Eclipse was equipped with a dual front Supplemental Restraint System (SRS) which deployed as the result of the impact with the stone wall. Exterior damage to the vehicle involved the front bumper, the hood, left front fender, and left head light assembly. The maximum crush of 36.2 cm (14.25") was located 36.8 cm (14.5") left of the vehicle centerline. The vehicle was not equipped with an ABS braking system. The frontal crush profile is listed in the following table:

Frontal Crush Profile	C ₁ = 26.0 cm (10.25")	C ₂ = 35.6 cm (14.0")	C ₃ = 30.5 cm (12.0")
	C ₄ = 24.1 cm (9.5")	C ₅ = 15.2 cm (6.0")	C ₆ = 14.0 cm (5.5")

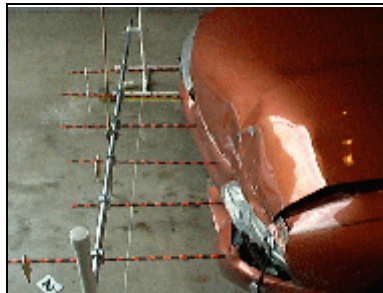
Figure 4- Lateral view of the frontal
plane showing the extent of crush

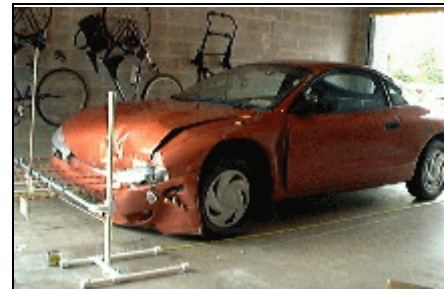
Figure 5- Left front corner view of
Vehicle #1

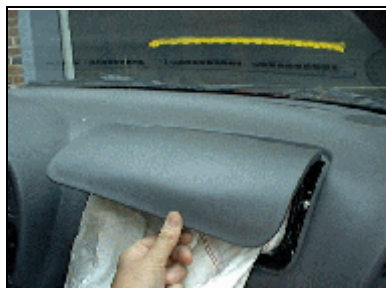
The front right air bag module was a mid mount design which incorporated a single flap that opened upward toward the windshield. The air bag module cover measured 35.6 cm (14.0") laterally and 22.9 cm (9.0") longitudinally. The left side of the module was located 19.1 cm (7.5") right of the vehicle centerline. The vinyl flap did not reveal any evidence of occupant contact during the deployment sequence (**refer to Figure 7**).

Figure 7- View of the front right air bag module cover

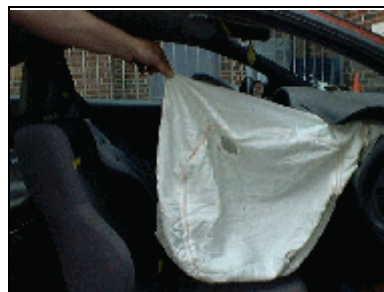
The longitudinal excursion of the front right air bag measured 73.7 cm (29.0") from the air bag module cover opening (**refer to Figure 8**). The right front seat was adjusted in the center position which measured 12.7 cm (5.0") rear of the full forward position and 12.1 cm (4.75") forward of the full rear position. The seat back support in this position was located 74.9 cm (29.5") rearward from the air bag module cover measured at a height of 45.7 cm (18.0") above the junction of the seat cushion.

Figure 8- Lateral view of the front right air bag showing extent of excursion

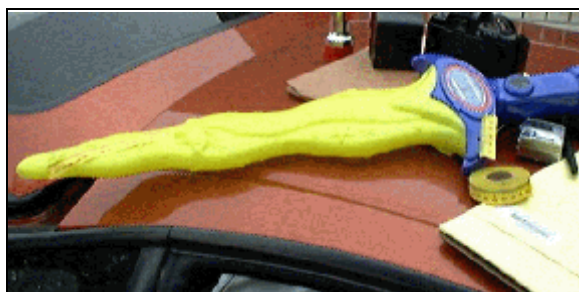
The driver and her six year old son had an active evening which included attendance at the circus and dinner afterwards. She had purchased a 0.9 m (3.0') bright yellow color plastic sword for him at the circus which he was holding while sitting in the right front seat (**refer to Figure 9**). The child being right handed held the sword

Figure 9- View of the sword held by the child at the time of the crash
