**REDESIGNED AIR BAG SPECIAL STUDY (RABSS)
SCI TECHNICAL SUMMARY REPORT**

NASS RABSS CASE NO. 1998-11-802G

RABSS VEHICLE - 1998 FORD TAURUS SE

CRASH DATE - JUNE, 1998

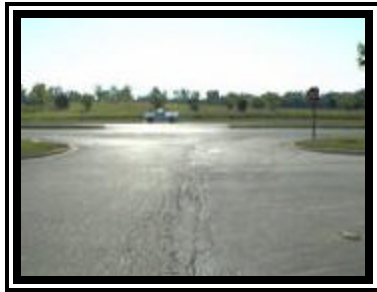
The 49 year old male driver of the 1998 Ford Taurus was operating the vehicle eastbound and exiting a parking lot (**Figure 1**) when he failed to observe the southbound Ford Escort as attempted to turn left (north). The NASS interview revealed that the driver was watching northbound traffic in anticipation of the left turn, and didn't notice the Ford Escort. The 16 year old female driver of the Ford Escort was operating the vehicle southbound (**Figure 2**) in the center lane at a driver reported

Figure 1. Eastbound approach for the 1998 Ford Taurus SE.

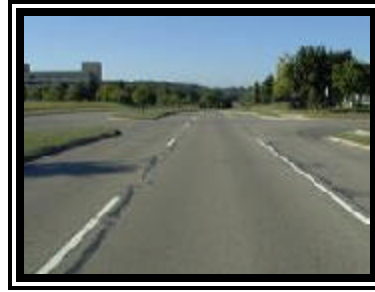
Figure 2. Southbound approach for the 1993 Ford Escort LX.

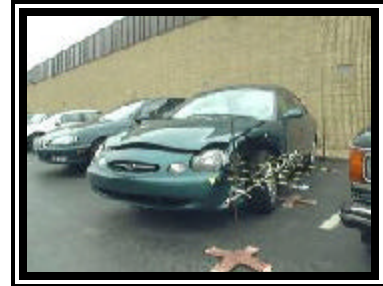
The 1998 Ford Taurus SE sustained moderate left side damage as a result of the impact with the Ford Escort (**Figure 3**). The direct contact damage began at the front left bumper corner and extended 89.0 cm (35.0 in) rearward. The combined direct and induced damage length (Field L) began at the front left bumper corner and extended 114.0 cm (44.9 in) rearward. Six crush measurements were documented at the level of the mid-door: C1= 0 cm, C2= 8.0 cm (3.1 in), C3= 10.0 cm (3.9 in), C4= 22.0 cm (8.7 in), C5= 13.0 cm (5.1 in), C6= 9.0 cm (3.5 in). Minor lateral displacement was noted to the hood. The windshield fractured at the right mid-windshield area from the interior passenger air bag module cover flap (only).

Figure 3. Left side damage to the 1998 Ford Taurus SE.

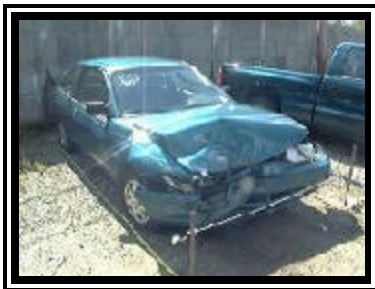
Figure 4. Frontal damage to the 1993 Ford Escort LX.

The 1993 Ford Escort LX sustained moderate frontal damage as a result of the impact with the Ford Taurus (**Figure 4**). The direct contact damage began at the front right bumper corner and extended 73.0 cm (28.7 in) inboard. An indentation was documented to the center section of the front bumper from the left front wheel of the Taurus. The hood was displaced up and rearward from engagement against the side surface of the Taurus. Induced buckling was noted to the right fender. The windshield was undamaged.

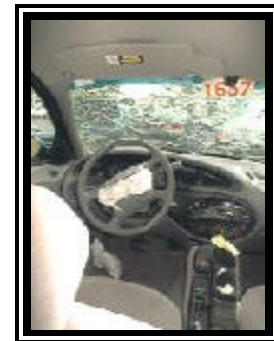
There was no damage to the interior surfaces of the Ford Taurus from intrusions or occupant contact (**Figure 5**).

Figure 5. Interior view.

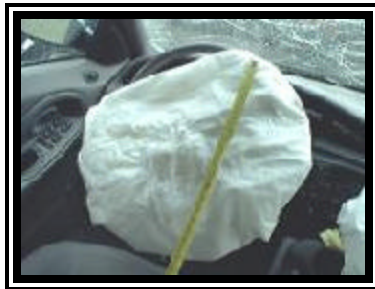
NASS researcher measured the diameter of the driver air bag at 49.0 cm (19.3 in) in its deflated state (**Figure 6**). The bag was tethered by two internal straps and vented by two ports located at the 11 o'clock and 1 o'clock sectors on the rear aspect of the air bag.

Figure 6. 1998 Ford Taurus SE redesigned driver air bag.

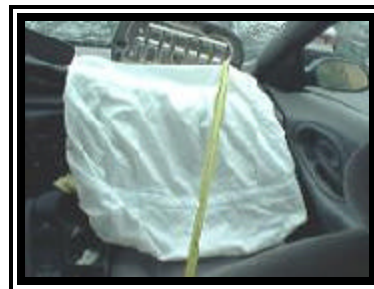
The front right passenger air bag deployed from the right top instrument panel area with a single cover flap design hinged at the forward aspect. The right windshield area was fractured by the cover flap during the air bag deployment. No contact evidence identified on the air bag or exterior surface of the module cover flap. The cover flap was rectangular in shape and measured 43.0 cm (16.9 in) in width and 30.0 cm (11.8 in) in height. The NASS researcher measured the passenger air bag at 63.0 cm (24.8 in) in width and 54.0 cm (21.3 in) in height in its deflated state (**Figure 7**). The bag was tethered by two internal straps. No vent ports were present. No cutoff switch was reported for the front right redesigned passenger air bag.

Figure 7. 1998 Ford Taurus SE redesigned passenger air bag.

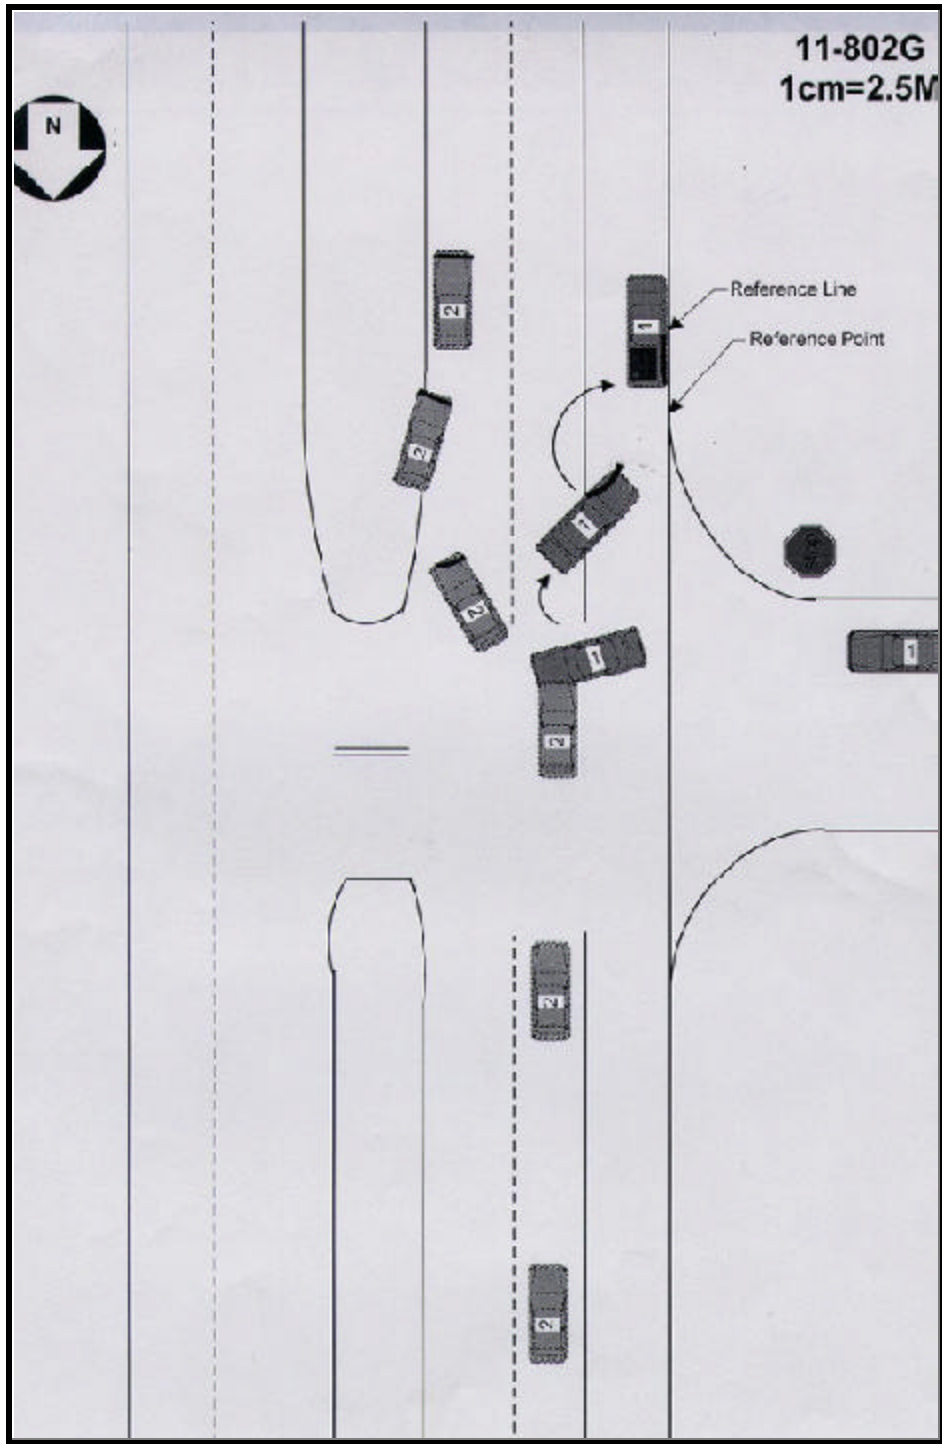
Figure 8. NASS Scene Diagram.

This two vehicle crash occurred during the afternoon hours of June, 1998. At the time of the crash, it was daylight with no adverse conditions as the roads were dry. The crash occurred in the southbound lanes (see **Figure 8 - page 5**) of a straight and level 5-lane north/south asphalt roadway which was divided by a center traffic island. Traffic control at the scene included a stop sign for eastbound traffic which had a posted speed limit of 64 km/h (40 mph).
