Remote, Redesigned Air Bag Special Study

Dynamic Science, Inc., Case Number (1998-048-802E)

1998 Toyota Tacoma

October, 1998

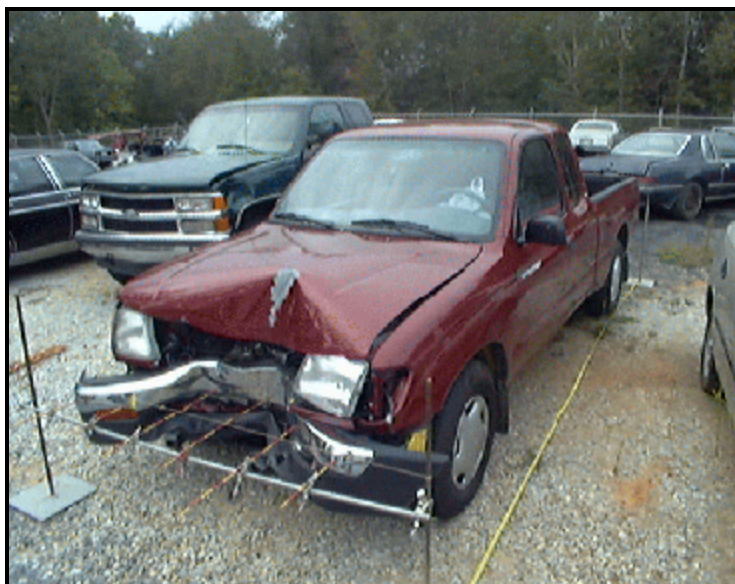
Figure 1. Exterior, Vehicle 1 (Toyota Tacoma)

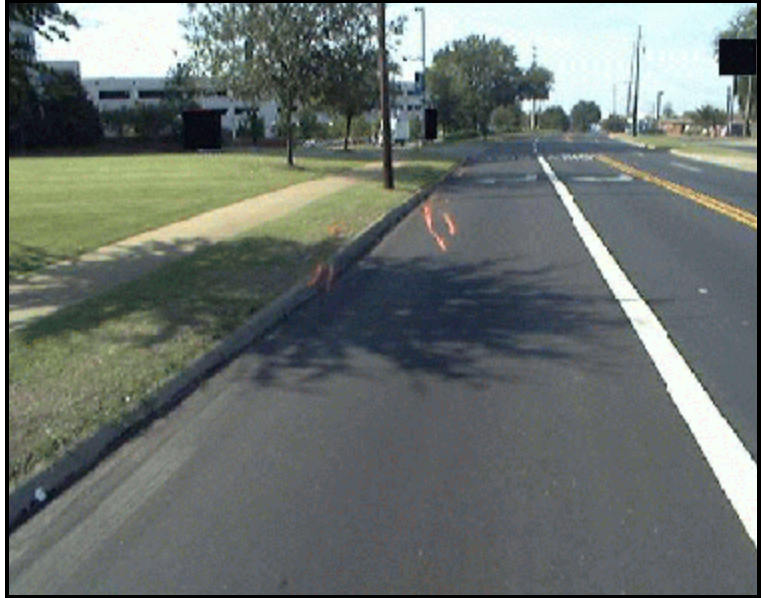
Figure 2. Approach to pole impact (event 3)

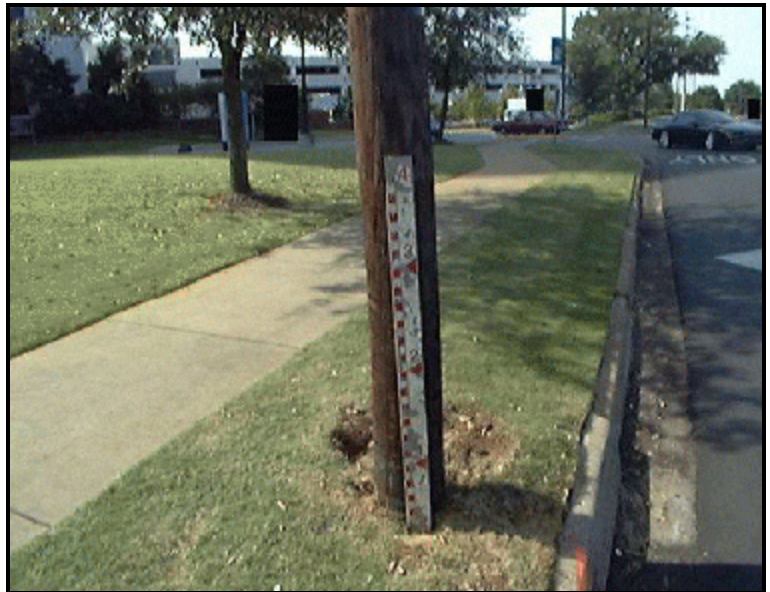
As a result of the third event frontal impact, the supplemental restraint system (driver side air bag) of the case vehicle deployed. The front right air bag did not deploy. The center instrument panel mounted passenger's side air bag switch was turned to the "off" position at the time of the crash.

Figure 3. Impact with pole (event 3)

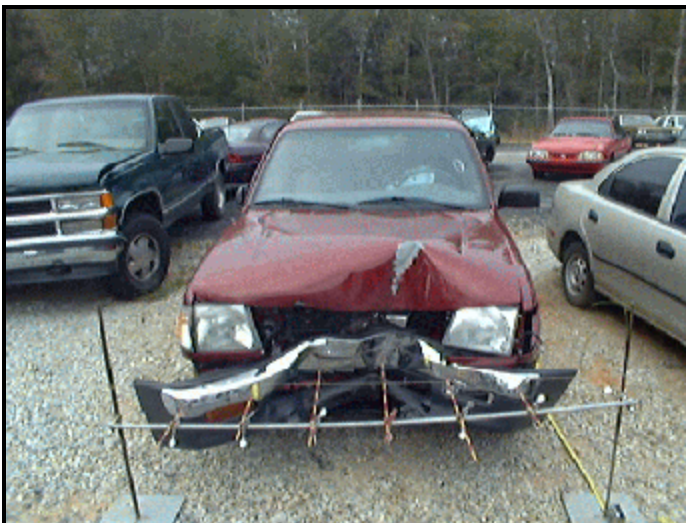
Plane of Impact	Field L cm/in.	C1 cm/in.	C2 cm/in.	C3 cm/in.	C4 cm/in.	C5 cm/in.	C6 cm/in.
Bumper	130	0	9	28	23	0	0
	51.2	0	3.5	11	9.1	0	0

Figure 4. Exterior, Vehicle 1 (1998 Toyota Tacoma pickup)

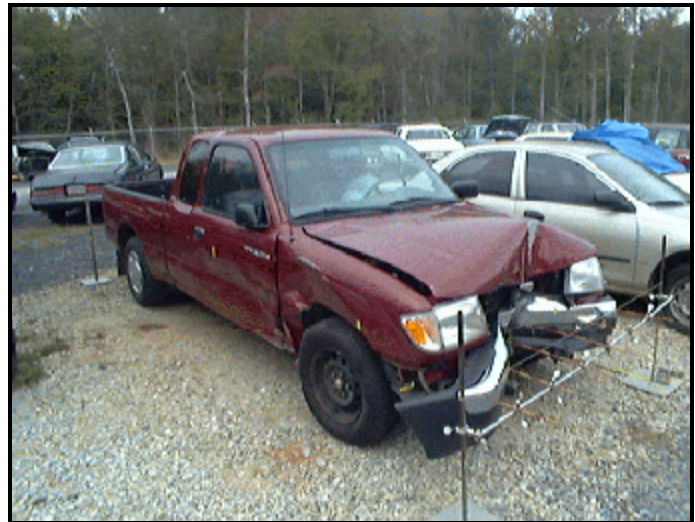
Figure 5. Exterior, Vehicle 1 (1998 Toyota Tacoma pickup)

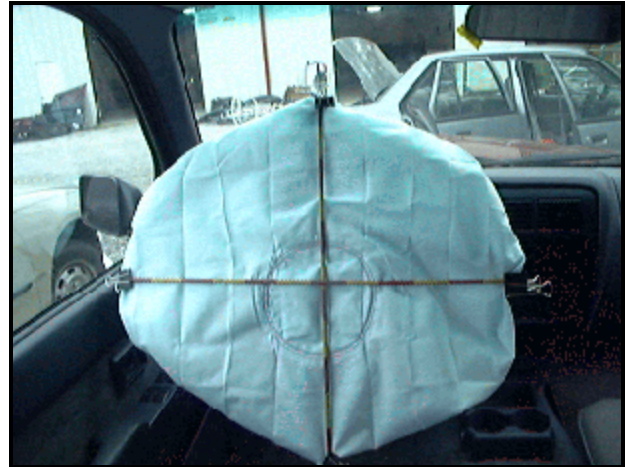
The front left air bag was housed in the steering wheel hub and was concealed by asymmetrical H-configuration cover flaps. The circular air bag was equipped with two tethers and two vent ports. No contact evidence was found on the bag and the bag was not damaged

Figure 6. Interior, case vehicle. Driver's side air bag

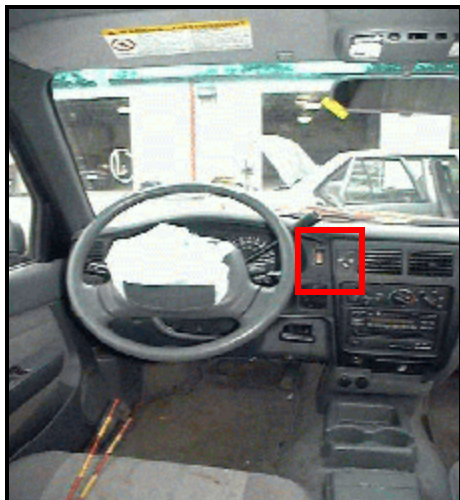
The front right air bag shut off switch was located on the center-instrument panel area. The switch is key activated and was turned to the left "Off" position. The switch is marked "Passenger Airbag" and was illuminated "Off" at the time of the crash.

Figure 7. Interior, case vehicle. Box indicates location of air bag shut off switch.

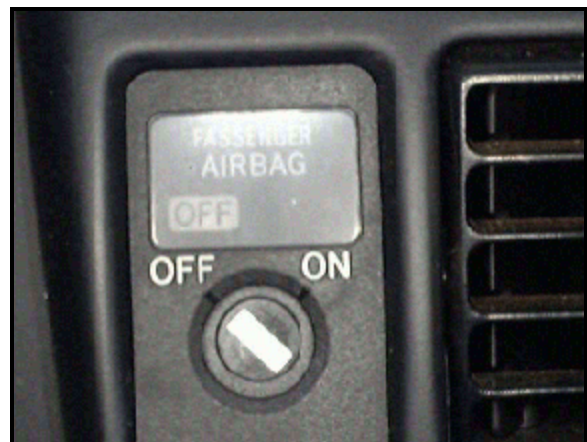
Figure 8. Interior, case vehicle. Passenger air bag shut off switch.
