Remote, Redesigned Air Bag Special Study FOR NHTSA'S INTERNAL USE ONLY

Dynamic Science, Inc., Case Number (1998-049-808E) 1998 Ford Taurus Texas September/1998

Summary

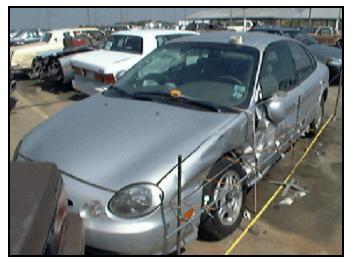
Figure 1. Exterior, Vehicle 1, 1998 Ford Taurus

Exterior of Case Vehicle

Model year, make and model	1998 Ford Taurus
VIN	1FAFP52U6WA
CDC	11LYAW2

Table 3. Crush Measurements

Plane of Impact	Field L cm/in.	C1 cm/in.	C2 cm/in.	C3 cm/in.	C4 cm/in.	C5 cm/in.	C6 cm/in.
Mid door	152	0	5	16	11	8	15
	59.8	0	2	6.3	4.3	3.1	5.9

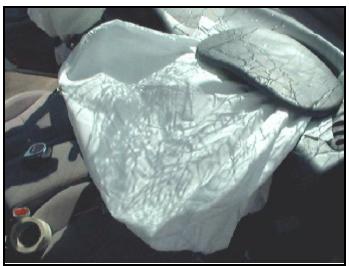
Figure 5. Passenger side air bag

The front right air bag was housed in the top-instrument

panel position and was concealed by cover flap. The rectangular air bag was equipped with one tethers and no vent ports.

Contact evidence consisting of what appeared to be blood was found on the bag. The air bag was not damaged.

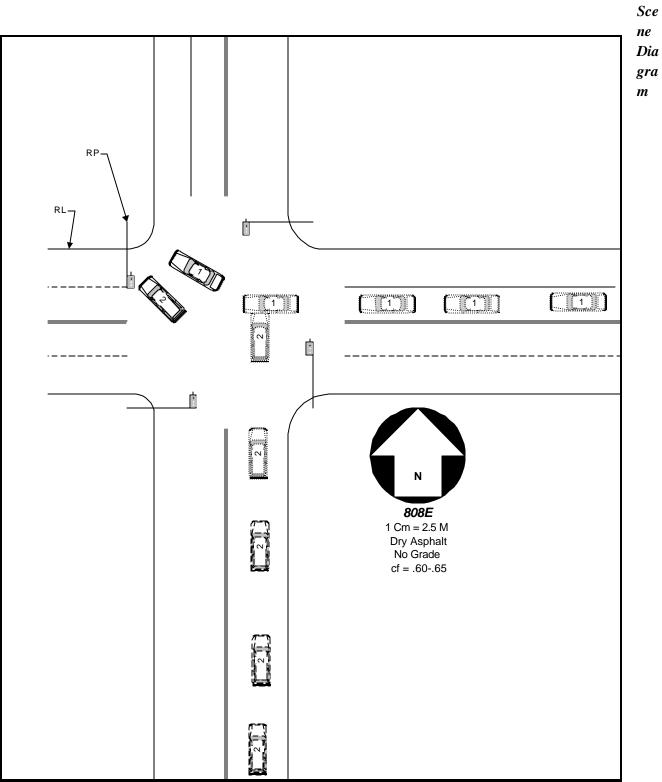
Figure 6. Scene diagram

The driver of Vehicle 1 failed to yield at the red light and entered the intersection. The front of the left side of Vehicle 1 (11LYAW2) was struck by the front of Vehicle 2 (82FDEW2). Vehicle 1 sustained a longitudinal delta V of -13 km/h (-8.1 mph) and a lateral delta V of +7 km/h (4.3 mph). Vehicle 2 sustained a longitudinal delta V of -7 km/h (-4.3 mph) and a lateral delta V of -12 km/h (-7.5 mph).

Vehicle 1 was pushed into a clockwise rotation and came to rest in the intersection facing to the northwest. Vehicle 2 was pushed into a counterclockwise rotation and came to rest facing generally northwest.
