INDIANA UNIVERSITY

ON-SITE REDESIGNED AIR BAG REPORT

CASE NUMBER - IN98-007
LOCATION - TEXAS
VEHICLE - 1998 FORD TAURUS SE
CRASH DATE - December, 1997

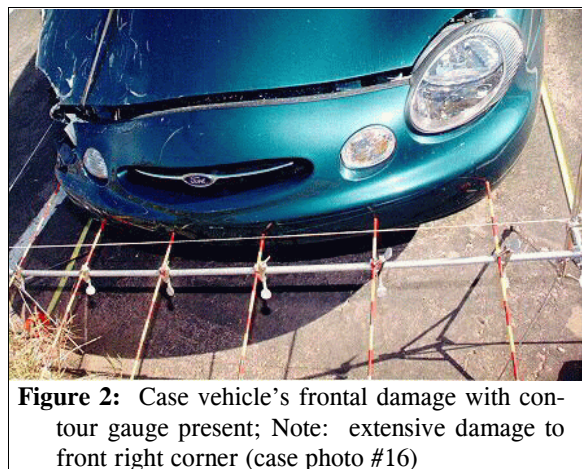
Figure 2: Case vehicle's frontal damage with contour gauge present; Note: extensive damage to front right corner (case photo #16)

The front right of the case vehicle (**Figure 2** above and **Figure 3**) impacted the left front of the Oldsmobile (**Figure 4**), causing the case vehicle's driver and front right passenger supplemental restraints (air bags) to deploy. As a result, the case vehicle rotated counterclockwise and came to rest mostly off the north roadside, facing northeast. The Oldsmobile rotated clockwise and came to rest on the roadway, facing east. Crash severity for the case vehicle's deployment impact was low [14-23 km.p.h. (9-14 m.p.h.)].

Direct damage began 6 centimeters (2.4 inches) to the right of the case vehicle's centerline and extended to the front right corner. Damaged components included the front bumper, grille, splash guard, front body apron, hood, radiator, cooling fan, air conditioner, windshield, right headlamp/turn signal assembly, right fender, right front door panel, left fender, and left front door panel (**Figures 3 and 5** above). Indirect damage extended to the rear of the right front fender and the forward seam of the right front door. In addition, there was indirect damage to the rear of the left front fender and the forward seam of the left front door.

The CDC for the case vehicle's single impact was determined to be: **12-FZEW-1** [maximum crush was 16 centimeters (6.3 inches)]. The WinSMASH reconstruction program, missing vehicle algorithm¹, was used on the case vehicle's highest severity impact. The Total, Longitudinal, and Lateral Delta Vs are, respectively: 10.7 km.p.h. (6.6 m.p.h.), -10.5 km.p.h. (-6.5 m.p.h.), and -1.9 km.p.h. (-1.2 m.p.h.). This contractor believes that the determined results for the deployment impact are low.

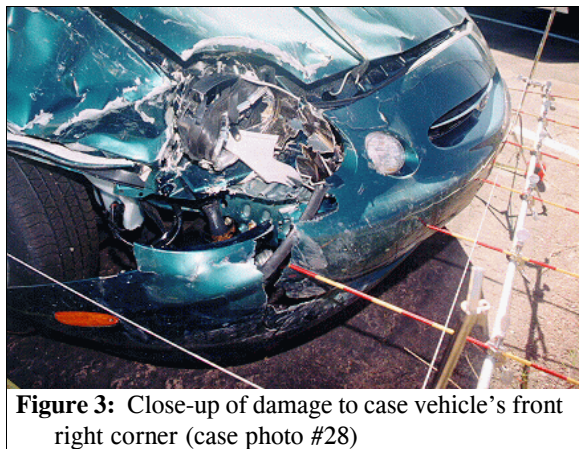
Figure 3: Close-up of damage to case vehicle's front right corner (case photo #28)

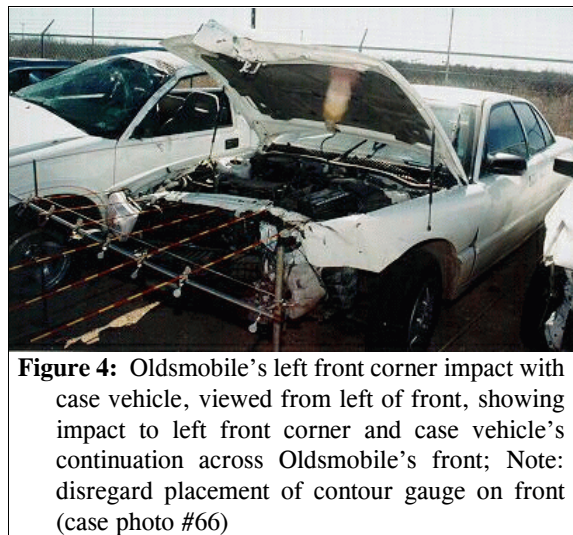
Figure 4: Oldsmobile's left front corner impact with case vehicle, viewed from left of front, showing impact to left front corner and case vehicle's continuation across Oldsmobile's front; Note: disregard placement of contour gauge on front (case photo #66)

The 1994 Oldsmobile Achieva S was a front wheel drive, four-door sedan (VIN: 1G3NL5532RM-----). The Oldsmobile was towed due to disabling damage. Based on the vehicle inspection, the CDC was determined to be: **10-LFEE-4** for the Oldsmobile [unknown maximum crush]. The Oldsmobile's driver (21-year-old male; unknown height and weight) was reportedly unrestrained and sustained "possible" injuries. He refused medical treatment at the scene. Although the Oldsmobile was equipped with a driver air bag, it did not deploy in the crash.

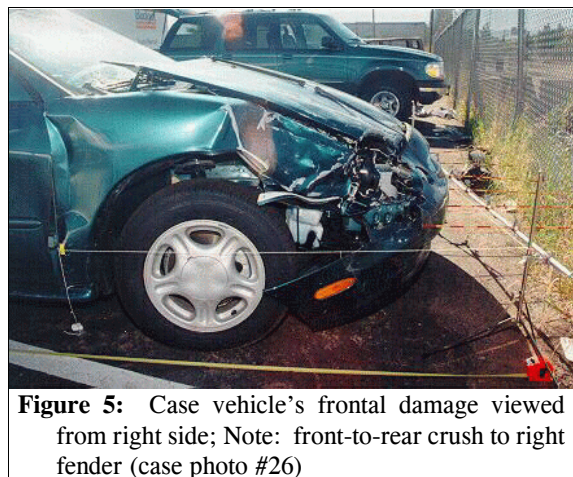
Figure 5: Case vehicle's frontal damage viewed from right side; Note: front-to-rear crush to right fender (case photo #26)

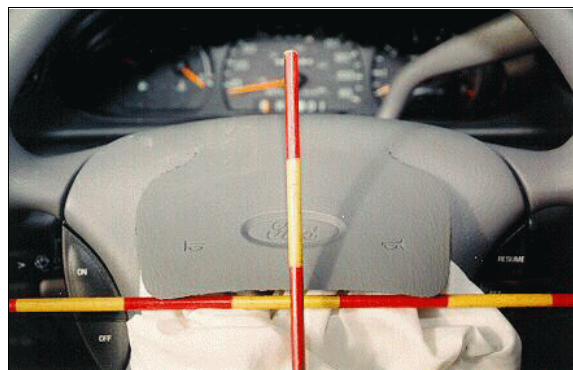
The 1998 Ford Taurus was equipped with a Supplemental Restraint System (SRS) that contained frontal air bags at the driver and front right passenger seat positions. Both air bags deployed as a result of the impact between the case vehicle and the Oldsmobile. The case vehicle's driver air bag was located in the steering wheel hub, with module seams in an asymmetrical, "H" configuration (**Figure 6**). Measurements for the larger, top cover flap were 10 centimeters (3.9 inches) along the top horizontal seam, 14 centimeters (5.5 inches) along the lower horizontal seam, 3 centimeters (1.2 inches) along the angled side seam, and 5 centimeters (2.0 inches) along the vertical side seam. Measurements for the smaller, bottom cover flap were 14 centimeters (5.5 inches) along the upper horizontal seam, 10 centimeters (3.9 inches) along the lower horizontal seam, and 5.6 centimeters (2.2 inches) at its maximum height (**Figure 7**). Both cover flaps opened along their designated tear seams. There was a possible driver contact to the top left of the upper cover flap, centered approximately 5 centimeters (2.0

Figure 6: Case vehicle driver air bag module's upper cover flap; Note: possible occupant contact to end of left upper seam (case photo #35)

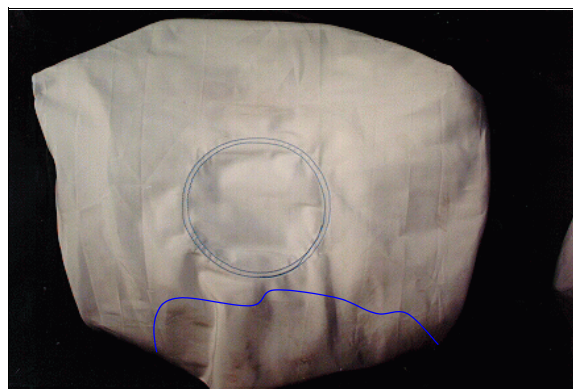
The front side of the driver's air bag (Figure 8) revealed a faint scuff to the top part of the upper right quadrant, some 20 centimeters (7.9 inches) up from the bag's horizontal axis and 5 centimeters (2.0 inches) right of the vertical axis. In addition, there was a large area of cloth transfers to the bottom right portion of the lower left quadrant and to most of the lower right quadrant, centered approximately 7 centimeters (2.8 inches) right of the vertical axis and 13 centimeters (5.1 inches) down from the horizontal axis. The reverse side of the driver's air bag fabric revealed a small scuff near the middle of the upper left quadrant (unmeasured), black scuffs near the circumferential seam of the lower left quadrant (unmeasured), and a small fluid spot near the middle of the lower right quadrant (unmeasured).

Figure 8: Case vehicle's driver air bag; Note: large area of cloth transfers at lower right (case photo #41)

The case vehicle's impact with the Oldsmobile, not only deployed the driver and front right passenger air bags, but thrust the driver forward and slightly upward, allowing her body to come into contact with the her air bag and depositing a large area of cloth transfers to the bottom right portion of the fabric's lower left quadrant and to most of the lower right quadrant. The impact also deployed the front right passenger air bag, and the front right passenger's movements would have mirrored those of the driver. Additionally, the front right passenger's right knee came into contact with the interior right front door panel, sustaining an abrasion. The front center and back center passengers were also thrust forward and slightly upward, but their forward reach would have been greater than that of the outboard passengers because they were not protected by a shoulder belt. The back outboard passengers were also thrust forward and slightly upward.

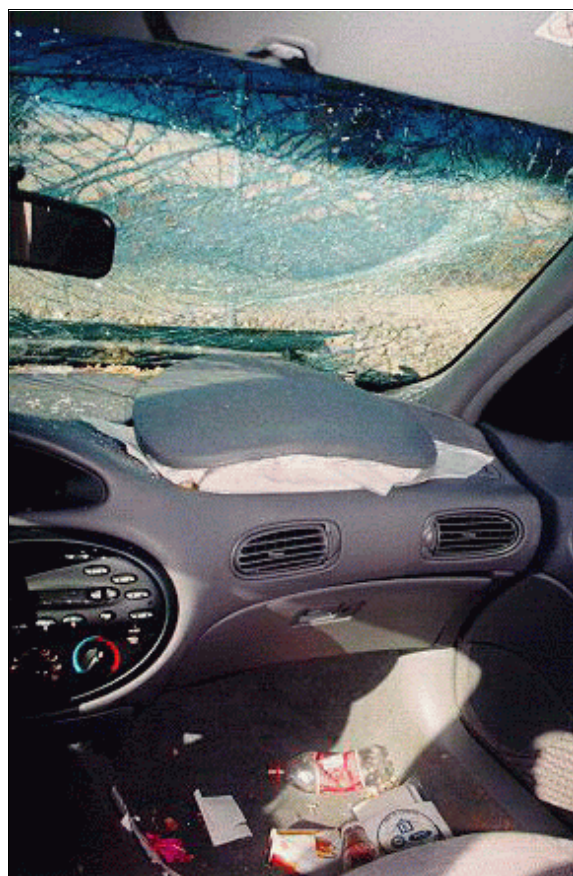
Inspection of the front right passenger's air bag, which was located in the top of the instrument panel, revealed that the single cover flap opened at its designated tear points. The shape of the cover flap was irregular and measured a maximum height of 30 centimeters (11.8 inches), a maximum length of 43 centimeters (16.9 inches) along its bottom seam, and contained three rounded corners (Figure 9). Deployment caused the cover flap to bend slightly in the middle and contact the windshield, with the flap's front seam abraded by the splintered glass. However, there did not appear to be any evidence of occupant contact to the cover flap. The deployed front right passenger air bag was rectangular, with a height of approximately 54 centimeters (21.3 inches) and a width of approximately 64 centimeters (25.2 inches). The front side of the passenger air bag fabric (Figure 10 below) revealed a small scuff at the mid-top of

Figure 9: Case vehicle front right air bag module's single cover flap; Note: asymmetrical shape (case photo #34)

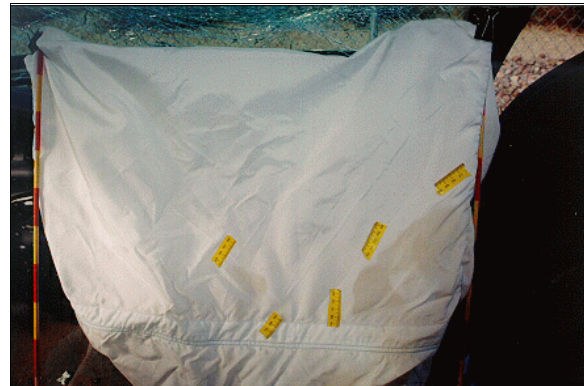
the upper left quadrant, a black scuff at the mid-top of the upper right quadrant, a small soda stain to the bottom left of the lower left quadrant, and a large coffee stain over the right two-thirds of the lower right quadrant, extending up into the bottom right corner of the upper right quadrant. The front right passenger's air bag was designed with one large tether, 52 centimeters (20.5 inches) wide, but had no visible vent ports.

Figure 10: Case vehicle's front right passenger air bag; Note: soda stain at lower left and large coffee stain at lower right (case photo #51)
