TRANSPORTATION RESEARCH CENTER

ON-SITE SIDE AIR BAG REPORT

CASE NUMBER - IN98-008
LOCATION - ARKANSAS
VEHICLE - 1997 MERCEDES BENZ E320
CRASH DATE - October, 1997

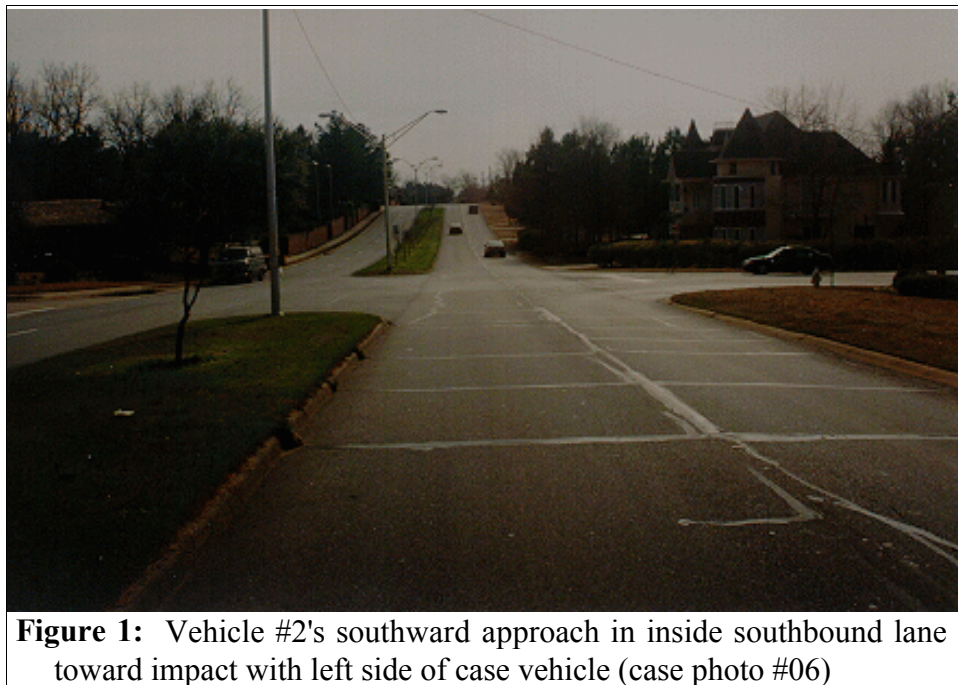
Figure 1: Vehicle #2's southward approach in inside southbound lane toward impact with left side of case vehicle (case photo #06)

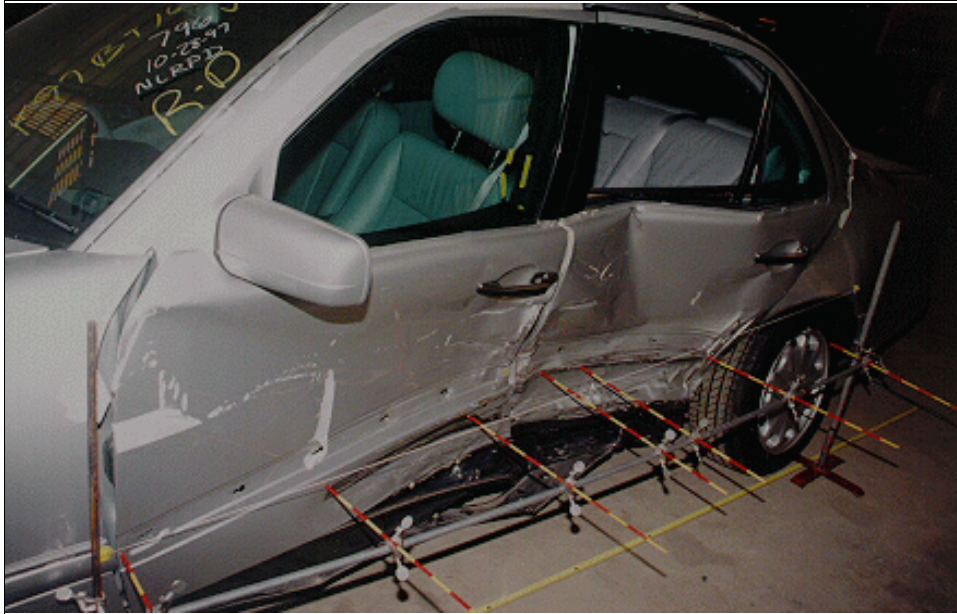
The case vehicle was a rear wheel drive 1997 Mercedes-Benz E320, four-door sedan (VIN: WDBJF55F3VJ-----) equipped with four-wheel anti-lock brakes. Direct contact was confined to the two left side doors, with some minor buckling of the left rear quarter panel (see **Figures 2 and 3**). Maximum crush was 27 centimeters (10.6 inches) and was located slightly rearward of the left "B"-pillar and approximately 30 centimeters (12 inches) above the sill. There was intrusion by left side components into the second seating row, including deformation of the seat cushion and buckling of the floor; see **Figure 7**. Intrusion into the driver's seating area was minor. The glazing in the left rear door was broken out, and both left side doors were jammed shut. The CDC for the case vehicle was determined to be **10-LPEW-2**. The winSMASH reconstruction program, damage only algorithm, was used on the case vehicle's highest severity impact. The Total, Longitudinal, and Lateral Delta Vs are, respectively: 17 km.p.h. (10 m.p.h.), -8 km.p.h. (-5 m.p.h.), and +14 km.p.h. (+9 m.p.h.). This was a low severity impact for the case vehicle.

Figure 2: Case vehicle's damaged left side, looking rearward (case photo #12)

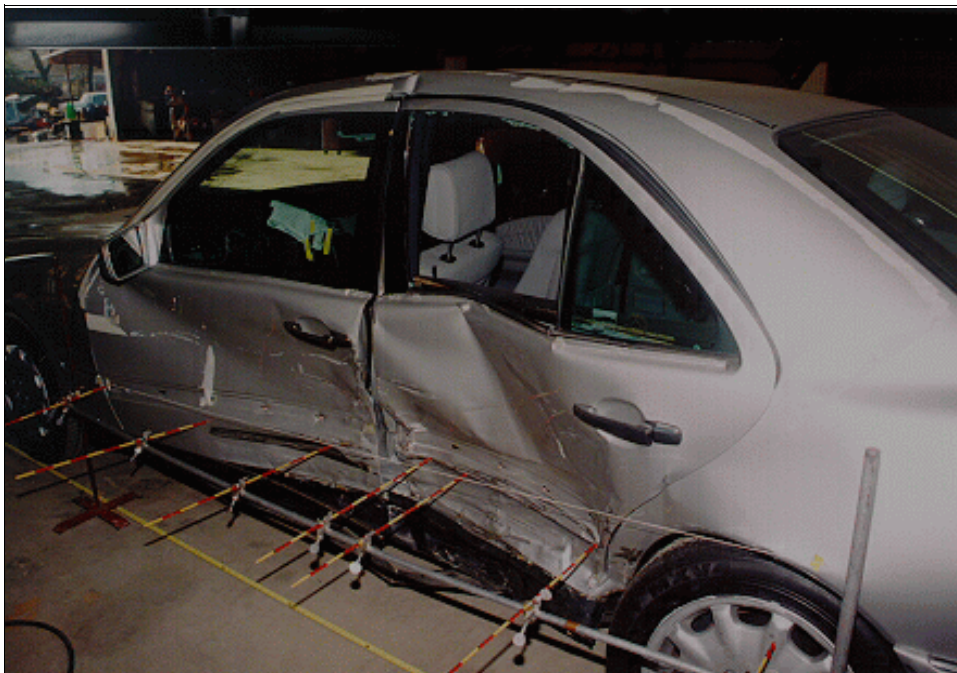
Figure 3: Case vehicle's damaged left side, looking forward (case photo #14)

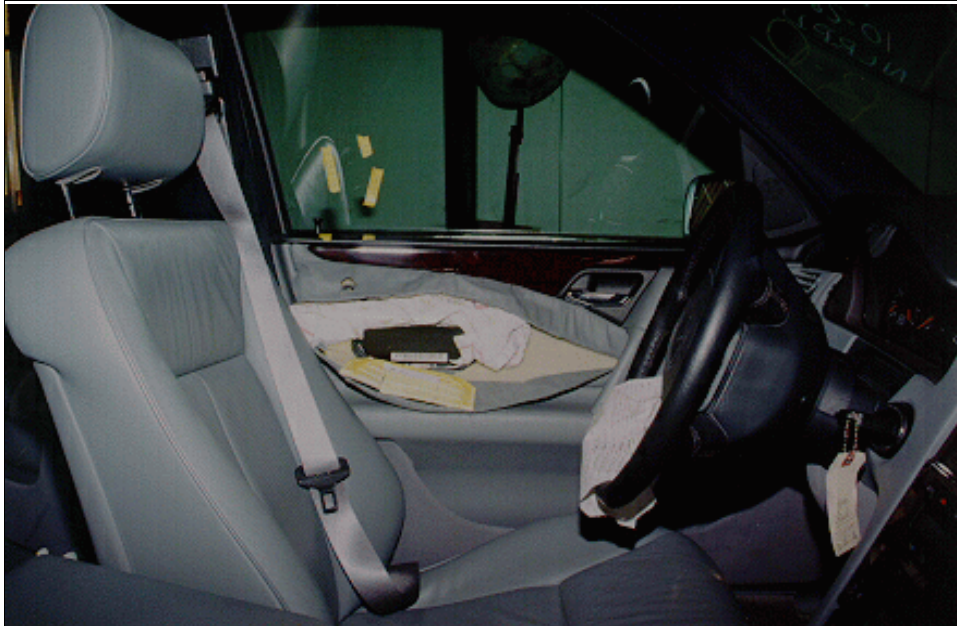
The driver's side air bag was located in the driver's door, immediately above the arm rest (see **Figure 4**). The deployed air bag was pear-shaped with the narrow end toward the front, approximately 50 centimeters (20 inches) long, 30 centimeters (12 inches) high at the wide end and 15 centimeters (6 inches) high at the narrow end (see **Figure 5**). The air bag module cover was made of flexible plastic/fabric with a pre-stressed seam running the entire length. The cover parted along the seam, with no evidence of damage to the cover panels or the adjacent door structures. The deployed air bag had several areas of scorching along the lower edge on the inside and outside surfaces (see **Figures 5 and 6**).

Figure 4: Case vehicle's driver seating area and left side air bag module (case photo #22)

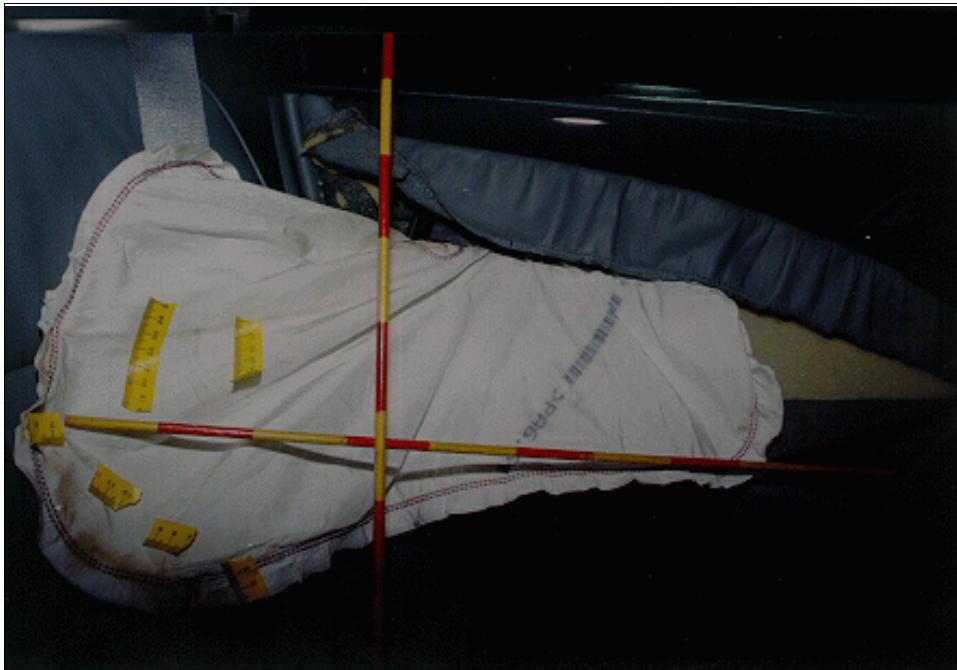
Figure 5: Outside surface of case vehicle's left side air bag (case photo #24)

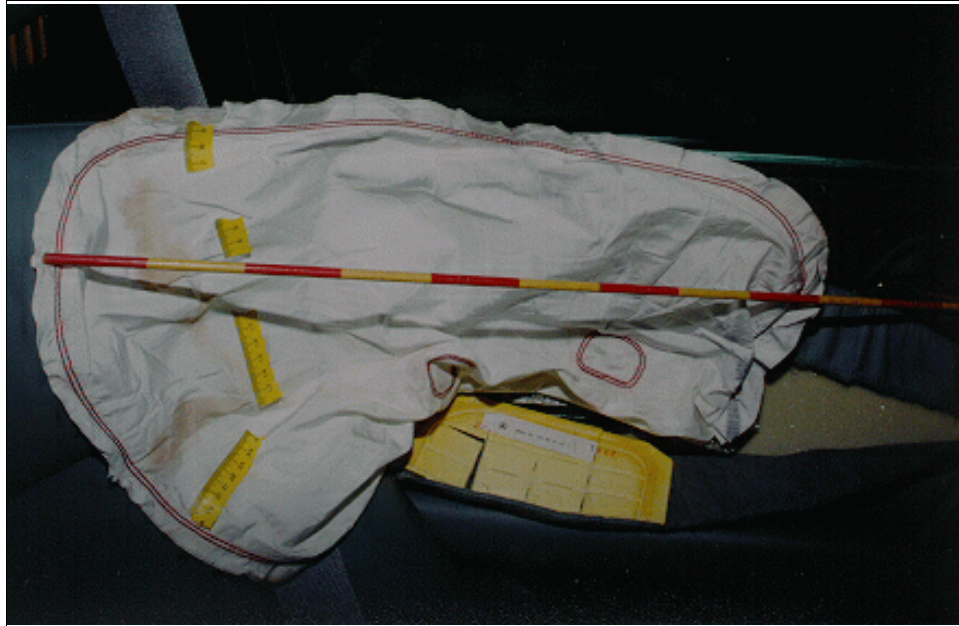
Figure 6: Inside surface of case vehicle's left side air bag (case photo #26)

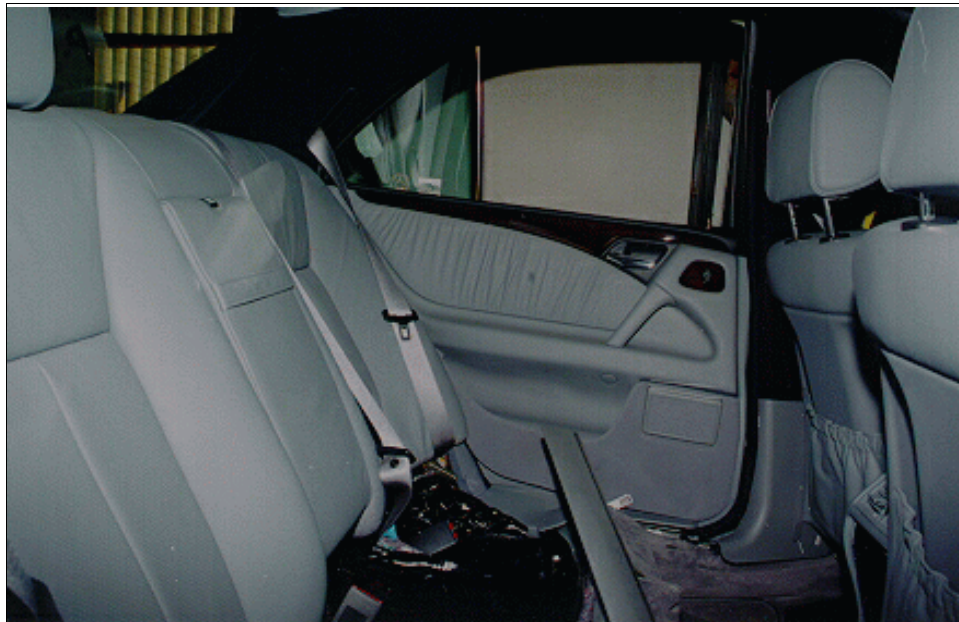
Figure 7: Case vehicle's back seat showing intruded left rear door and removed left rear seat cushion (case photo #36)

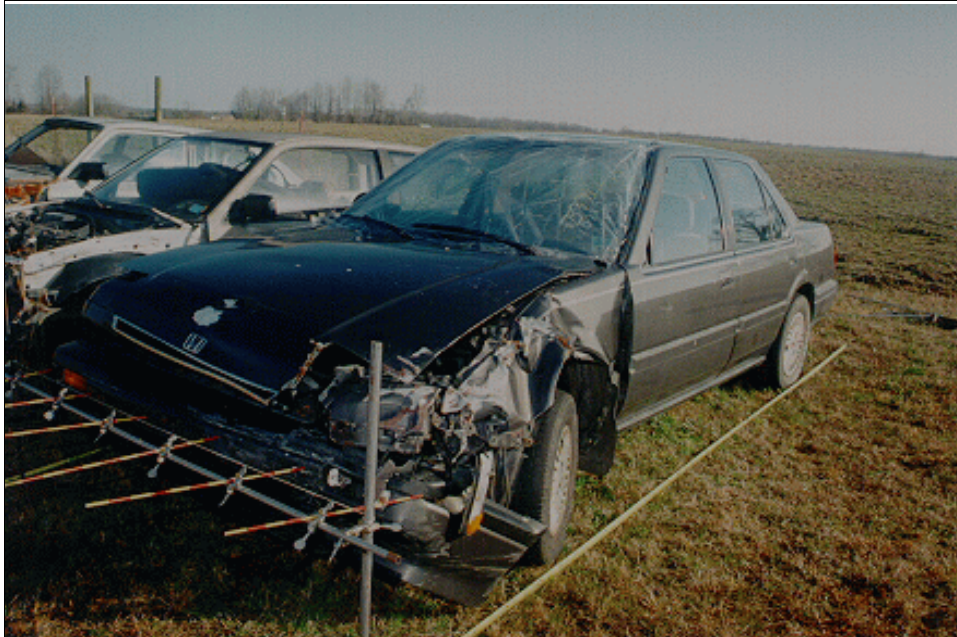
Vehicle #2 was a front wheel drive 1986 Honda Accord, four door sedan (VIN: 1HGBA7433GA-----). Direct contact damage was present across the left two-thirds of the front plane, with maximum crush 22 centimeters (8.7 inches) at the front left corner (see **Figure 8**). The CDC for vehicle #2 was determined to be **01-FDEW-1**. The winSMASH reconstruction program, damage only algorithm, was used on vehicle #2's highest severity impact. The Total, Longitudinal, and Lateral Delta Vs are, respectively: 21 km.p.h. (13 m.p.h.), -19 km.p.h. (-12 m.p.h.), and -7 km.p.h. (-4 m.p.h.).

Figure 8: Vehicle #2's front and left side (case photo #38)
